RAILWAY INVESTIGATION REPORT

R17W0175

Main-track train derailment

Canadian Pacific Railway

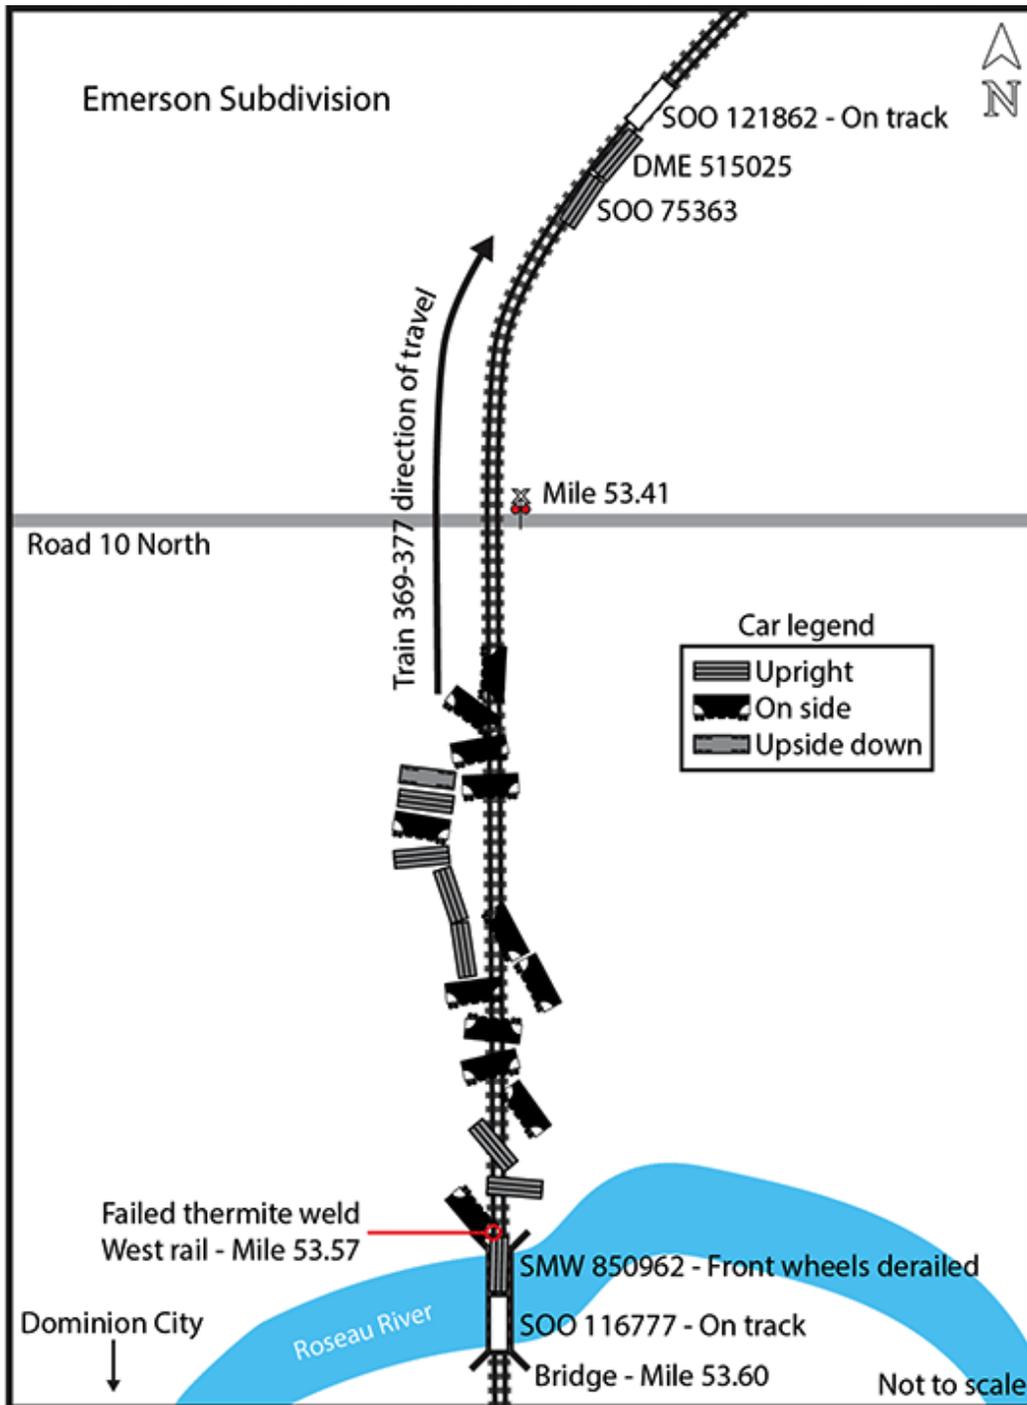
Figure 2. Occurrence site diagram, including the position of each derailed car

The cars derailed at 2 locations, separated by about 600 feet (Figure 2).

The first 2 cars to derail were the 58th car (DME 515025) and the 59th car (SOO 75363) from the head end. Although remaining upright, these 2 cars had made it over the Road 10 North crossing (Mile 53.41) and had travelled about 3000 feet past the bridge in the derailed condition. The crossing sustained damage due to the derailed equipment.

The other 20 derailed cars were clustered together in various positions between the crossing and the north end of the bridge. Most of these cars had derailed to the west side of the track.

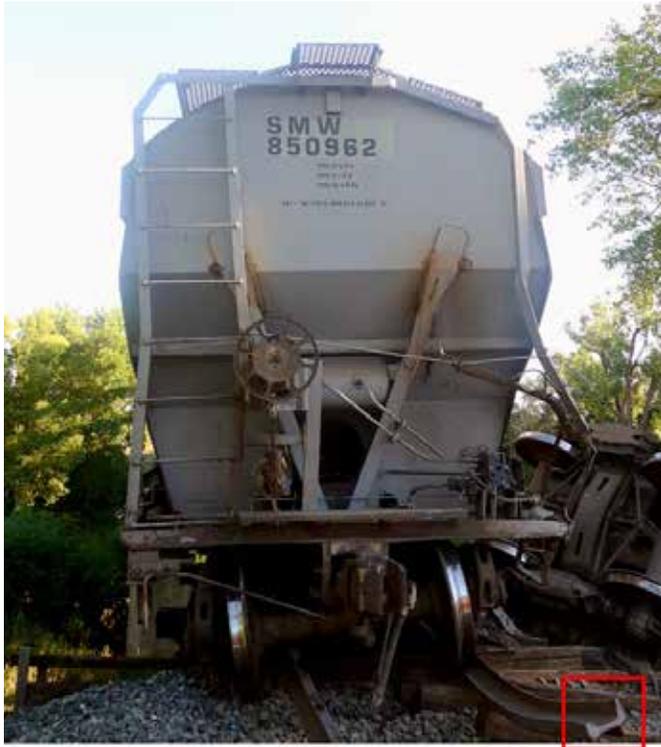
About 20 feet north of the bridge, a broken thermite weld² was observed in the west rail at Mile 53.57 (Figures 3 and 4). The thermite weld had been installed on 30 October 2008.

Figure 3. Looking south at the bridge's north approach with the failed thermite weld highlighted

Following the accident, Canadian Pacific Railway installed 5022 feet of 136-pound continuous welded rail between Mile 52.9 and Mile 53.8, and 568 ties between Mile 53.0 and Mile 54.0.

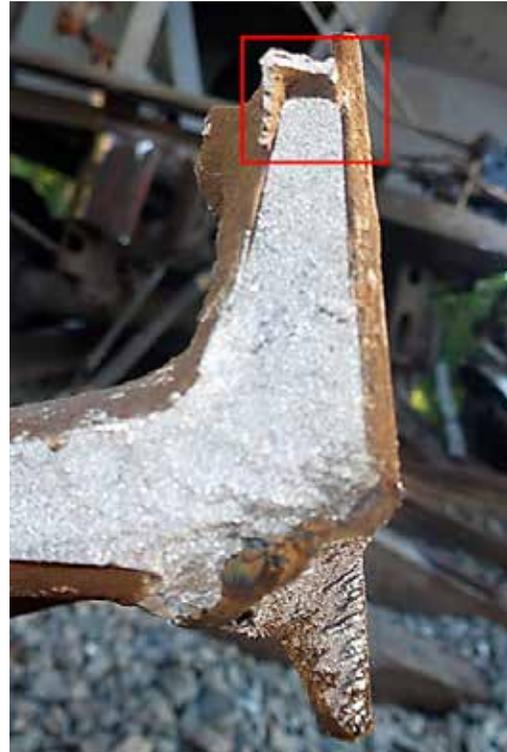
Figure 4. Close-up of the failed thermite weld's fracture surface with the origin highlighted

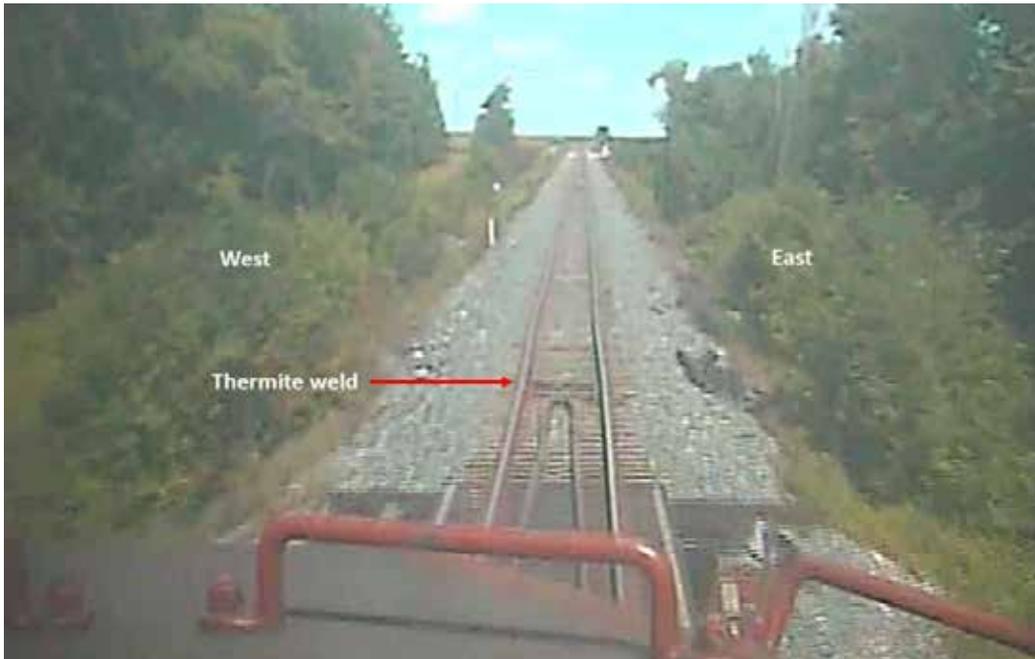
- the thermite weld was located in the left (west) rail just beyond the guard rails³ that extended off the north end of the bridge (Figure 5);
- a slight westward misalignment was present in the rail just north of the thermite weld (Figure 6); and
- the locomotive was jolted westward as it travelled over the misalignment location (Figure 7).

Figure 5. Thermite weld in the left (west) rail just beyond the guard rails that extended off the north end of the bridge (Source: Canadian Pacific Railway, with TSB annotations)

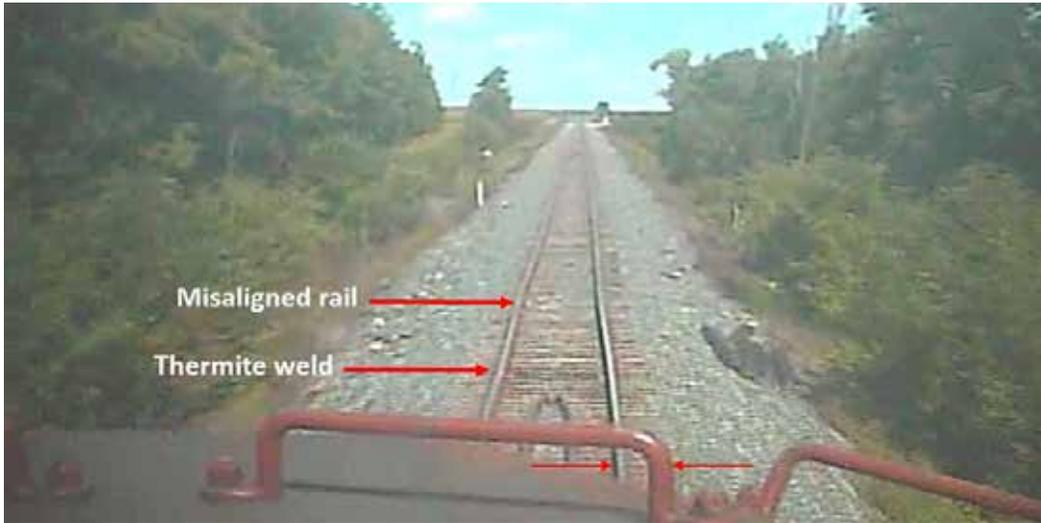
Figure 6. Slight rail misalignment just north of the thermite weld (Source: Canadian Pacific Railway, with TSB annotations)

- A westward track alignment deviation: An alignment deviation in the rail can cause wheels on rolling stock to kick outward, placing additional stress on the ties and the rail, particularly at the toe of the base of the rail on the field side (west).

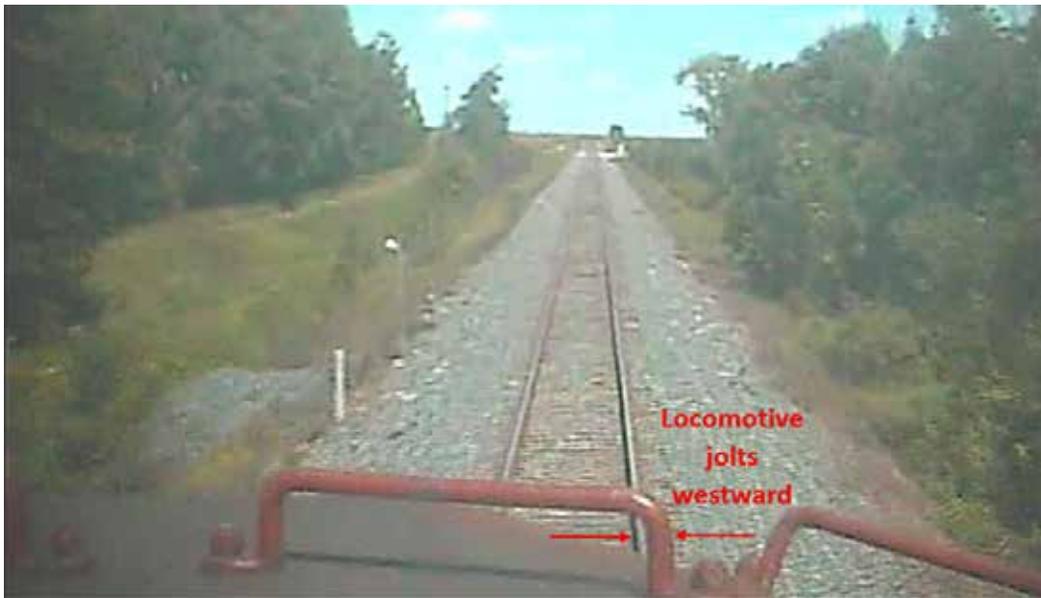
Figure 7. Locomotive jolts westward at the location of the misalignment in the west rail, with arrows highlighting the shift, as compared to Figure 6 (Source: Canadian Pacific Railway, with TSB annotations)

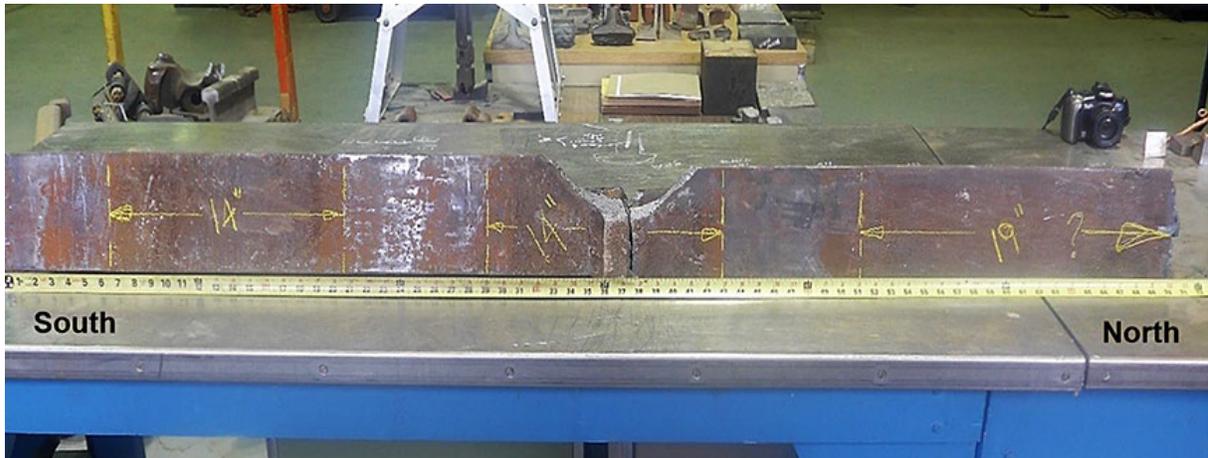
The underside of the rail showed irregular tie spacing. The crib adjacent to the thermite weld had no tie contact for at least 19 inches (Figure 8).

Figure 8. Tie spacing, as observed on the base of the rail

- Irregular tie spacing: The crib adjacent to the thermite weld in the west rail had no tie contact for at least 19 inches, resulting in greater vertical deflection of the rail at this location.

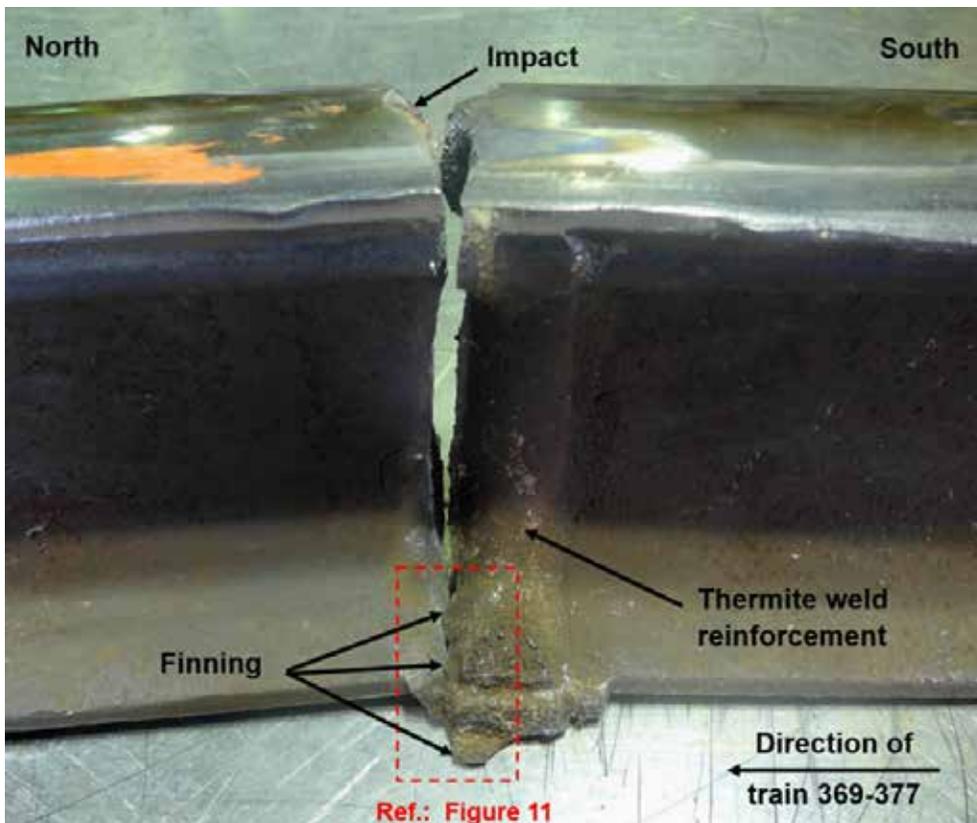
The break at the thermite weld was vertical and generally flat, and corresponded to the north edge of the thermite weld reinforcement (Figure 9).

Figure 9. Side view of thermite failure and fracture origin

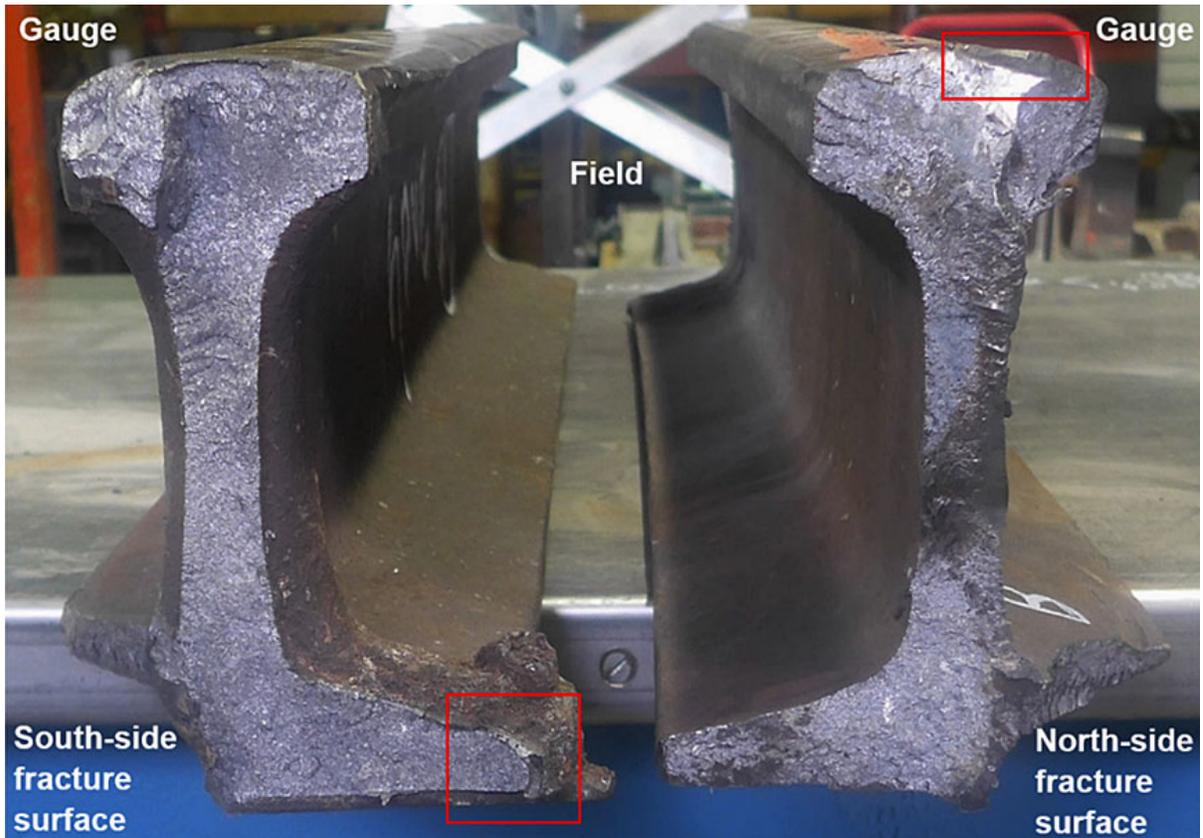
The running surface of the rail on the north-side fracture surface exhibited impact marks that were consistent with the train's direction of travel, indicating that the north side of the break had been exposed and was impacted by 1 or more wheel treads (Figure 10).

Figure 10. Exposed fracture surfaces showing probable fracture origin (square on rail base) and impact (rectangle on rail head)

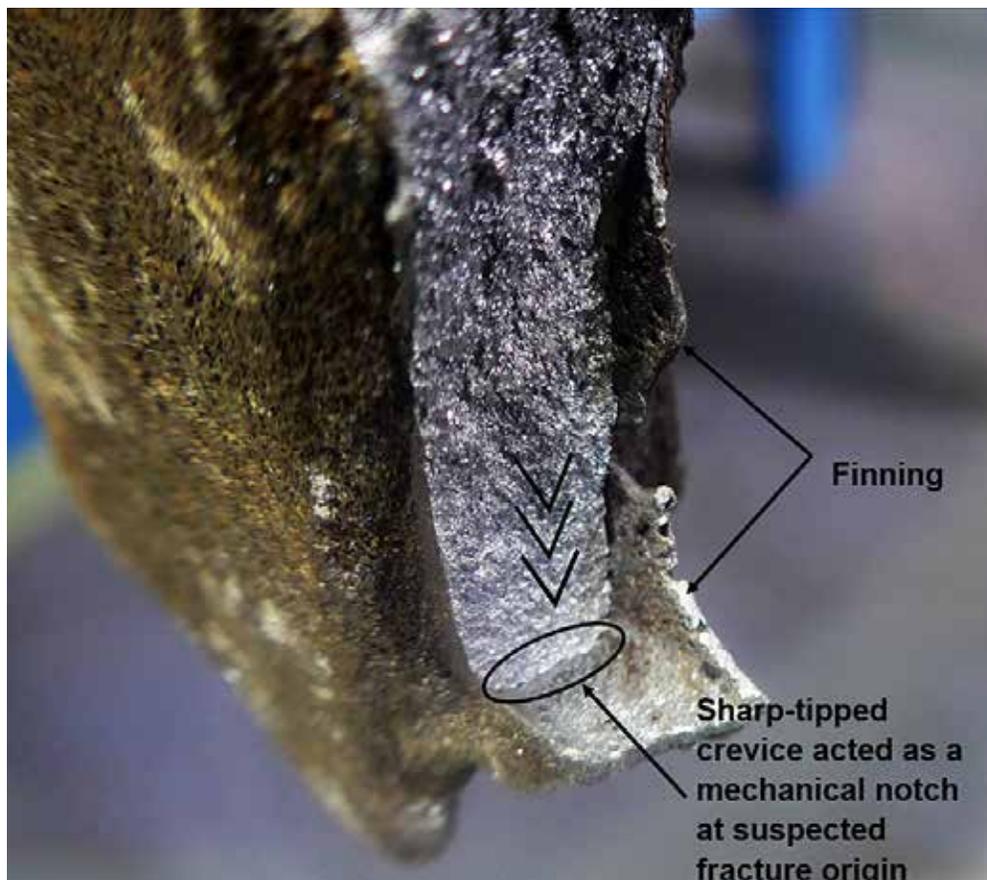
The fracture surfaces revealed a V-shaped chevron pattern, typical of a brittle failure. The chevrons pointed back to and identified a fracture origin on the field side of the fractured thermite weld at the outside surface of the rail base flange.

The fracture origin displayed an original thermite weld manufacturing process anomaly known as “finning.” A sharp-tipped crevice had formed and acted as a mechanical notch at the suspected fracture origin (Figure 11). There was no indication of fatigue failure.

Figure 11. Chevrons pointing back to fracture origin at thermite welding finning anomaly

The fracture origin displayed an anomaly referred to as “finning,” which occurred when the thermite weld was installed in October 2008. During the thermite weld process, finning occurred at the toe of the rail base when molten metal leaked from the mould and did not fuse with the rail, resulting in a sharp-tipped crevice (mechanical notch) that acted as a stress riser. With repeated tensile forces due to normal train operations, the finning at the toe of the rail base on the west rail’s field side became the nucleation site for the propagation of the brittle transverse fracture, leading to the failure of the thermite weld.
