AVIATION OCCURRENCE REPORT

A97H0011

LOSS OF CONTROL ON GO-AROUND (REJECTED LANDING)

AIR CANADA CANADAIR CL-600-2B19 C-FSKI
FREDERICTON AIRPORT, NEW BRUNSWICK
16 DECEMBER 1997

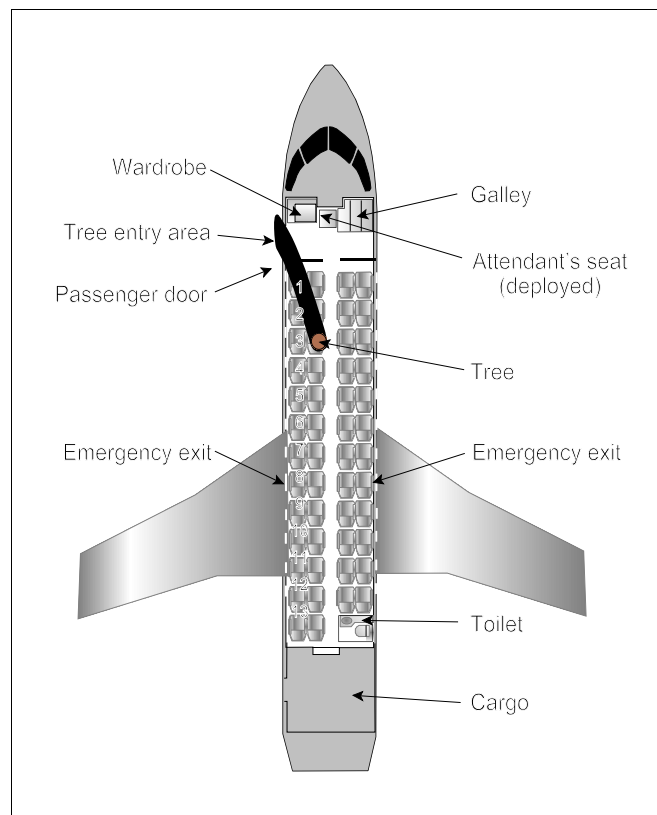
Figure 1 - Aircraft interior

The aircraft remained generally intact, with no damage to the empennage and damage to the top of the aircraft limited to the tear caused by the large tree. Damage to the wings was limited to an indentation on the leading edge of the left wing, caused by striking either the ground or a tree, and the inboard flaps were damaged by ground contact. The winglet of the right wing bent upwards on runway contact but remained attached to the wing until just before the aircraft stopped. The underside of the cockpit and nose area, back to the avionics bay door, was demolished by the departing nose gear and contact with the runway and ditch. The wreckage trail was strewn with electronic equipment and structure from the nose area, and with the three landing gear and associated structures. The underside of the aircraft, from the landing gear area aft to the rear fuselage equipment bay door, was damaged by the separating landing gear and by impacts with the ditch and the hill. The aircraft struck the tree at the passenger door, the tree remaining intact. As the aircraft moved forward, the tree cut through the aircraft cabin to a point about nine feet aft of the door, just left of the centre line of the aircraft. Apart from damage where the tree had torn through the aircraft, the rest of the cabin floor, seat rails, seats, and overhead bins showed no signs of deformation or damage. The area of the aircraft ahead of the galley, looking forward, was twisted counter-clockwise a significant amount.

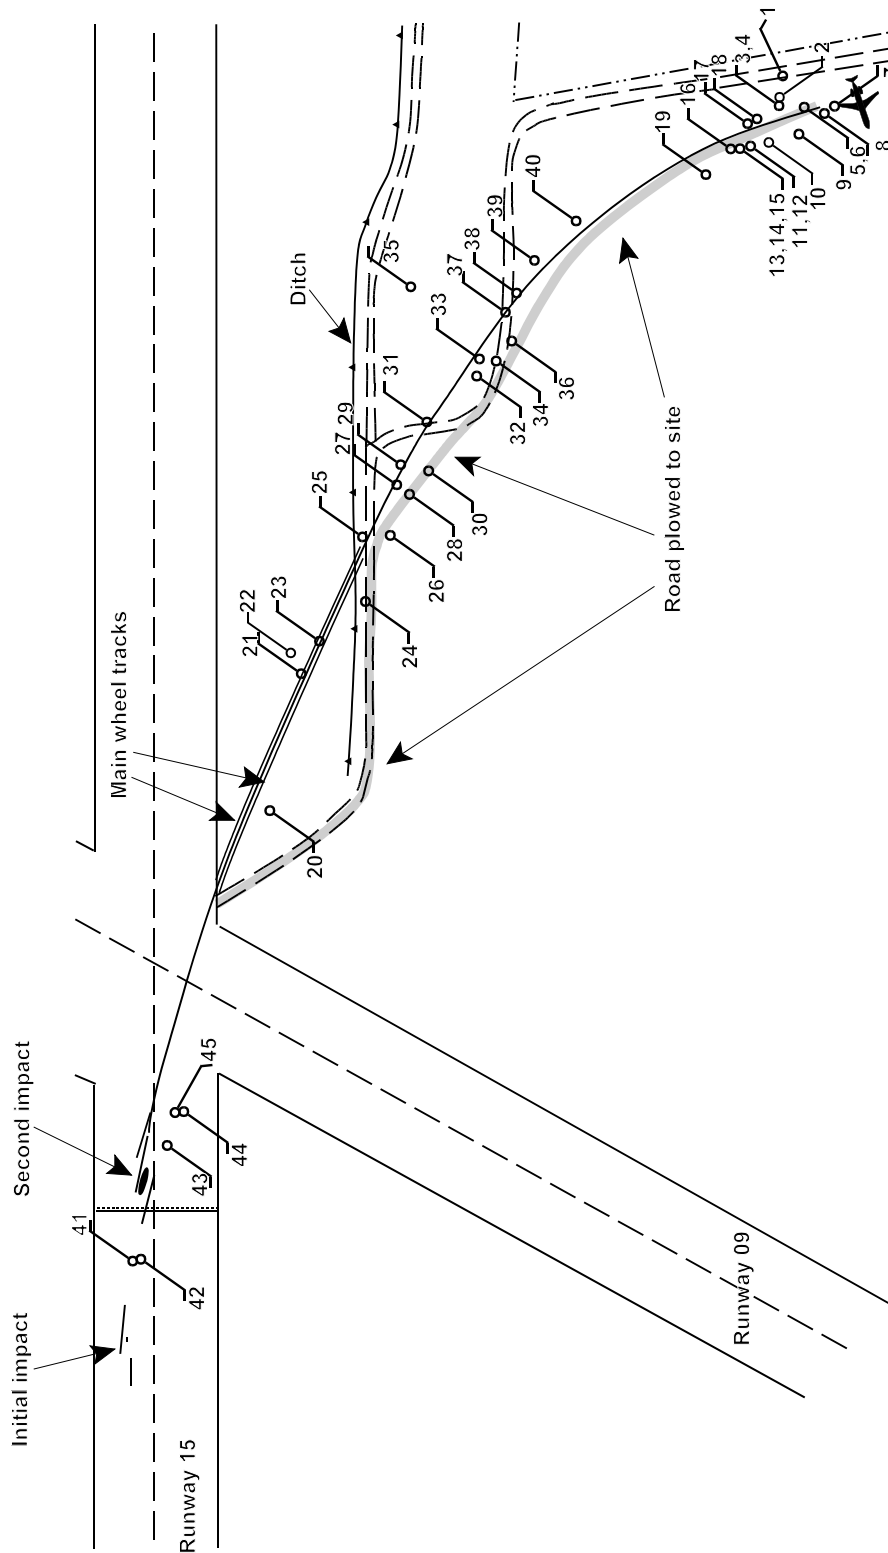
Appendix B1 – Aircraft Wreckage Plot

from the threshold and 45 feet left of the centre line, the right wing tip bending upwards about four feet from the tip. The aircraft rolled left toward wings level, then, about 260 feet further down the runway, struck it again, this time banked about 20 degrees to the right with the nose down about 12 degrees. The nose wheel assembly broke off, the right winglet broke off, the radome and underside of the nose cockpit area were heavily damaged, and electrical power, except for emergency lighting, was lost. The aircraft rolled left onto its main wheels and, with the engines now at full power, departed the right side of the runway just past the intersection with runway 09/27. The aircraft plowed through the snow, on its main wheels, until it struck a ditch parallel to and about 200 feet from the runway. The tracks in the snow past the ditch were much lighter than the tracks left by the main wheels.

These marks were made by flap fairings and aircraft equipment dangling on wiring still attached to the aircraft. The marks show that the aircraft became airborne after striking the ditch, very low to the ground, and flew in an arc to next strike a sand hill about 1000 feet right of the runway. Ground marks made by the aircraft were largely obliterated by traffic during the rescue, and it could not be determined where the aircraft first hit the hill; however, there were pieces of the aircraft near the bottom of the hill. At the top of the hill, the aircraft slewed to the right, struck some trees, one approximately 22 inches in diameter, and came to rest. The aircraft stopped on a heading of 314° magnetic, about 1130 feet west of the runway and 2100 feet from the first impact point on the runway. See diagram at Appendix B1.
