AVIATION OCCURRENCE REPORT

LOSS OF SEPARATION BETWEEN

AIR CANADA BOEING 767 C-GAUB (ACA109) AND

REPORT NUMBER A97P0153

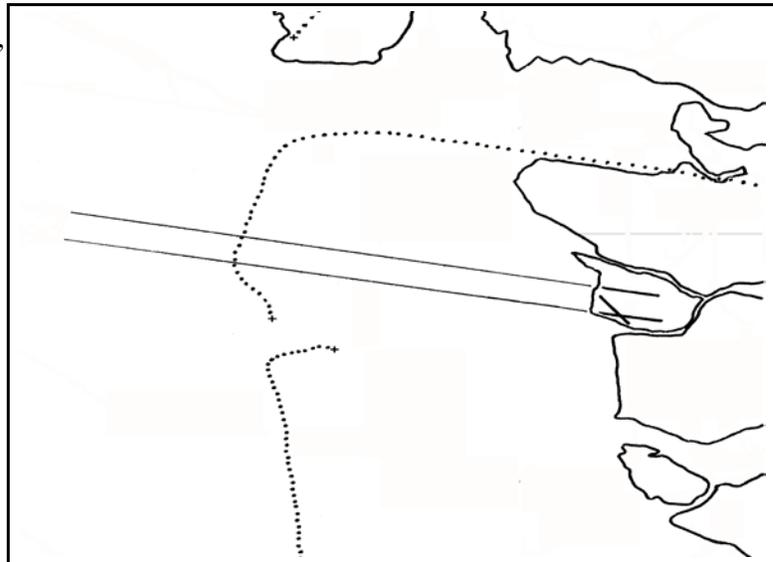
Based on the projected flight path of ACA109 which had now crossed both localizers at 3,000 feet, the controller immediately instructed MAL7072 to quickly turn right to a heading of 060° to maintain lateral separation. At 1455:00, the controller instructed ACA109 to "...maintain 2,000, expedite descent", and to turn right to a heading of 230°. The pilot acknowledged these instructions; however, the captain had already begun a firm, left turn back to the airport, and the aircraft was now headed directly toward MAL7072. The captain had been anticipating a left turn, and he thought the controller had instructed him to turn to a heading of 230°, a heading which was consistent with his expectations. The first officer then asked for confirmation of the heading, and when the controller repeated the 230° heading, the captain began a turn to the right. The aircraft continued at 3,000 feet.

At 1455:34, the controller again instructed ACA109 to descend, using the phrase "...descend to 2,000 now"; 26 seconds later, the aircraft began to descend from 3,000 feet. In the meantime, the delay caused by this additional communication exacerbated the collision course geometry with MAL7072, and the arrival controller turned MAL7072 to a heading of 120°; this action, however, did not prevent the loss of separation between ACA109 and MAL7072.
