AVIATION OCCURRENCE REPORT

IN-FLIGHT WING SEPARATION

SKYHOPPER (AMATEUR-BUILT) C-FRDG
SMITHS FALLS-MONTAGUE
(RUSS BEACH) AIRPORT, ONTARIO 2 mi S
01 MAY 1998

Report Number A9800104

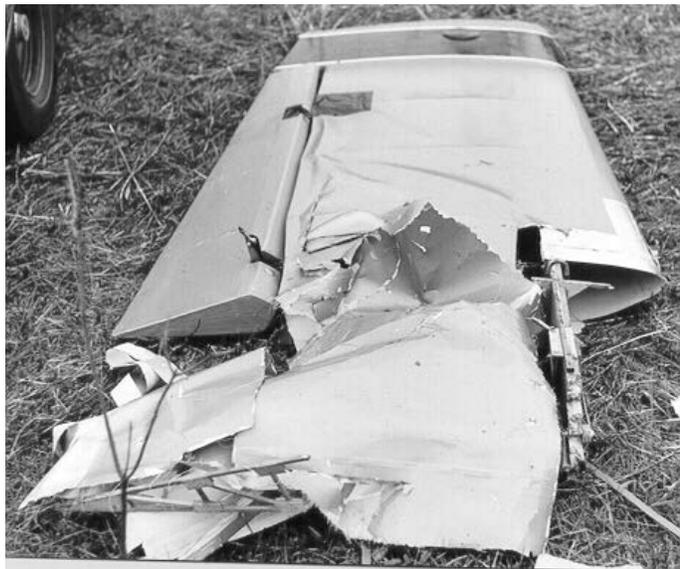
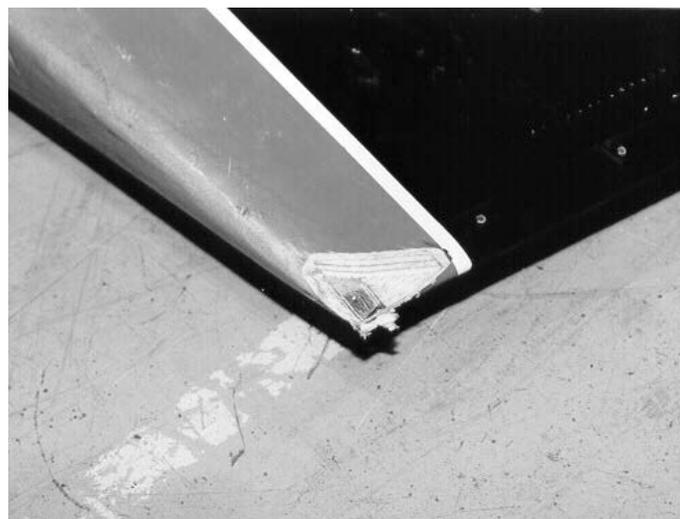
The main wreckage was located two miles south of the airport and the separated section of the right wing was 3 000 feet north of the main wreckage, resting above the ground in brush type trees. The right wing main spar separated from the aircraft 97 inches in from the wing tip, and the rear spar separated 56 inches in from the wing tip. The front spar had fractured in one location and the rear spar in three locations. There was no sign of rubbing on the surfaces of any of the spar fractures. The bottom surface of the trailing edge of the right wing tip was ground down through two layers of wood. The ground-off surface had a fresh appearance and was free of dirt or debris.

The freshly ground-off surface on the bottom side of the aircraft right wing tip was typical of damage resulting from the wing tip contacting the ground during a recent ground loop or severe swerve to the left. The lack of dirt or debris on the scrape mark indicates the damage occurred from contact with an asphalt or concrete surface. Although it was not possible to quantify the forces applied to the wing as a result of the tip scrape, it can be concluded, from appearance alone, that the forces applied at the time of the scrape were significant enough to crack and weaken one or both of the right wing spars. The lack of any sign of rubbing on the fractured surfaces also indicates that any cracking of the wing spars was recent, possibly as recent as the last take-off or landing. Had there been cracks in the wood spars for a lengthy period of time there likely would have been signs of rubbing on the fracture surfaces as a result of the two surfaces of the crack rubbing together during normal wing loading in flight.
