AVIATION INVESTIGATION REPORT

A00P0208

MAIN-ROTOR BLADE FAILURE

MD HELICOPTER 369D, C-GXON

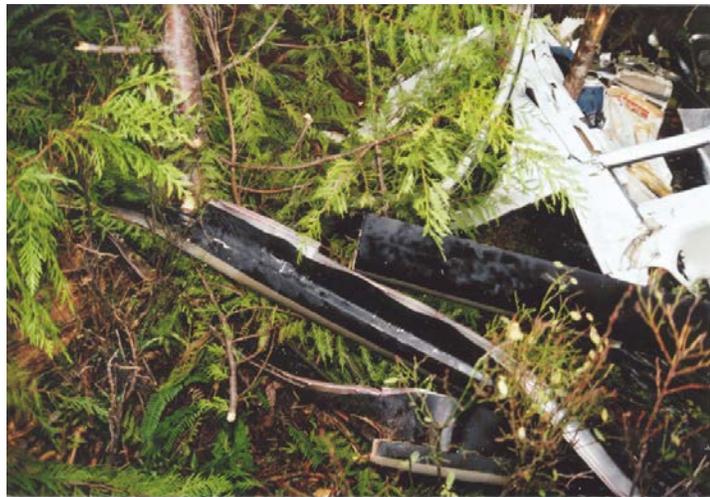
Marks on the aft fuselage showed that the main rotor blades had severed the tail section. All of the lead and lag blade dampers were torn apart. The helicopter is fitted with five main-rotor blades that are identified by colour. The red blade was notable in that it showed a clean break about one-third of the distance from its root (see Figure 1). The break was perpendicular to the leading edge of the blade, and the break in the spar was recessed from the skin. The outboard two-thirds of this blade was not found. The white blade was missing completely, including its main-rotor blade grip. The yellow blade was missing its end one-third and showed clear damage from hitting the tail section. The green blade was torn into two pieces after it had stopped turning. The blue blade was the only blade in one piece. Apart from the damage caused by the blades striking the aft section of the fuselage in flight, the damage to the main-rotor system and the blades was consistent with that exhibited when the rotor is not turning or being driven at ground impact.

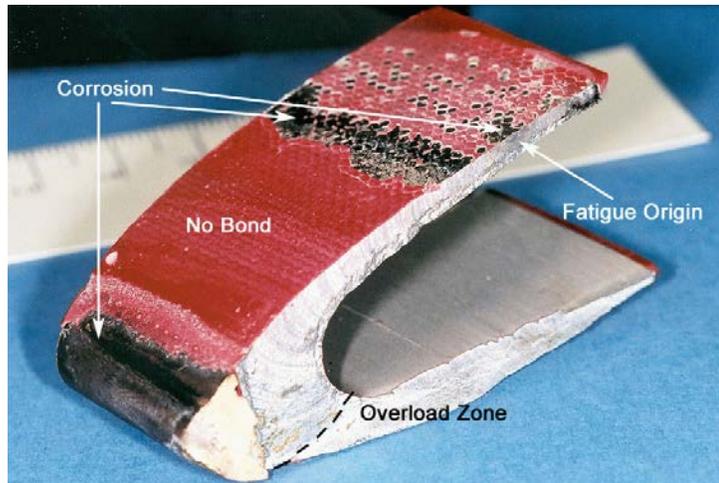
The red blade, with the clean break, was removed from the wreckage and transported to an independent engineering facility for examination. Detailed visual and scanning-electron microscope inspections revealed a bonding void between the blade skin and the spar. It also revealed corrosion pits in the spar, in the area of the bonding void. A fatigue crack had propagated from one of the pits and through the spar until the weakened blade failed from overload. The corrosion pit revealed chlorine and sulphur, as happens when the corrosion is from a marine or industrial environment.

The crack in the spar of the failed rotor blade did not manifest itself through the outer skin because of the lack of bonding between the main-rotor blade spar and the outer skin. Therefore, the crack would not have been identifiable by visual inspection before the blade failure.

After confirming that there was a manufacturing flaw—the lack of bonding in the area of blade separation—in the main-rotor blade, the manufacturer of the blades took immediate action. The manufacturer informed operators of the problem and issued a Mandatory Service Bulletin on 6 November 2000 to check the bonding on affected 369D blades before the next flight. The US Federal Aviation Administration issued an Airworthiness Directive on 20 November 2000 requiring compliance with the aforementioned Mandatory Service Bulletin. The Airworthiness Directive calls for a one-time inspection, before the next flight, of all of the 369D main-rotor blades manufactured by the approved parts manufacturer and establishes new criteria for acceptable voids in all new blades.
