AVIATION INVESTIGATION REPORT

A04Q0026

SEPARATION OF MAIN ROTOR ON RUNUP

SCHWEIZER 269C-1 (HELICOPTER) C-FZQF

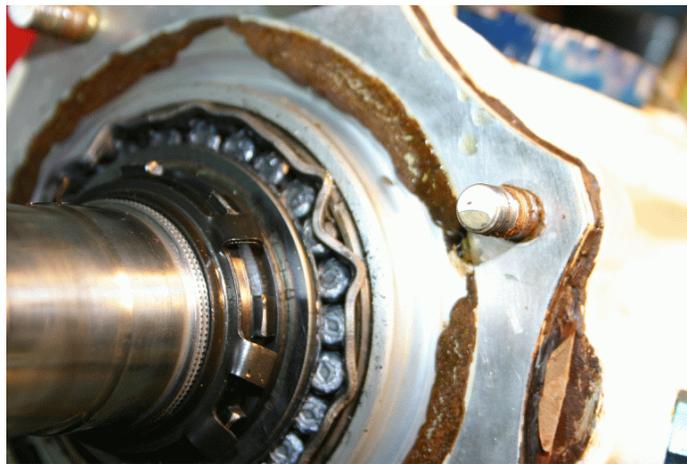
When the main transmission gearbox was being reassembled, the input quill bearing housing was assembled incorrectly. It was rotated clockwise 90 degrees in relation to the main transmission gearbox oil inlet and outlet ports. This condition contributed to the blockage of the oil passage feeding the bearings and caused the catastrophic failure of the input quill bearings. This type of failure is known as skewing, where the individual bearings jam together when the bearing cage fails (see Photo 1).

Photo 1. Distorted bearing cage

1. The input quill bearing housing was not positioned in accordance with the procedures described by the manufacturer; therefore, the flow of oil was obstructed, causing the catastrophic failure of the input quill bearings.
2. Independent inspection did not detect the incorrect reassembly of the main transmission gearbox.

At the completion of the main transmission overhauls or at sudden stoppage inspections or in any other situations in which the retainer has to be removed, AOG Heliservices Inc. will paint a red witness line on the retainer and on the transmission housing to assure alignment of oil ports. Also, they will run the transmission for fifteen minutes to check that there is oil flow in the transmission and to check for oil leaks at the seal and split line. These changes will be put into their worksheets.
