AVIATION INVESTIGATION REPORT
A07O0095

LANDING GEAR COLLAPSE AFTER TOUCHDOWN

**WABUSK AIR
PIPER PA31 C-GRVW
MOOSONEE, ONTARIO
09 APRIL 2007**

Report Number A07O0095

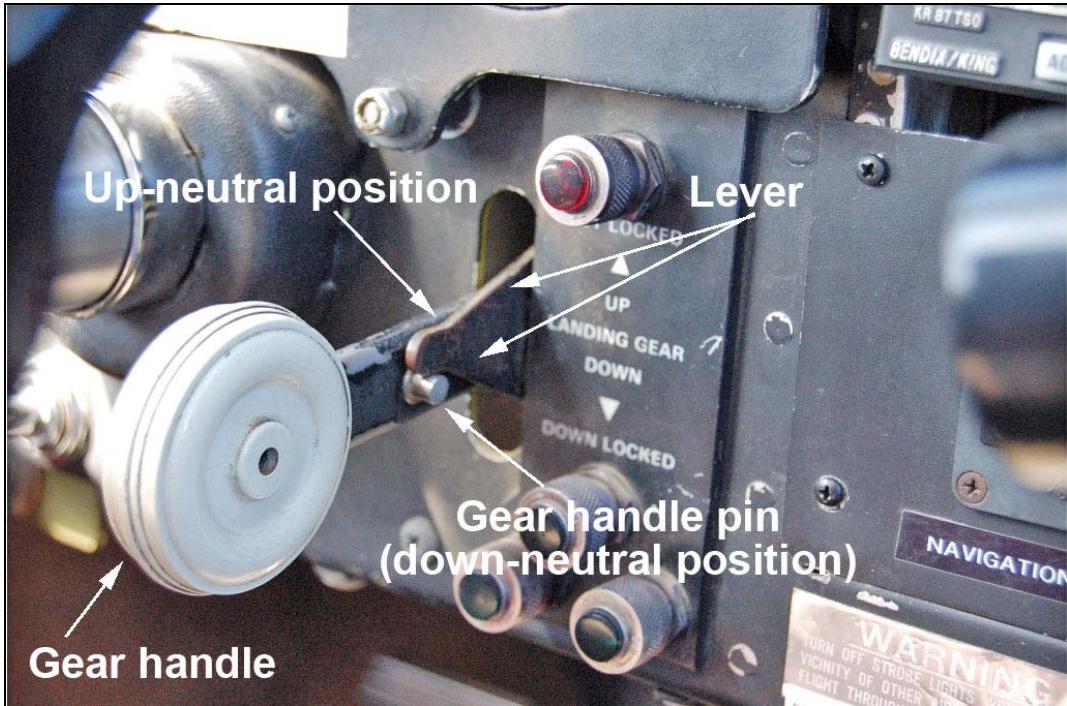
Photo 1. Landing gear handle

The landing gear handle was in the down neutral position (see Photo 1). The aircraft was lifted to enable extension of the landing gear. Once in the air, it was found that snow had packed into landing gear bays as the aircraft was dragged to the apron. The landing gear free-fell to the down position once the snow was cleared away. All three landing gear locked into the down position using the hand pump, and there were corresponding gear down indications. The landing gear was examined, and there was no mechanical failure to any of the landing gear components. Additionally, there were no discrepancies noted in the rigging of the landing gear, and the landing gear oleo extension appeared normal.

The landing gear handle is designed so the handle is spring-loaded to a forward position (towards the console). There is one pin on the inboard side of the handle that rests against a lever that acts as a neutral stop (see Photo 1). A spring ensures that the landing gear handle is positively seated in the forward position and cannot be moved unintentionally beyond the neutral stop. One end of the spring was found to be broken and the spring appeared to be weak. This caused the handle to be loose and prevented the landing gear handle from positively retracting to the forward position. During testing, the landing gear handle could be easily bumped over the down neutral position with the weight off the wheels and the master switch turned on. With the weight on wheels and the master switch on, the anti-retraction switch prevented any movement of the landing gear handle above the neutral stop. However, with weight off wheels, the landing gear selector could easily be bumped to a position where it was just above the centreline of the neutral stop, bypassing the solenoid-operated lock, but not triggering any of the warning horns. When weight on wheels was achieved, the landing gear handle could be selected to the up position. Additionally, movement of the landing gear handle to a position approximately 0.375 inches above "UP" neutral began the landing gear retraction sequence, allowing the landing gear to retract.

1. The spring in the landing gear handle was broken and allowed easy movement of the landing gear handle past the neutral stop.
2. During the approach, the landing gear handle was most likely placed in a position that bypassed the anti-retraction system.
3. The landing gear handle inadvertently moved to an "UP" selection during the landing roll, which activated the gear warning horn and retracted the landing gear.

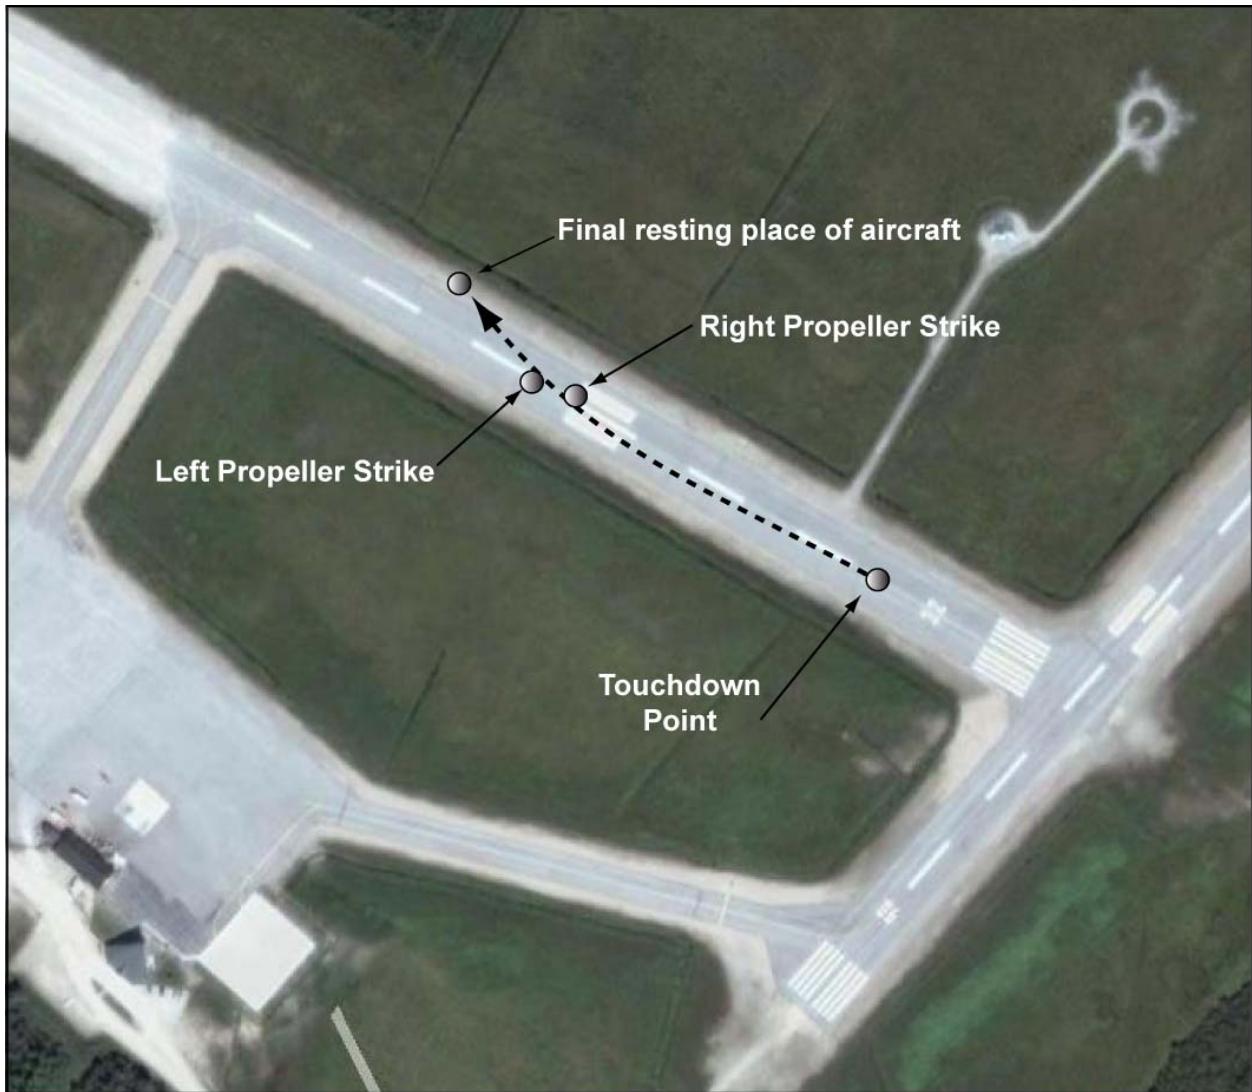
Appendix A – Site Diagram

When investigators arrived, the aircraft had been dragged from the runway to the apron area and was left secured for examination. The runway was examined and propeller strike marks were found for both propellers (see Appendix A). The marks confirmed that the right main gear collapsed first, followed by the remaining landing gear. The flaps and landing gear were in the retracted position. There was damage to the underside of the right wing tip, the underside of the aircraft fuselage, and the nose gear doors. The right engine propeller blades were bent back around the engine nacelle and were not feathered. The left engine propeller blades were bent back around the engine nacelle and were feathered.
