**AVIATION INVESTIGATION REPORT
A13W0070**

**LOSS OF TAIL ROTOR EFFECTIVENESS, AND COLLISION
WITH TERRAIN**

**AURORA HELICOPTERS LTD. (DBA WOOD BUFFALO
HELICOPTERS)
BELL 206B C-FZWB
FORT MCMURRAY, ALBERTA 75 NM N
29 MAY 2013**

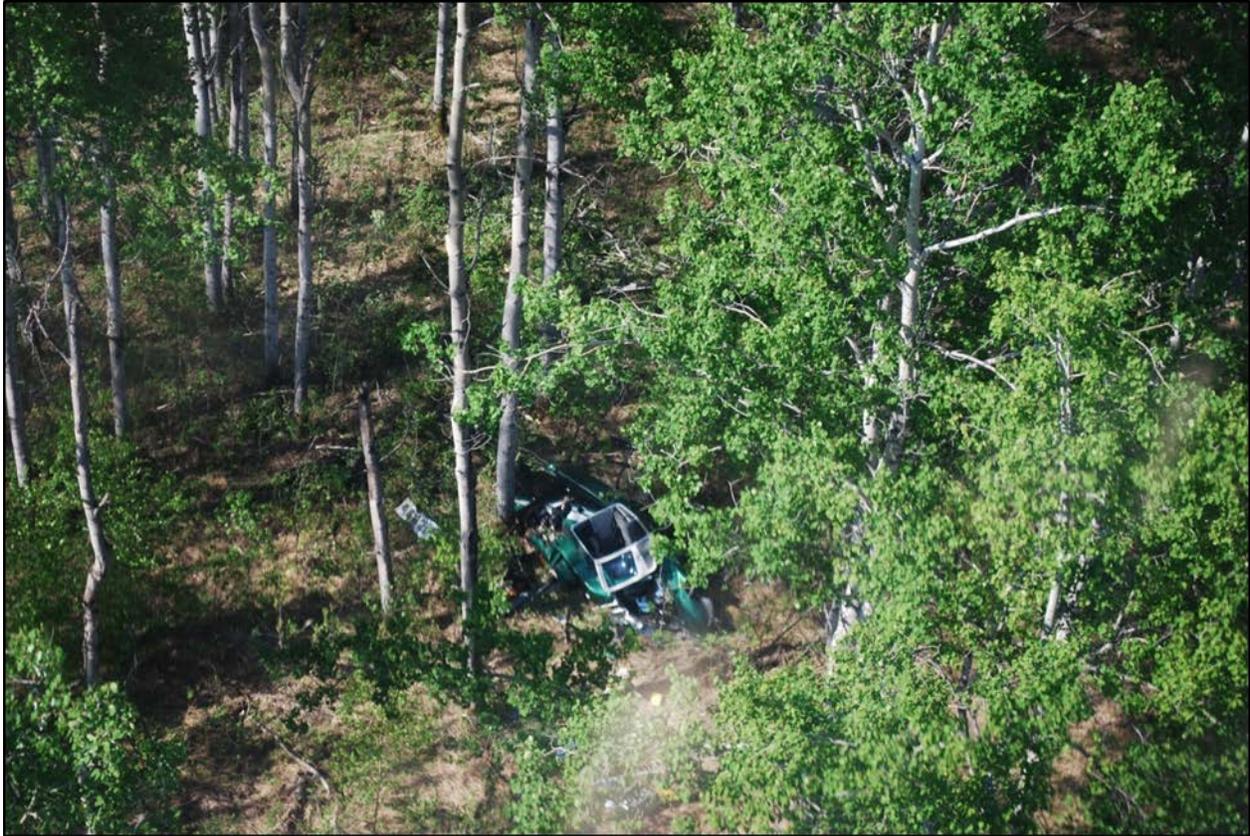
At 1056:34, the helicopter was at 115 feet agl with a ground speed of 16 knots. At this point, a right turn to the south was initiated. The ground speed had reduced to 5 knots. A final global positioning system (GPS) waypoint was recorded at 1056:54 with the aircraft at 18 feet agl with a ground speed of 3 knots. Upon completion of the turn to the south, the helicopter would have been exposed to a tail-wind condition. The helicopter entered an un-commanded rotation to the right. There were no indications of mechanical malfunction prior to or during the rotation. The helicopter descended into a stand of poplar trees 60 to 70 feet tall, coming to rest on its right side.

Photo 1. Wreckage of helicopter C-FZWB in the stand of poplar trees

All of the helicopter's components were identified within a 100-foot radius of the aircraft. The helicopter's cabin and fuselage were in a single piece, but it had sustained substantial impact damage, particularly on the right side of the fuselage. The main rotor head shaft had separated below the rotor head, and was located 26 feet from the wreckage. One main rotor blade had sustained 2 fractures. The other main rotor blade, while still attached to the rotor head, was substantially damaged.

The tail boom was adjacent to the fuselage but it was severed approximately 3 feet aft of the horizontal stabilizers. It had indications that it had struck a tree at that point, on the left side of the tail boom. The remainder of the tail boom, including the vertical fin and tail rotor, was located about 7 feet aft and slightly east of the forward section. The aft section was oriented with the tail cone towards the main wreckage.

The tail rotor was mostly intact with one blade still attached to the yoke. This blade was straight with minor impact damage to the skin. The other blade had fractured just outboard of the yoke, and was lying on the ground approximately 5 feet east of the aft section of tail boom.

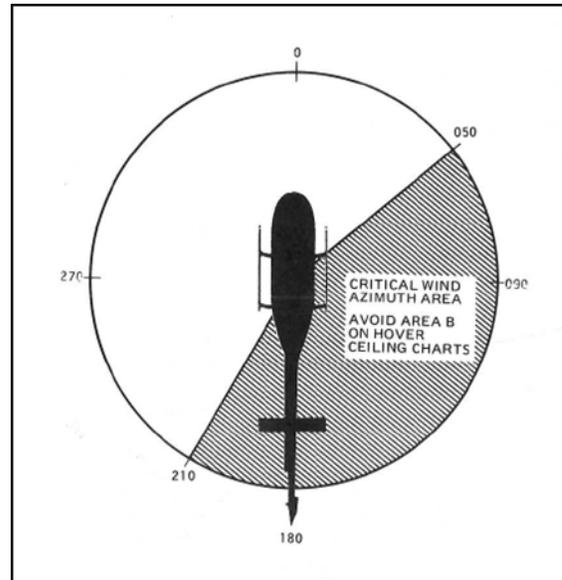
Figure 2. Critical wind azimuth area (source: Bell Helicopters, *Bell Jet Ranger-II Model 206B Flight Manual* (2009))

The Bell 206 aircraft flight manual advises caution when operating when the relative wind is within the critical wind azimuth area. The aircraft flight manual goes on to discuss hovering ceilings, and alerts the pilot that when operating within area B,⁷ depicted by the hatched area in Figure 2, tail rotor control margin and/or control of engine temperature may preclude operation in area B of the hover ceiling charts when the relative wind is in the critical wind azimuth area. As a result, there is the potential for a loss of tail rotor effectiveness.

The helicopter was operating in a flight regime where it was exposed to the left crosswind and tail wind, which would have placed the relative wind into the critical azimuth zone. While conducting a reconnaissance for landing, the helicopter was flown at a low speed and high power setting. As the pilot progressively reduced speed, the helicopter became increasingly vulnerable to LTE. The damage to the under-surface of the main rotor blades indicated that the pilot attempted to increase his collective control input in an effort to power out of the area. The application of power in this particular flight regime would have exacerbated the right yaw tendency and aggravated the loss of control. The helicopter experienced LTE, causing a loss of directional control at a height above the trees that precluded an effective recovery.

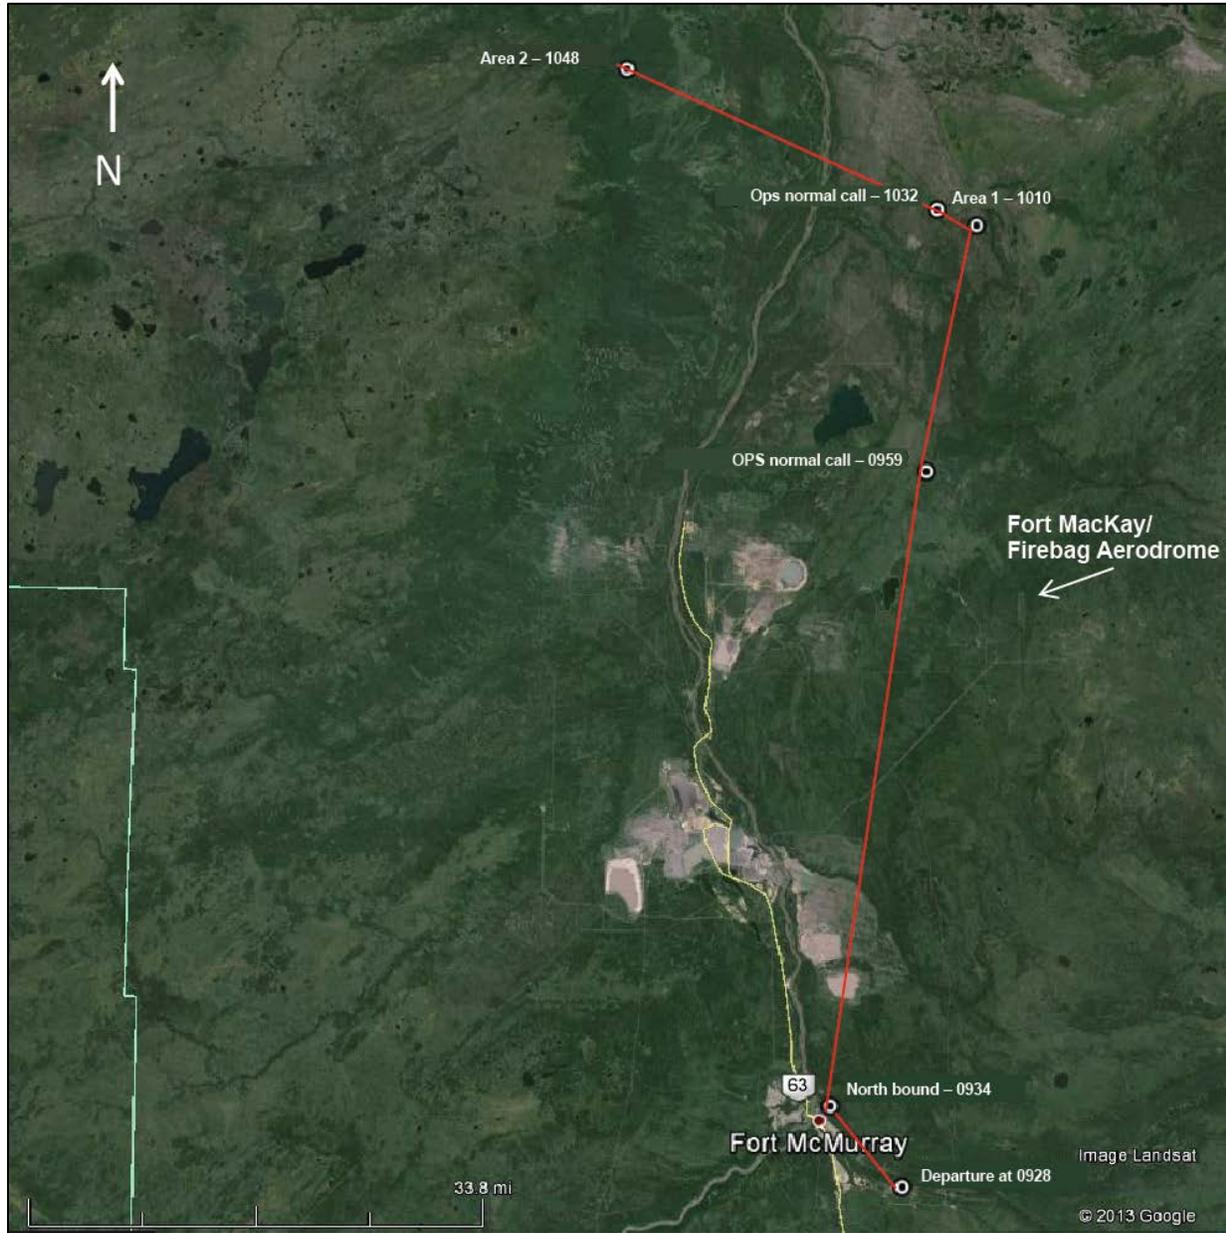
Appendix A – Flight Path

At 1055, the helicopter orbited the area and executed a wide left-hand turn at 140 feet agl. At 1056:14, the helicopter turned eastbound at 120 feet agl at a ground speed of 36 knots. At 1056:24, the helicopter was at 105 feet agl at a ground speed of 27 knots. The wind component at this time would have been predominantly a left crosswind from the north at approximately 5 knots.
