**AVIATION INVESTIGATION REPORT  
A15O0031**

**IN-FLIGHT BREAKUP  
PIPER PA-32RT-300T, C-GDWA  
FRENCH RIVER PROVINCIAL PARK, ONTARIO  
17 MARCH 2015**

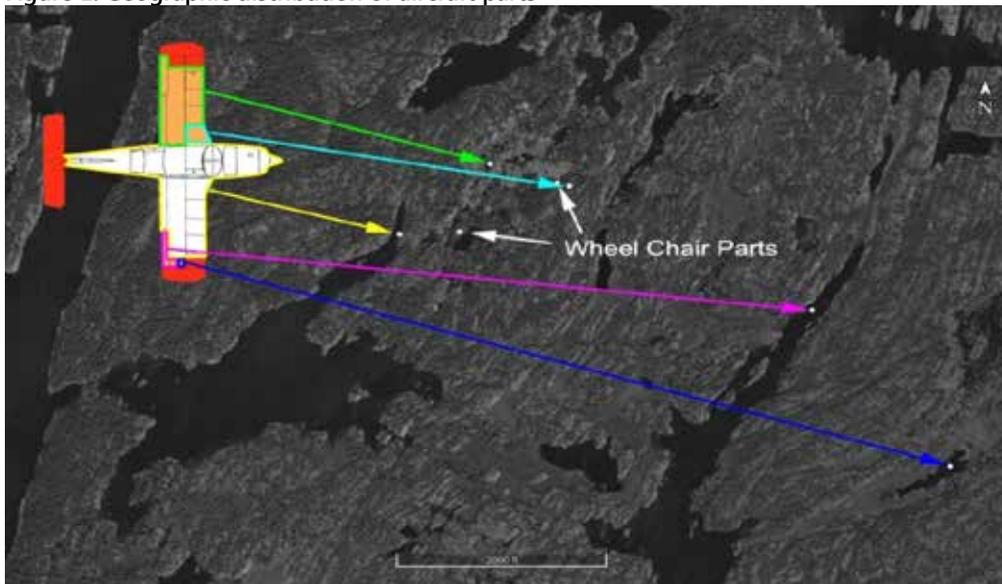
Figure 1. Geographic distribution of aircraft parts

Table 1 lists the aircraft parts and baggage items that were recovered, along with their respective distances and bearings from the main wreckage, and Figure 1 shows their distribution.

Aircraft pieces that the investigators did not locate included the 2 fiberglass wing tips, most of the outboard wing skins, and the horizontal stabilator<sup>8</sup> (Appendix A).

Both wings' spars had failed as a result of instantaneous positive *g*-overload fractures; there was no indication of pre-existing fatigue or mechanical defect.

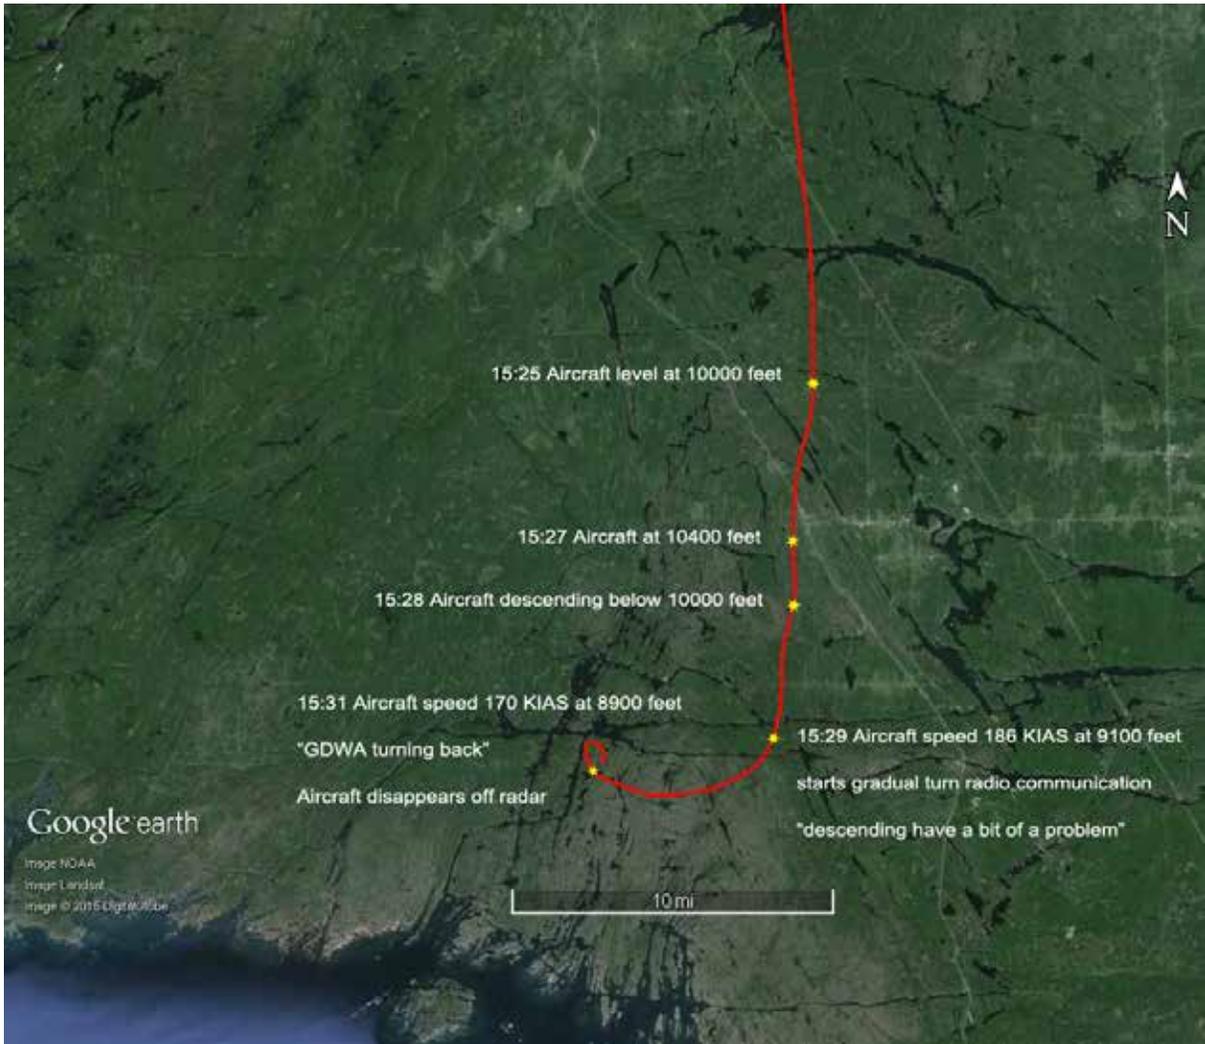
*Appendix B – Flight path*

The aircraft was not equipped with a flight data recorder or cockpit voice recorder, nor was either required by regulation. However, it was equipped with instruments capable of recording some data, such as engine performance. These, along with the remainder of the flight instruments and radios, were severely damaged by the fire, and no useful information could be recovered. The TSB Laboratory reconstructed the flight using the available radar, ATC radio communications, and weather data. The radar information for this area came from radars located in North Bay, Ontario, east of the accident site. Based on all available data, the information was compiled and a final flight path was reconstructed (Appendix B).
