Air Transportation Safety Investigation Brief A16W0094

COLLISION WITH TERRAIN

North American Aviation Inc. T28-B, C-GKKD
Canadian Forces Base Cold Lake, Alberta
17 July 2016

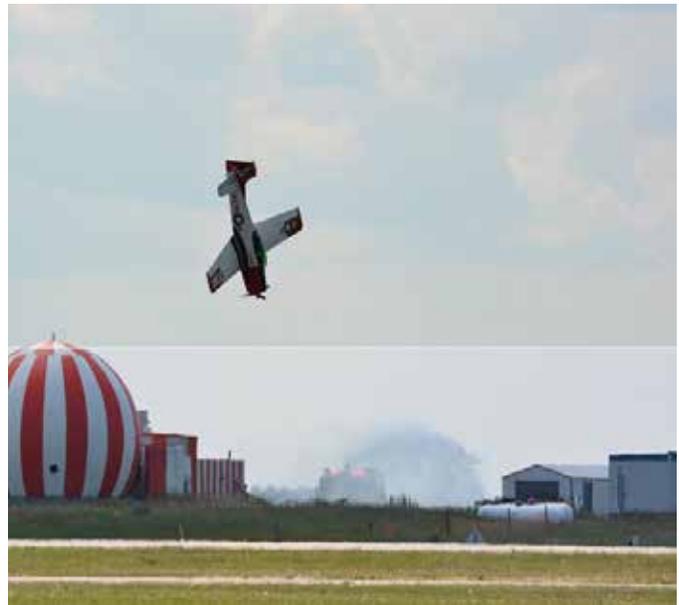
The pilot flew from show right to left at about 500 feet above ground level (AGL) within the defined airspace for the routine, then entered a roll just before show centre. As the aircraft reached the inverted position, the roll stopped and the nose began to pitch toward the ground. The aircraft elevator was seen to move to full up deflection as the aircraft continued toward the ground in an arc until its collision with terrain, in a near-vertical position with a slight right roll (Figure 1).

Figure 1. Composite image of 2 photographs taken 3 minutes apart. The upper portion of the image was photographed just prior to impact, and the lower portion during the emergency response.

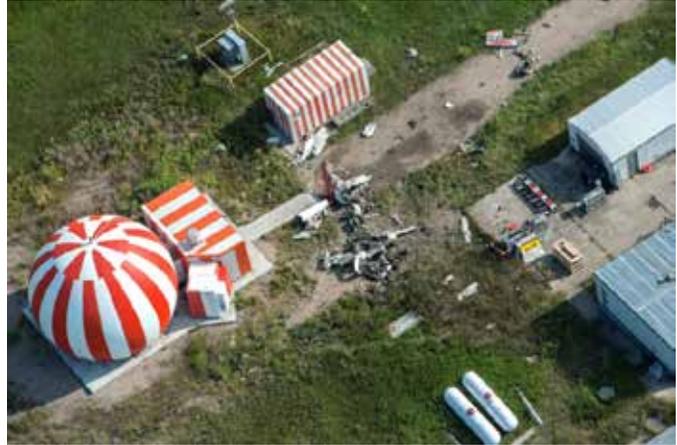
The aircraft struck the ground at a high velocity, in a near-vertical attitude. It was destroyed by impact forces. The impact site was located among several structures used for provision of airfield services. These included the buildings that housed the precision approach radar equipment and its backup power generator, and twin 1000-gallon propane tanks (Figure 2).

Debris from the aircraft penetrated the walls of the backup power generator building; however, there was no significant damage to any of the infrastructure and it remained operational.

Figure 2. Aerial photograph of the accident site, located near the precision approach radar facility (Source: Department of National Defence)

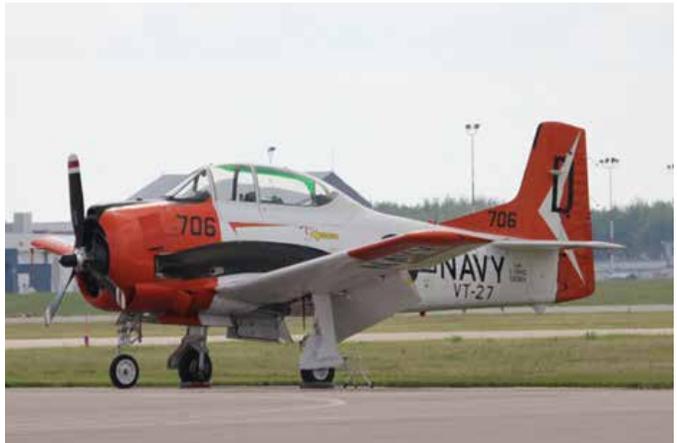
Figure 3. C-GKKD, pictured at Canadian Forces Base Cold Lake on the day of the accident (Source: Department of National Defence)
