AVIATION INVESTIGATION REPORT

A16P0180

Loss of control and collision with terrain

de Havilland DHC-2 (Beaver), C-GEWG
Laidman Lake, British Columbia, 11 nm E
10 October 2016

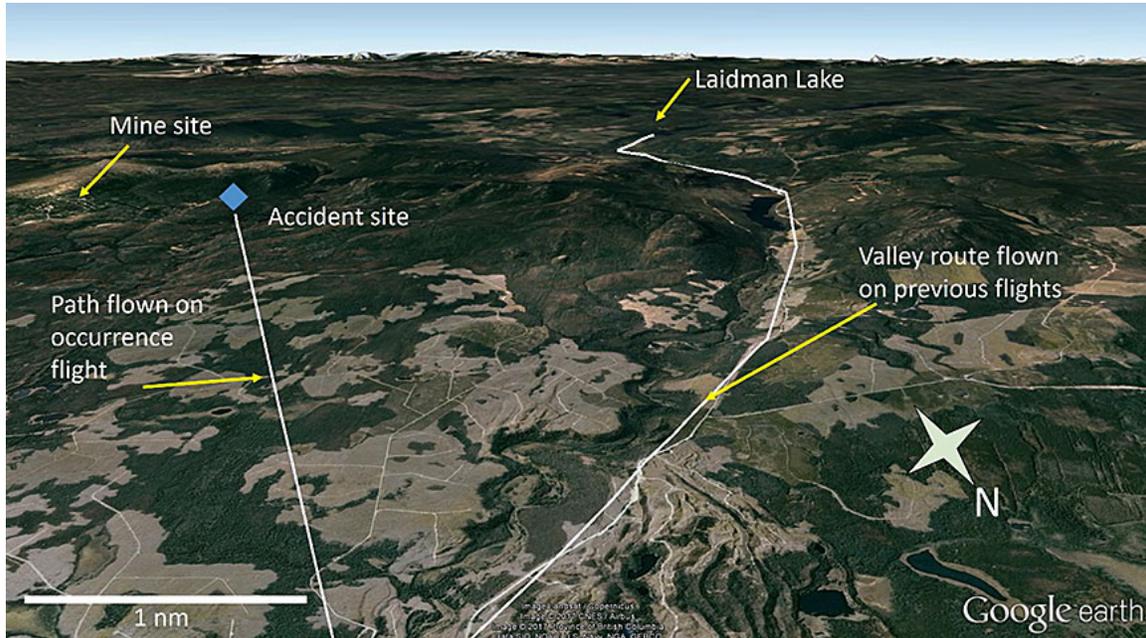
On previous trips to the recreational property, the pilot had usually flown a direct track for the majority of the route and then entered and followed a river valley that led to Laidman Lake (Figure 1). Ground elevations along that valley routing remained relatively constant at about 3100–3200 feet above sea level (ASL). Accordingly, for approximately 20 minutes after departure, the flight continued in a southwesterly direction at approximately 300–500 feet AGL. When the aircraft was about 12 nautical miles (nm) from Laidman Lake, the pilot diverted from the usual route and turned the aircraft to fly over a mining exploration site located on higher terrain east of the lake. Ground elevations in that area rise from 3200–4600 feet ASL over a distance of about 4.5 nm. The aircraft continued to

fly at a constant altitude over the rising terrain for about 4 minutes until its height above the hillside had decreased to approximately 100 feet above the trees.

Figure 1. Aerial view of the general flight area from the direction of CAU4 (Source: Google Earth, with TSB annotations)

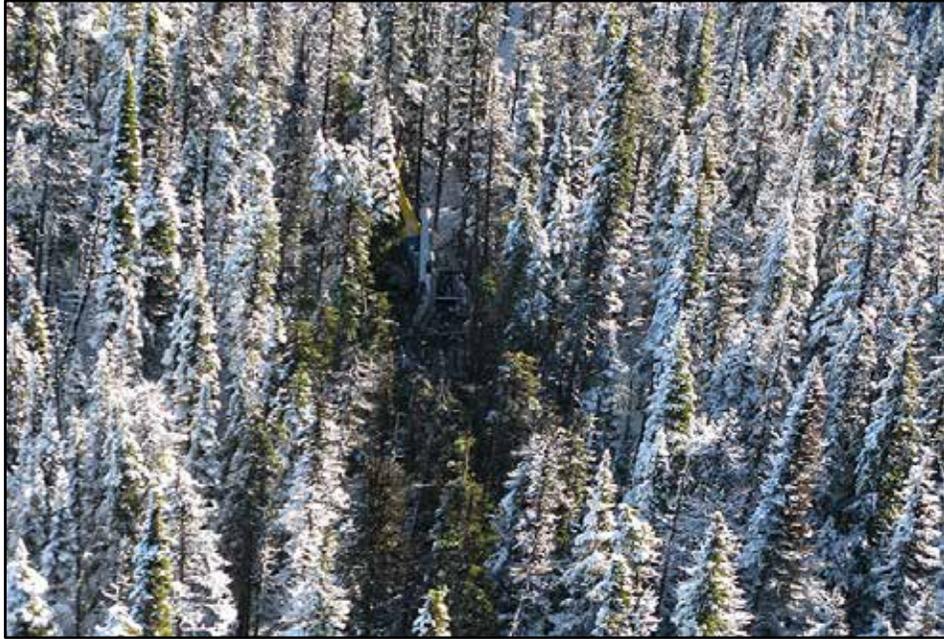
The wreckage was found in a snow-covered, uniformly forested area approximately 1.5 nm northwest of the mine site and 11 nm east of Laidman Lake. The aircraft was substantially damaged when it struck trees and the ground (Figure 2). There was no post-impact fire.

Figure 2. Photo of the accident site showing the aircraft wreckage, as viewed from the direction of flight

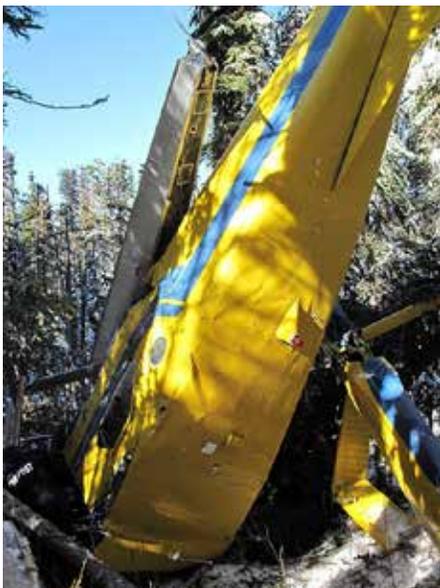
The aircraft entered the trees in a wings-level, slightly nose-high attitude, at an elevation of approximately 4600 feet ASL. The initial impact occurred when the aircraft's right horizontal stabilizer struck the treetops. The aircraft then continued through the trees in the direction of flight for approximately 130 feet before pitching forward and striking the ground in a steep nose-down and right-wing-low attitude. The aircraft came to rest nose down and semi-inverted (Figure 3).

Figure 3. The occurrence aircraft at the accident site

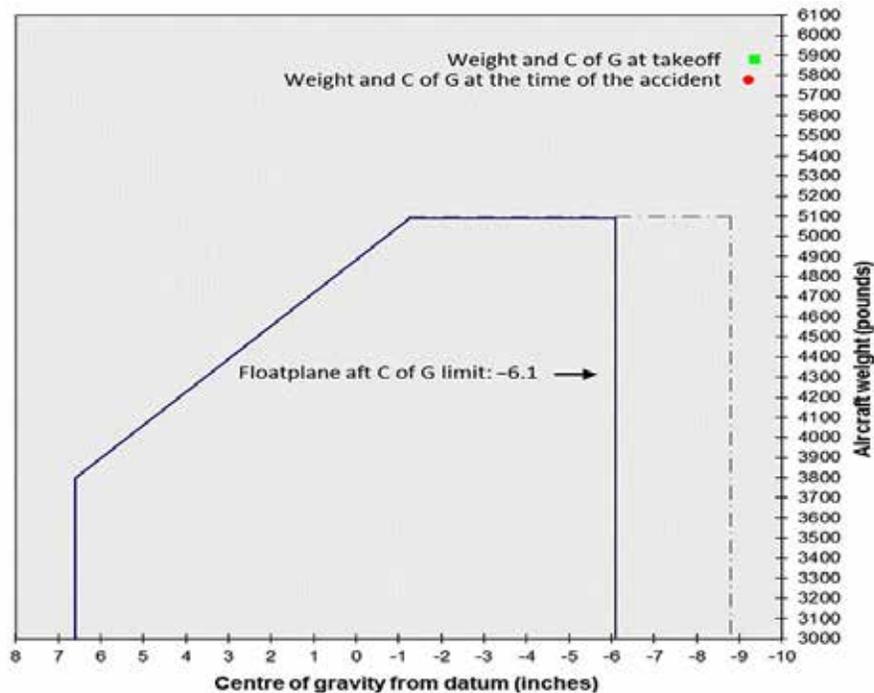
The investigation determined that the aircraft was carrying 495 pounds of cargo and 209 pounds of fuel, and that the combined weight of its occupants was 1032 pounds. Its resulting total weight was 5772 pounds, with a centre of gravity (C of G) 9.2 inches aft of the datum (Figure 4), which placed the aircraft 682 pounds over its maximum allowable gross weight, with a C of G 3.1 inches beyond the aft limit.

Figure 4. Weight and centre of gravity of the occurrence aircraft

The pilot did not weigh or secure the cargo and did not calculate the aircraft's weight or centre of gravity before departure. At the time of the accident, the aircraft was 682 pounds over its maximum weight and its centre of gravity was 3.1 inches beyond the aft limit. The aircraft's out-of-limit weight-and-balance condition increased its stall speed and degraded its climb performance, stability, and slow-flight characteristics. As a result, its condition, combined with the aircraft's low altitude, likely prevented the pilot from regaining control of the aircraft before collision with the terrain.
