Air Transportation Safety Investigation Report A17O0209

COLLISION WITH WATER

Cessna 150J, C-FHPU
Goderich, Ontario
20 September 2017

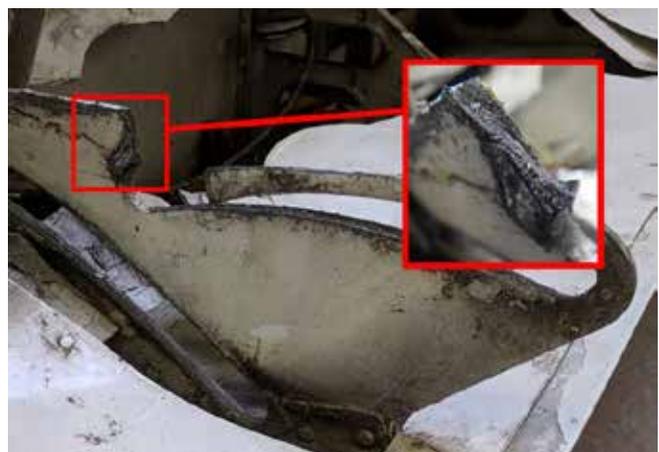
The forward section of the left wing inboard aft flap track was fractured (Figure 1). As a result, the left flap inboard aft roller, which is normally positioned inside the associated flap track, was located outside of the broken flap track.

The outboard flap track was still intact and, as a result, it was possible for the left flap to be cocked in position, preventing it from travelling.

Figure 1. The fractured flap track, with an expanded view of the fractured area

In this accident, an in-flight flap asymmetry could not be ruled out. The broken flap track was heavily corroded, which weakened its structural integrity and life expectancy. The corrosion had been present for some time, but was not noticed in any of the annual inspections that followed standards set out in the CARs. The manufacturer recommends periodic supplemental corrosion inspections; however, these are not required by regulation, and none were documented as having been completed.

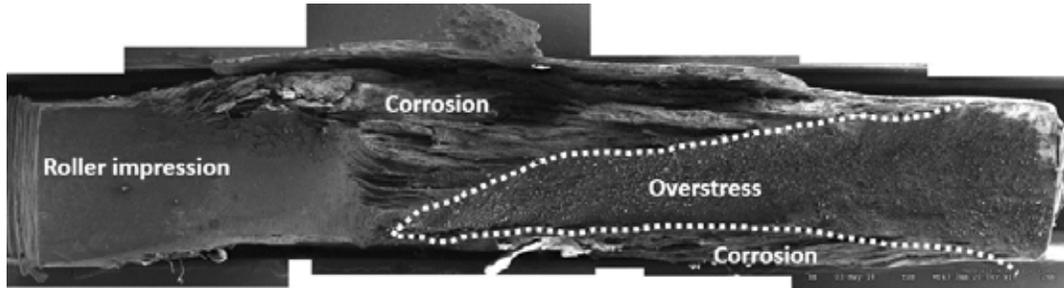
The fractured surface of the inboard flap track was examined with a scanning electron microscope. It was determined that the damage was caused by corrosion, which gave the appearance of

delamination (Figure 2). The corrosion had been present prior to the occurrence; however, when or how it began could not be determined. Corrosion has a detrimental effect on the strength of an aluminum component and can significantly diminish the structural integrity and life expectancy of an aircraft component.

Figure 2. Scanning electron microscope image of the fractured flap track, showing areas of corrosion, overstress, and the flap roller impression on top of corrosion

The fracturing of the non-corroded portion of the flap track was caused by overstress from a combined shear and tension load. However, it could not be determined whether this happened before or during impact.

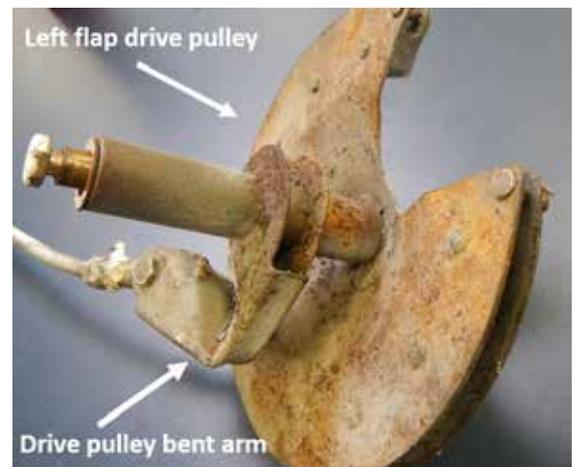
The arm attached to the flap drive pulley in the left wing was bent almost 90° from its original position as a result of tensile overload (Figure 3). It is possible that this damage occurred during the impact sequence. However, there was no corresponding damage to the left flap, which is connected to the drive pulley arm via a push-pull rod. It is also possible that the bending of the drive pulley arm occurred during operation of the flaps. If the left flap was unable to move, the arm may have been bent from the cable tension produced by the flap actuator.

Figure 3. The left flap drive pulley
