Transportation
Safety Board
of Canada

Air Transportation Safety Investigation Report A1800150

MID-AIR COLLISION

Cessna 150G, C-FGMZ (privately owned)
and
NLG Air Inc.
Piper PA-42 Cheyenne III, C-FCSL
Ottawa/Carp Airport, Ontario, 1.3 nm S
04 November 2018

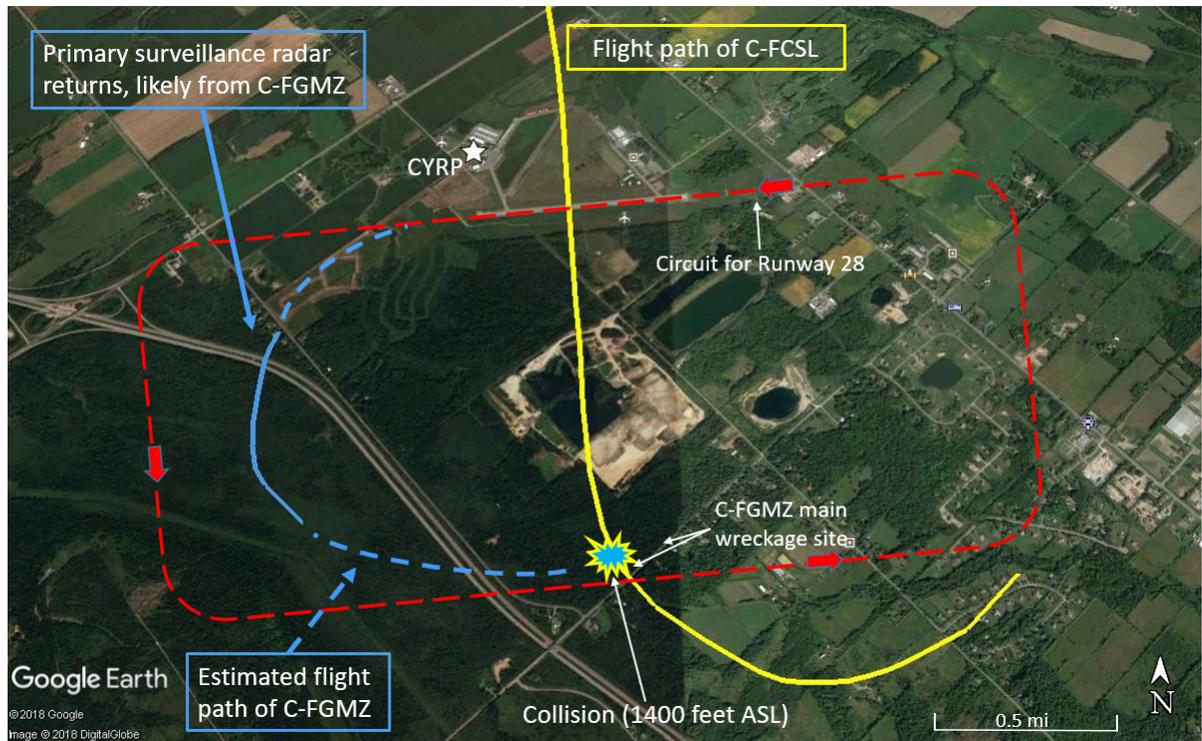
At 1010, the Piper was on approach to the airport from the north. It had flown over Runway 10/28 at circuit altitude to join the circuit at the midpoint of the downwind leg for Runway 28, when the 2 aircraft collided at approximately 1400 feet ASL, about 1.3 nautical miles (nm) south of the airport (Figure 1). The pilot of the Piper did not see the Cessna while crossing over the airport. The investigation was unable to determine whether the pilot of the Cessna saw the Piper or took evasive action prior to the collision.

Figure 1. Flight paths of the Piper (C-FCSL) and the Cessna (C-FGMZ). The left-wing outboard section of C-FGMZ was found 635 feet southwest of the main wreckage site. (Source: Google Earth, with TSB annotations)

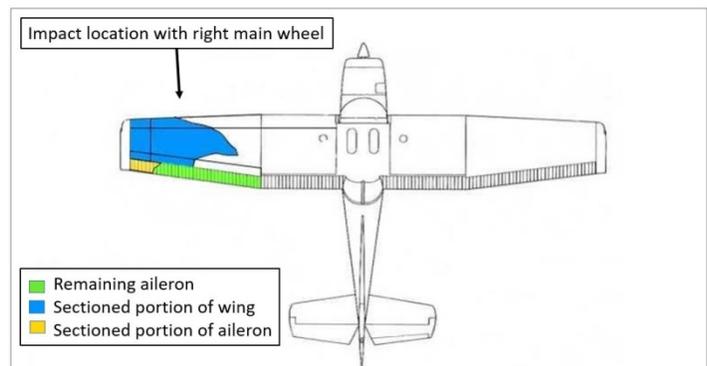
The investigation determined that, as the 2 aircraft collided, the Cessna's left wing struck the Piper's extended right main-wheel assembly at a point 5.75 feet from the Cessna's outer left-wing rib. The impact damage to the leading edge of the wing indicates that it struck the outboard face of the Piper's wheel assembly, nearly perpendicular with the Piper's longitudinal axis.

The damage sustained by the wing structure caused the failure and subsequent separation of the outer section of the wing and aileron (Figure 2). The aircraft became uncontrollable and rapidly entered a steep dive, striking the ground in a near-vertical attitude. The aircraft was destroyed by the impact forces and post-impact fire.

Figure 2. The Cessna's in-flight damage (Source: Cessna Aircraft Company, with TSB annotations)
