Air Transportation Safety Investigation Report A18Q0100

COLLISION WITH TERRAIN

Air Saguenay (1980) Inc.
de Havilland DHC-2 (Beaver), C-FYYT
Manic-Cinq, Quebec, 44 nm WSW
01 July 2018

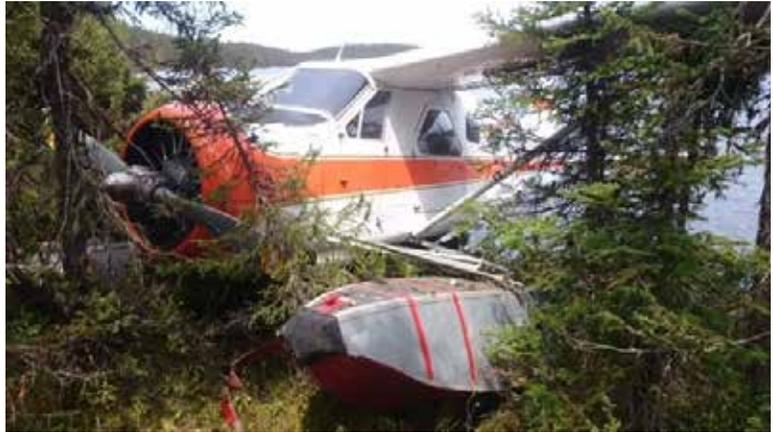
Once take-off speed was reached, the pilot manoeuvred to lift the floats off the water. However, the pilot considered that the remaining distance on the lake was insufficient to complete the takeoff and climb safely, and therefore decided to shut off the engine to reject the takeoff. The aircraft continued straight ahead and could not be stopped in time to avoid colliding with trees (Figure 1).

Figure 1. The aircraft after colliding with trees (Source: Air Saguenay)

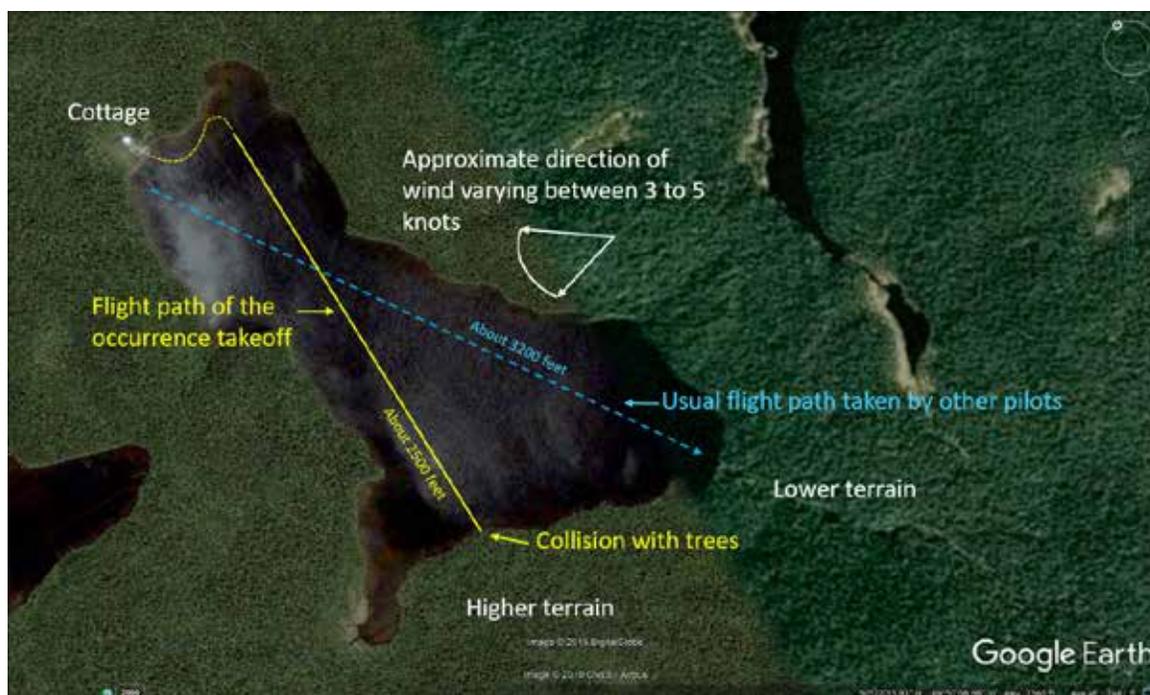
In this occurrence, the initial intention was to take off in an arc from the bay northeast of the cottage toward the lower terrain. However, according to the information gathered, the actual take-off path was largely in a straight line until the point of impact. The flight path toward the higher terrain required the aircraft to fly over the higher terrain at low altitude or to turn left immediately after takeoff to avoid the higher terrain. Furthermore, a greater take-off distance may have been required because the aircraft was heavier.

Calculations based on the take-off performance chart for an aircraft equipped with floats (as published by the manufacturer, de Havilland Aircraft of Canada Ltd., in the DHC-2 flight manual^{8,9}) indicate that the total take-off distance to clear a 50-foot obstacle is 1590 feet.^{10,11} Of this distance, about 1100 feet are with the floats touching the surface of the water (Point A, Figure 2).

The investigation determined that when the winds are from the southeast, as in this occurrence, the flight path taken by other company pilots is oriented differently to provide a greater take-off distance and fly over the lower terrain, allowing them to avoid having to make a turn during the initial climb (Figure 2).

Figure 2. Diagram showing the flight path of the occurrence takeoff on Jules Lake in relation to the usual flight path taken by other pilots, as well as estimates of the minimum distance required for takeoff from the surface of the water (A) and the optimal point for a rejected takeoff (B) according to the performance tables (Source: Google Earth, with TSB annotations)

flight manual^{12,13,14} (Point B, Figure 2). However, this distance may be shorter if drag is increased, for example by orienting the aircraft into the wind or by deliberately shifting the attitude forward to increase the resistance of the floats on the water, while remaining within the prescribed limits. In this occurrence, the engine was shut off after the aircraft had passed the rejected-takeoff point, and the aircraft could not be slowed down sufficiently to avoid a collision with the shore and trees.
