Marine Occurrence Report

F.V. "NORTHERN OSPREY" sank
in approximate position
60°23'N 60°54'W,
off Northern Labrador,
as a result of
being damaged by ice
27 June 1990

Report Number M90M4020

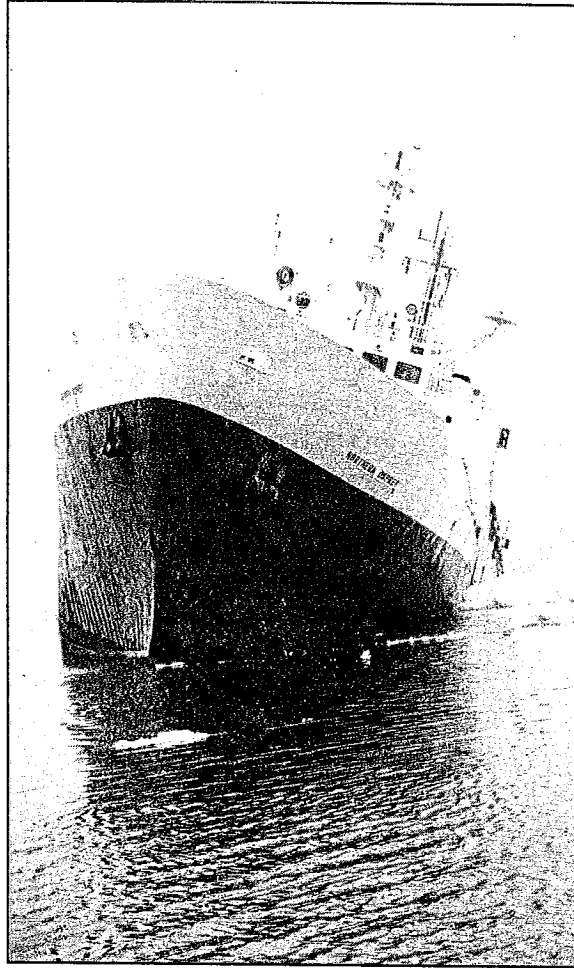
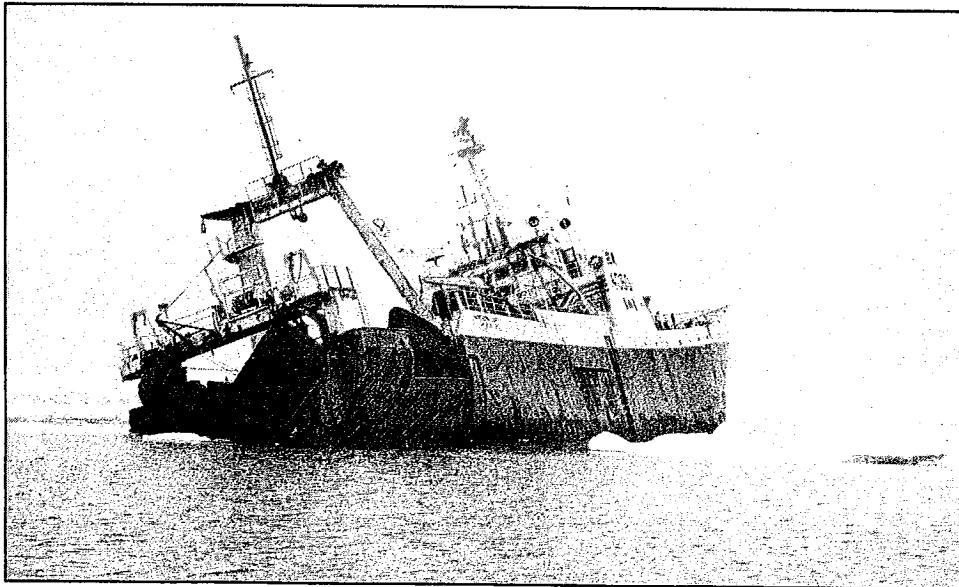
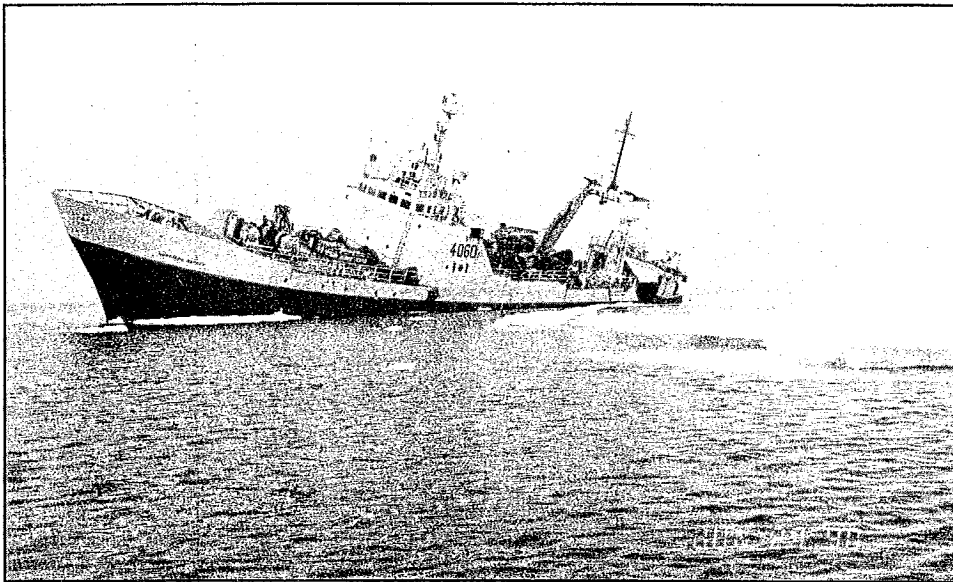
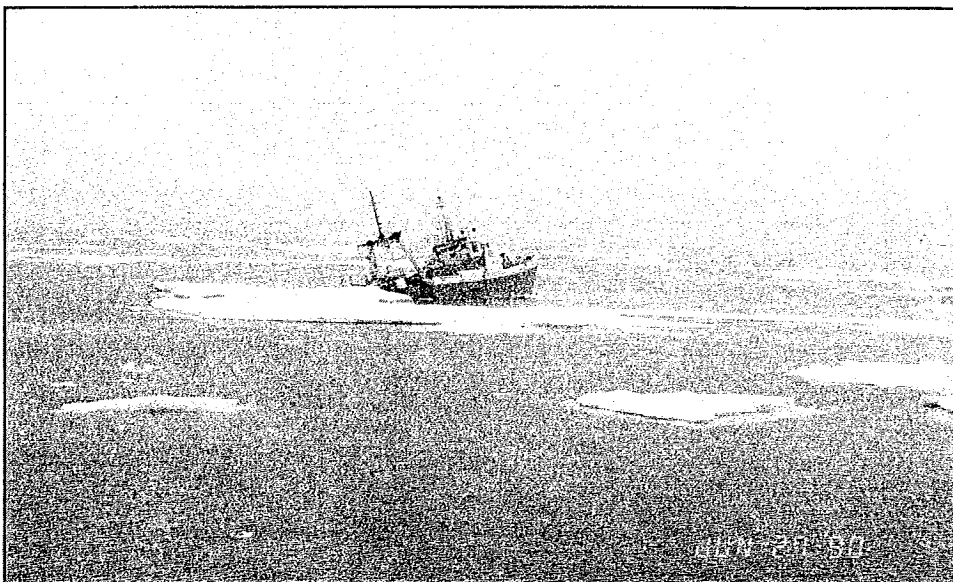
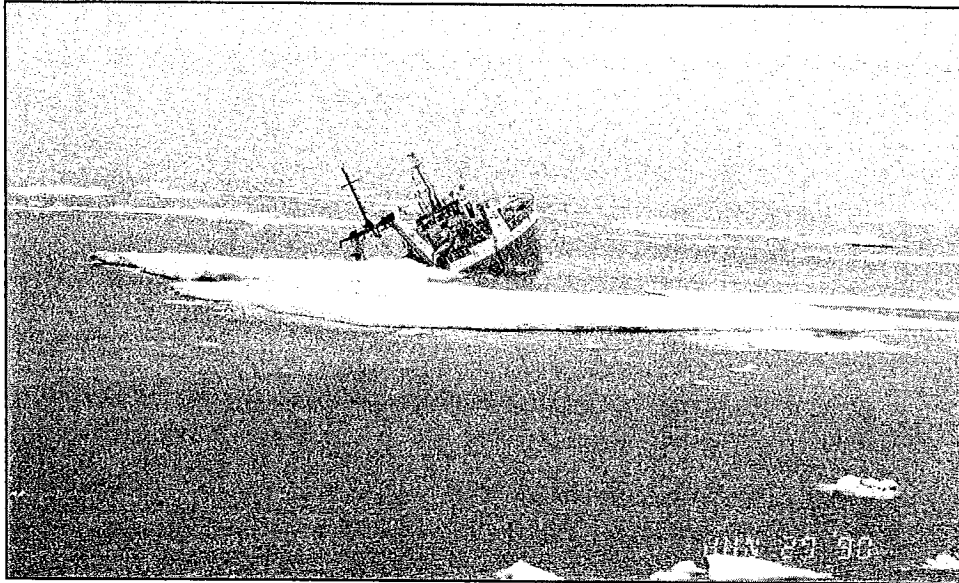
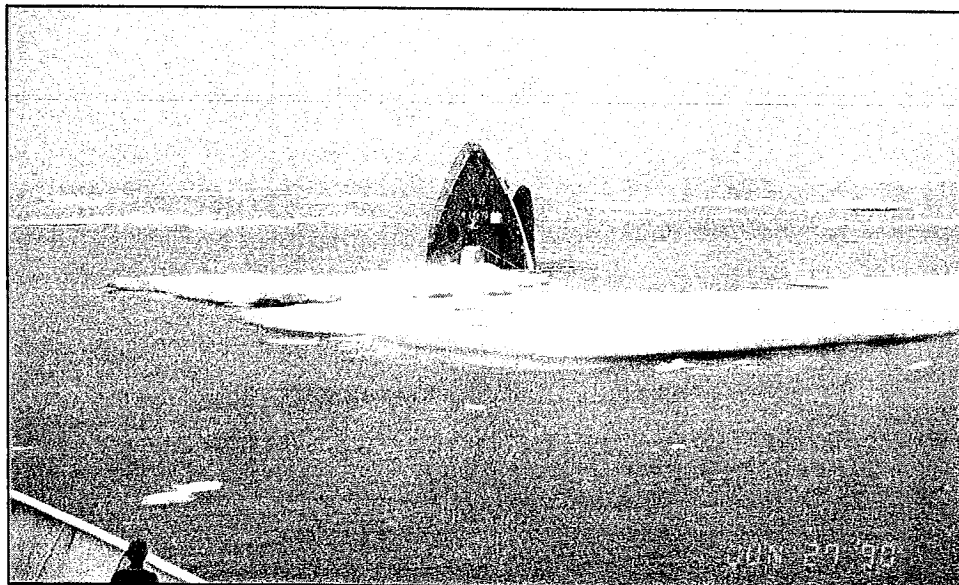
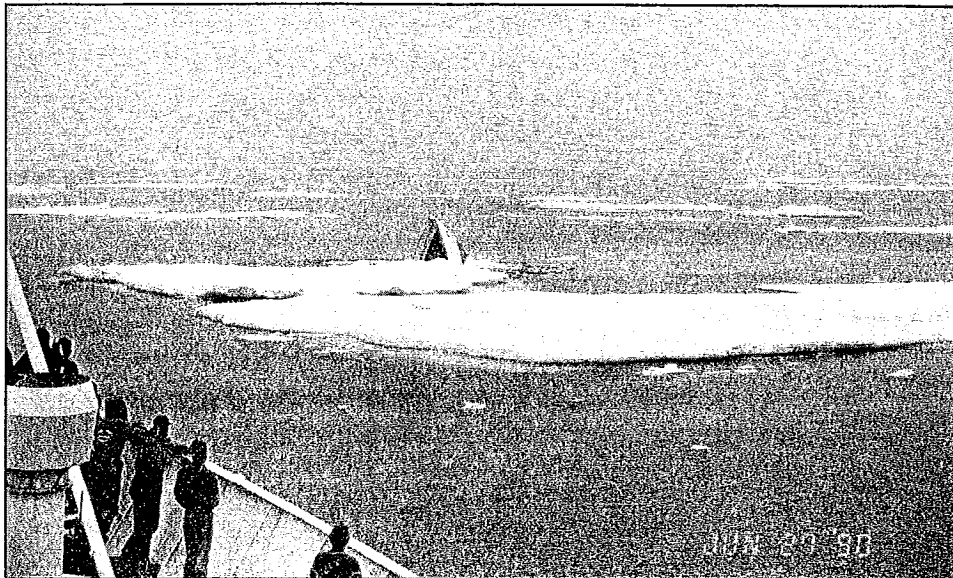
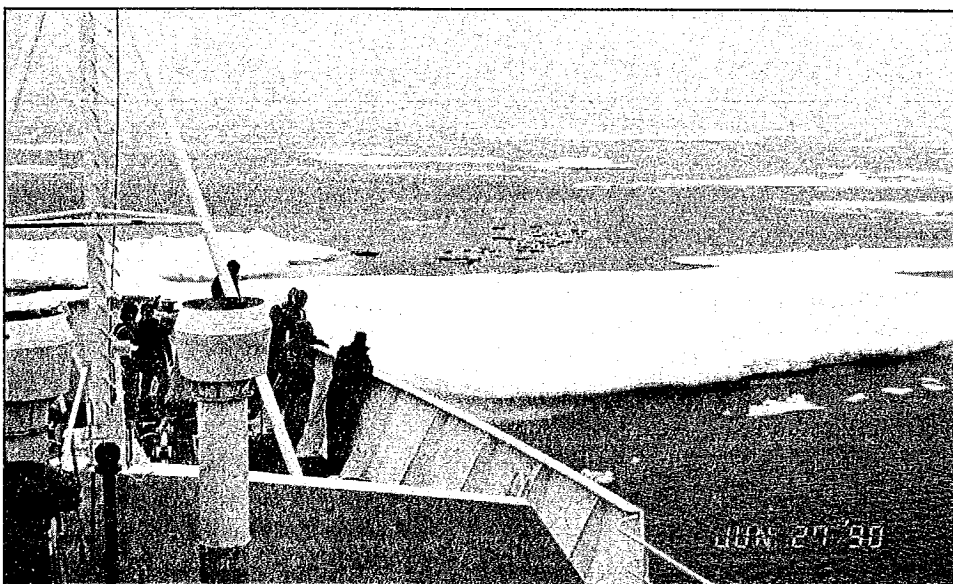
SINKING OF THE
"NORTHERN OSPREY"

At approximately 1015, when weather conditions were "heavy fog with 10 to 20 per cent ice coverage", the master ordered the "NORTHERN OSPREY" abandoned, and the crew, wearing immersion suits, boarded liferafts and the dinghy without incident. At approximately 1115, all hands were rescued by the "THOR TRAWL", and from that vessel, saw their own vessel sink, stern first, at 1200, in position 60°23.1'N, 60°54'W.

While manoeuvring in ice-infested waters, the "NORTHERN OSPREY" likely suffered damage which caused the fish hold to partially flood with fuel oil. The action taken to remedy this situation led to the loss and abandonment of the vessel.

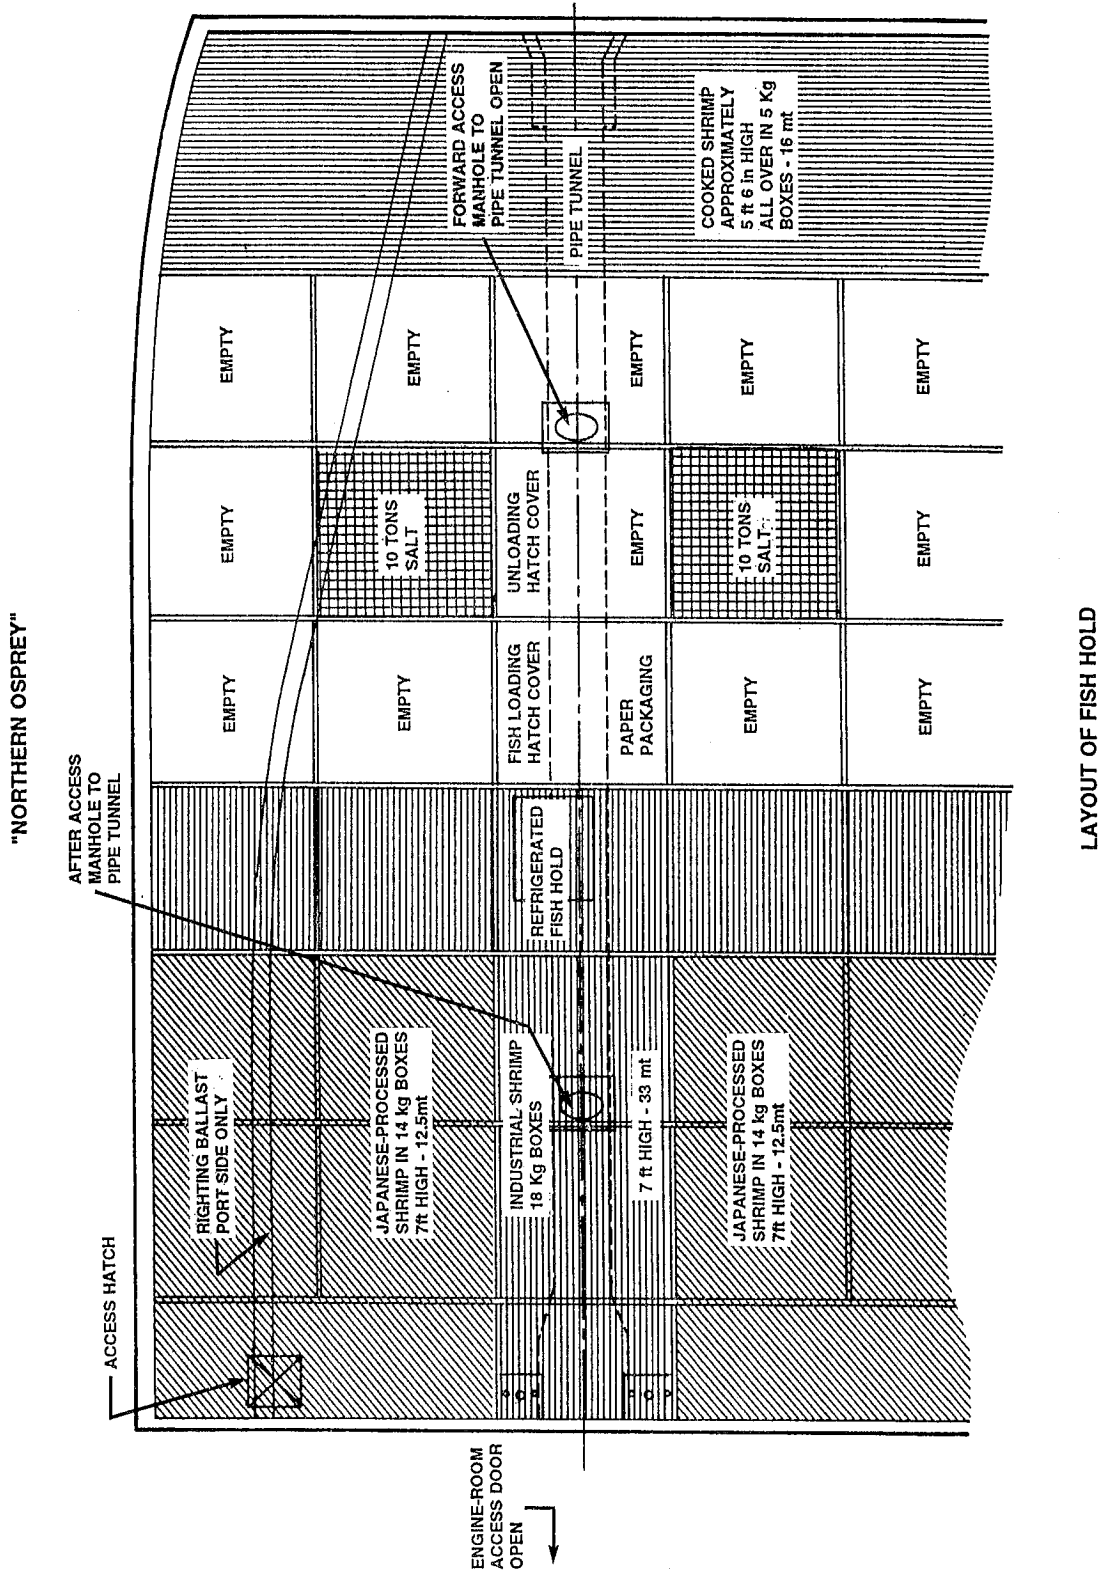
Appendix C - Layout of Fish Hold

The initial assessment of damage to the vessel was confined to a suspected internal fracture in the bulkhead between the starboard forward fuel tank designated (5 S) and the fish hold, near the starboard side of the vessel. Soundings did not indicate any ingress of water to that tank. During the oversight surveys, no damage was sighted (apart from polished areas of shell plating) and no oil or air bubbles were seen in the clear mirror-like surface of the sea.

The master, fearful of the free surface effect caused by the diesel oil in the fish hold where the cargo was already contaminated by the fuel, had the manhole cover between the fish hold and the pipe tunnel removed, and the access door between the pipe tunnel and the engine-room opened. This had the effect of allowing the oil to flow from the fish hold to the engine-room bilge via the pipe tunnel but also created a common compartment by linking these two spaces. The vessel was designed to survive one compartment flooded, but not two.

After the bulk of the oil in the fish hold had been evacuated into the pipe tunnel and the seepage from the cargo had ceased, the manhole cover at the bottom of the fish hold was not completely replaced nor secured.

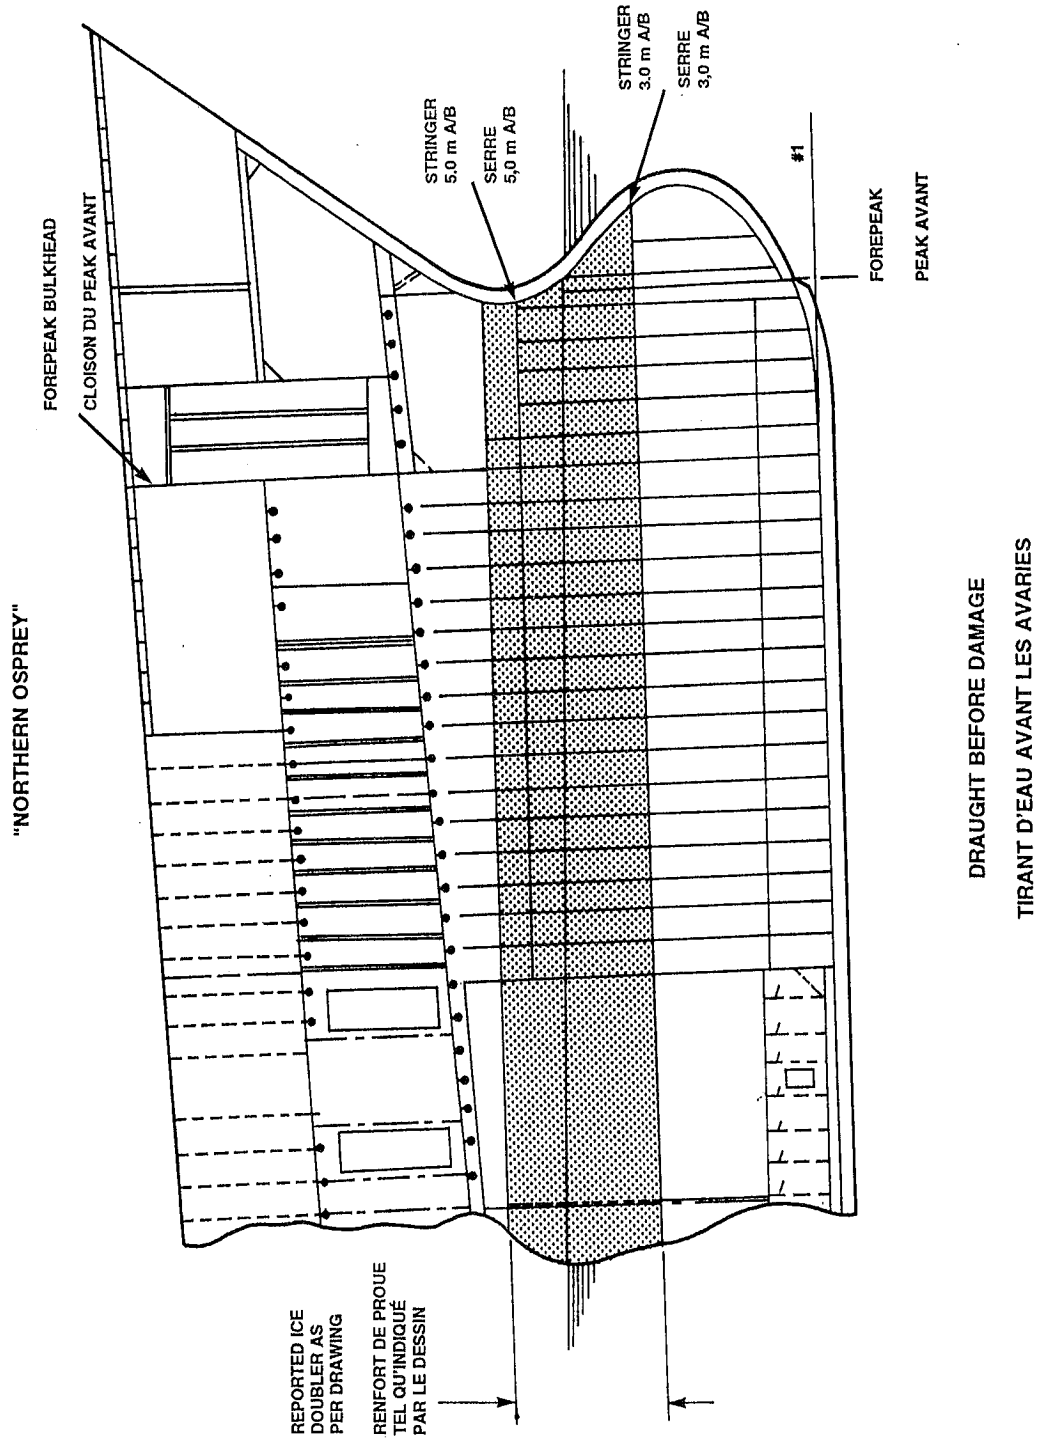
Appendix D - Draught Before Damage

It was reported by the master that the ice damage had likely occurred at a point below this extra banding. The pre-damage waterline was approximately 1.3 m above the lower edge of the extra plating, and as stated elsewhere in this report, the ice possibly extended to a depth of 9 m below the surface of the sea.
