MARINE INVESTIGATION REPORT

M00C0033

PASSENGER VESSEL "TRUE NORTH II"

16 JUNE 2000

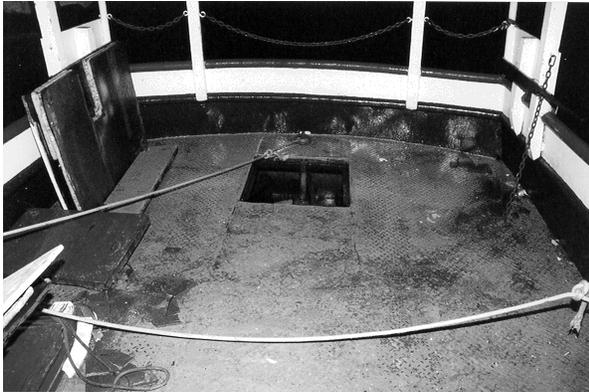
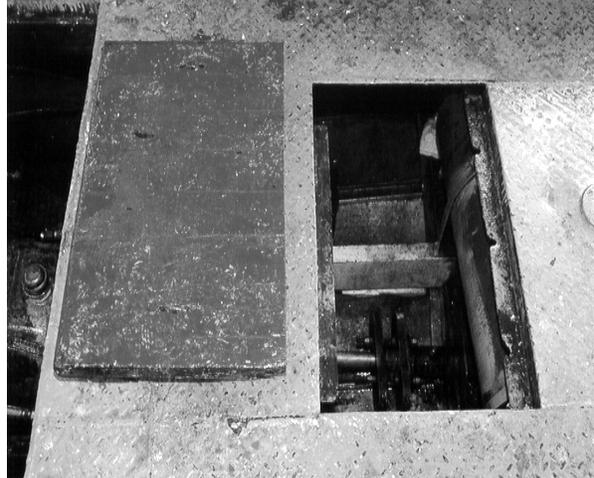
Neither the access hatches nor the main engine casing boundary in the main deck were fitted with watertight gaskets or securing devices. Any water shipped and retained on the main deck was thus allowed to freely enter the underdeck compartment (see photographs 2 and 3).

Main deck plating was extensively corroded around the boundary of an irregularly shaped opening that provided access to the main engine control, steering gear and electrical cables inside the wooden console at the steering position. This opening allowed any water shipped and retained on the main deck to freely enter the underdeck compartment.

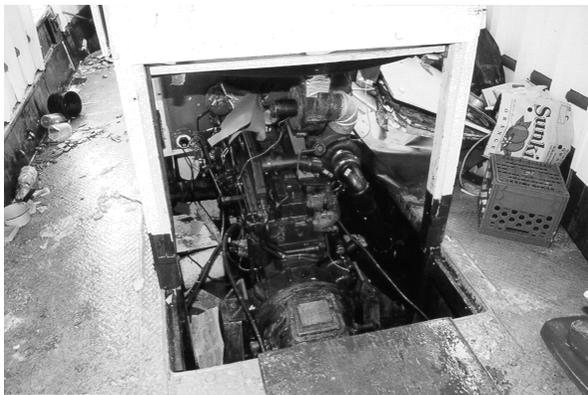
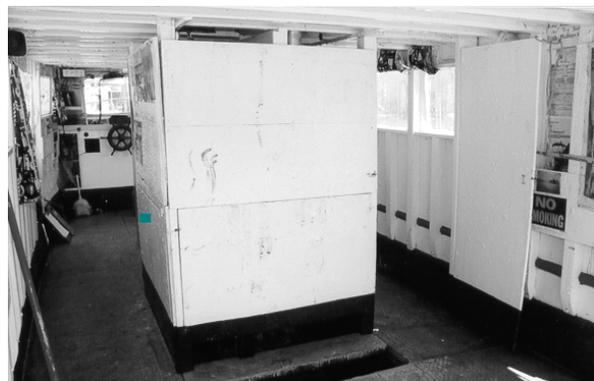
The lower edges of the 75 mm by 100 mm open ventilators at the port and starboard sides of the engine-room were approximately 165 mm above main deck level, and were not fitted with a means of closing. These openings allowed water shipped and retained on the main deck to freely enter the underdeck compartment as the vessel rolled or heeled to either side.

The lower edge of the portable plywood panel forming the after end of the engine casing structure did not extend down to the main deck level, leaving an opening 15 cm by 1.05 m wide across the bottom of the casing end. This opening was provided to enhance ventilation and air supply to the main engine. However, its location at deck level also allowed free entry into the underdeck compartment of any water shipped and retained on the main deck (see photographs 4 and 5).

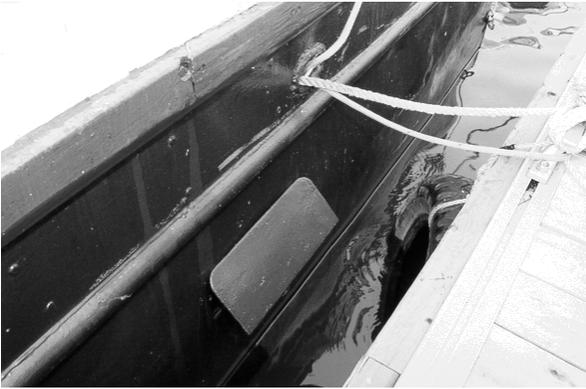
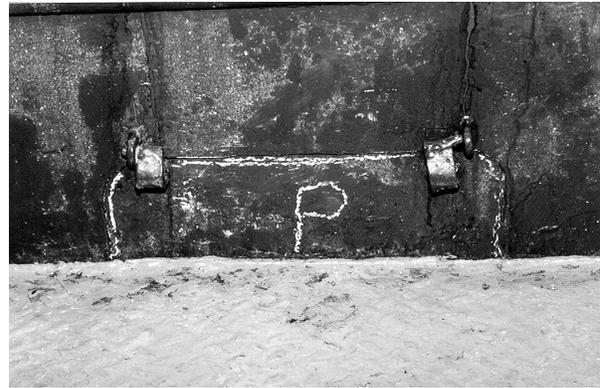
The drainage scupper at the centre of the transom bulwark was found to be effectively sealed shut by a large decal, bearing the vessel's name, that was fixed to the outside of the transom.

This obstruction, in conjunction with the welding-shut of the two freeing ports near midships, reduced the vessel's ability to clear any water shipped on the main deck (see photographs 6 and 7).

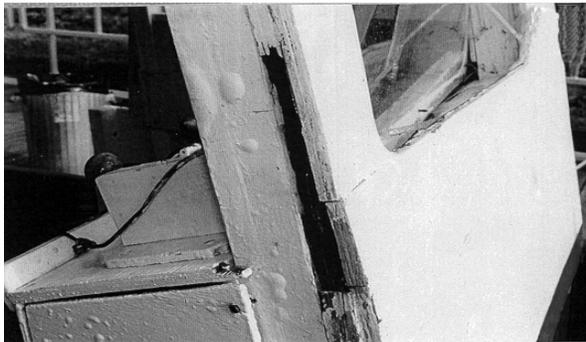
Visual, probing and mallet pounding examinations of the wooden superstructure in general, and the bridge front and its door and door frame in particular, showed areas of significant deterioration due to advanced and incipient rot (see photograph 8).

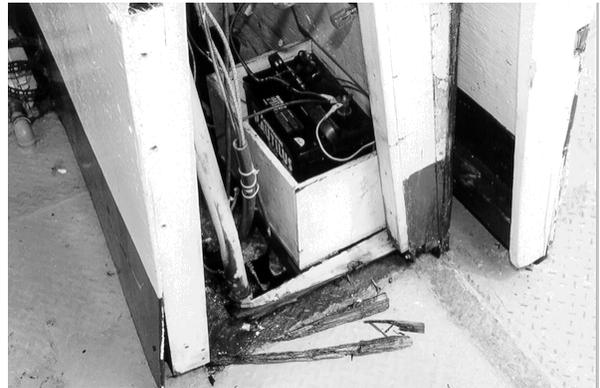
The wooden framing of the bridge front, console and door frame was discoloured and softened by decay, and the lower ends were partially disintegrated (see photograph 9).

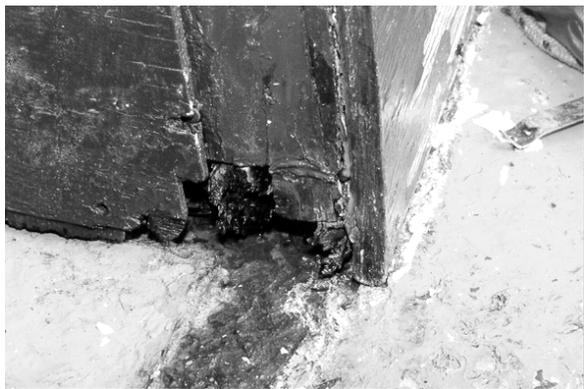
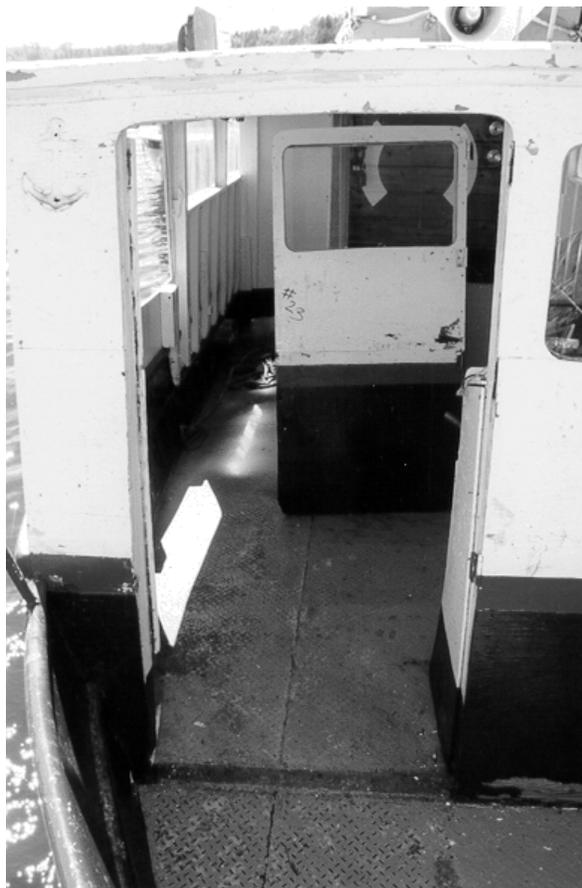
The deteriorated condition of the inboard edge of the wooden frame in way of two of the three hinges of the bridge front door was such that the holding power of the 25 mm long screw fastenings was markedly reduced. The timber and wood packing in way of the hinge screw holes was decayed such that the screws were pulled clear with the door. The third and lowest door hinge remained attached to the door frame, and its screw fastenings were pulled clear from the door itself.

The 20 mm by 20 mm wooden door stop and its nail fastenings to the framing at the door's outboard edge (which were found to have been bent backwards through 90 degrees), extended down from the top of the door frame to within some 350 mm of the deck and consequently did not provide any support to the lower area of the door.

The 63 mm by 63 mm thick wooden door stop, forming a sill across the bottom of the door, had been unbolted and removed for repair the day before the occurrence. The sill had been replaced without its bolted connection, which reduced support to the lower area of the bridge front door (see photographs 10 and 11).

The deteriorated condition of the bridge front and its wooden framing in way of the door and window frames and the reduced support in the lower area of the door were such that, in the event, the bridge front door and window were unable to withstand the forces imposed on them.

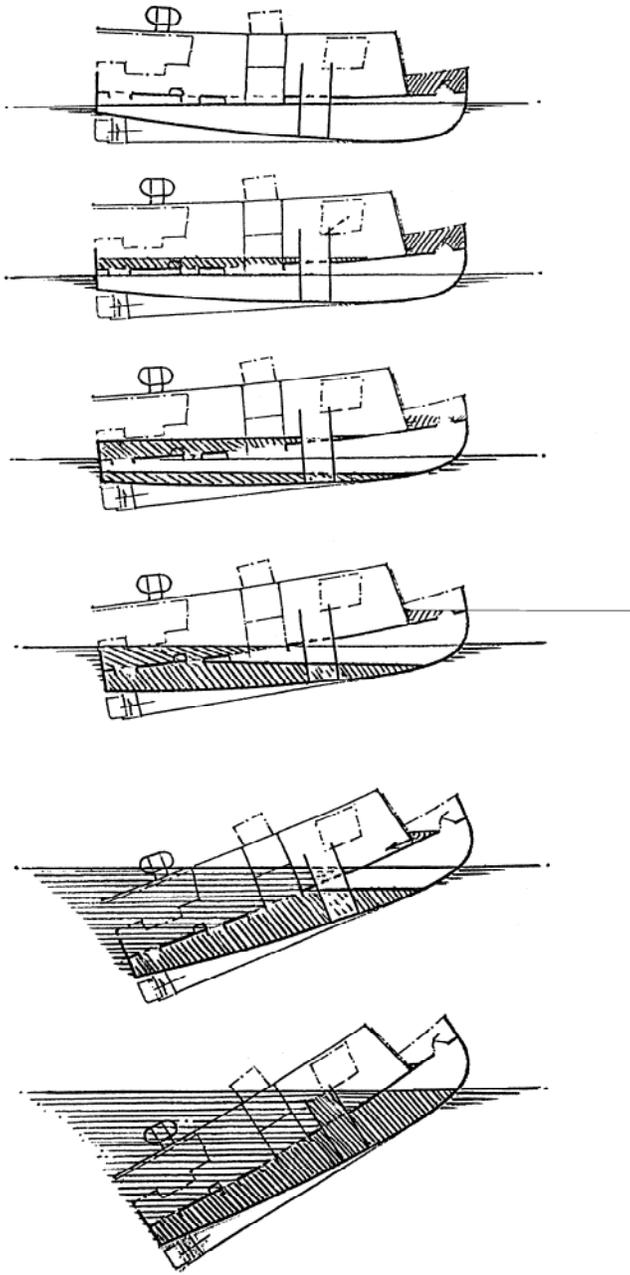
Downflooding and Sinking Sequence

The additional weight of the water suddenly shipped when the bridge front door was stove in further reduced the transverse stability as it surged aft along the port side alleyway and also caused the vessel to trim rapidly by the stern. The vessel initially heeled severely to port, as transverse stability was virtually eliminated due to the increasing free-surface effects of water shipped and retained above the main deck and the accumulated downflooding water inside the hull.

Rolling and heeling effects, imparted by wave motions while the vessel was trimmed by the stern and sinking, preclude a precise determination of the many trimmed attitudes the vessel could have taken. However, based on the reported sequence of events, the chronology of the occurrence—from the initial shipping of water over the bow to the subsequent sinking—can be determined, and is illustrated in Figure 2.

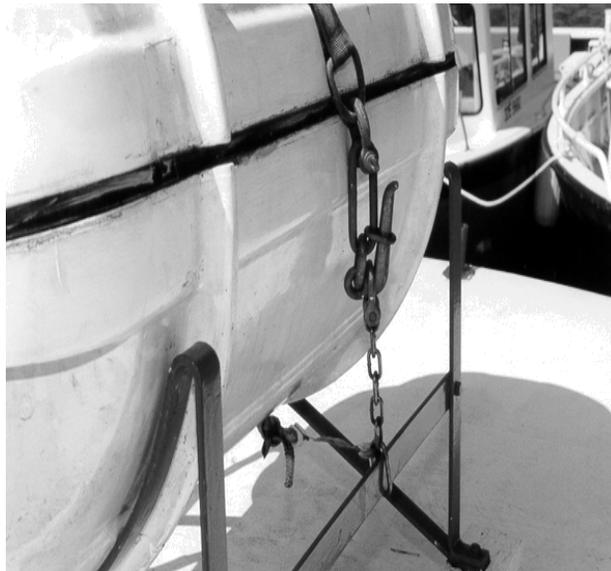
In 1997, following discussions with TCMS inspectors, the vessel was equipped with an inflatable liferaft. A 20-person Dunlop-Beaufort liferaft was installed in a cradle located on top and at the after end of the wooden superstructure. It was secured by a nylon lashing, which was attached to the cradle by a shackle at one end of the lashing and by a Senhouse slip at the other end. Such a securing arrangement requires human intervention for the launching. The master did not have ready access to the liferaft, as there was no means, such as a ladder, to climb atop the superstructure where it was stowed. Its installation on the vessel was accepted by TCMS inspectors (see photograph 13).

After being washed out of the vessel, the master swam on top of the superstructure but did not reach the inflatable liferaft in time to release it before it sank with the vessel. Since 1978, safety requirements provide for either deep chocks or a hydrostatic release unit to allow the liferaft to float free. Without the benefit of a liferaft, passengers were immersed in the cold water for up to 50 minutes as they clung to the buoyant apparatus; this increased their risk of hypothermia and drowning.
