MARINE INVESTIGATION REPORT

M00W0303

STRIKING OF A BRIDGE

TUGBOAT *MILLER RICHMOND* AND
BARGES *MILLER 201* AND *MILLER 206*
PITT RIVER HIGHWAY BRIDGE, BRITISH COLUMBIA
18 DECEMBER 2000

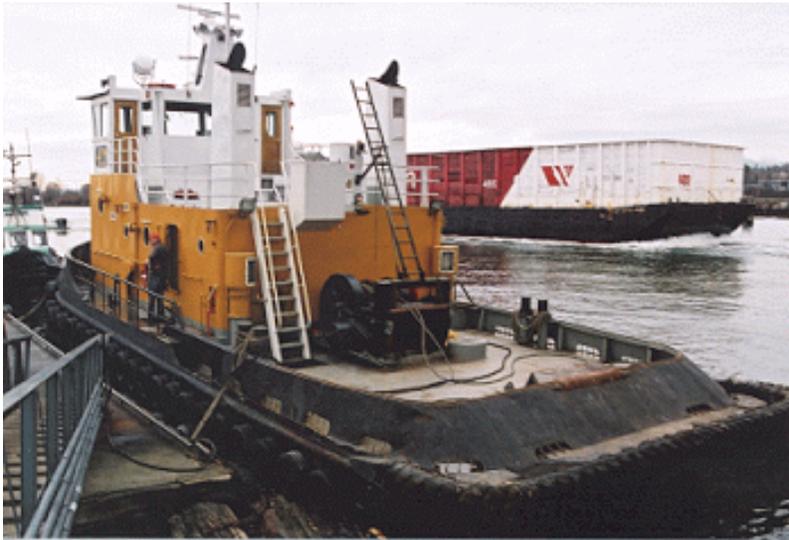
The *Miller Richmond* (See Photo 1) is a shallow draft steel tug with the superstructure located forward. The vessel is equipped with a hydraulically operated towing winch on the after deck with 670 metres (m) of 28 millimetre (mm) diameter steel wire towing cable, and a 25 mm diameter steel wire towing bridle approximately 17 m in length. Two 100 mm diameter polypropylene couplers, each approximately 10 m in length and fitted with eyes at both ends, are used to connect barges.

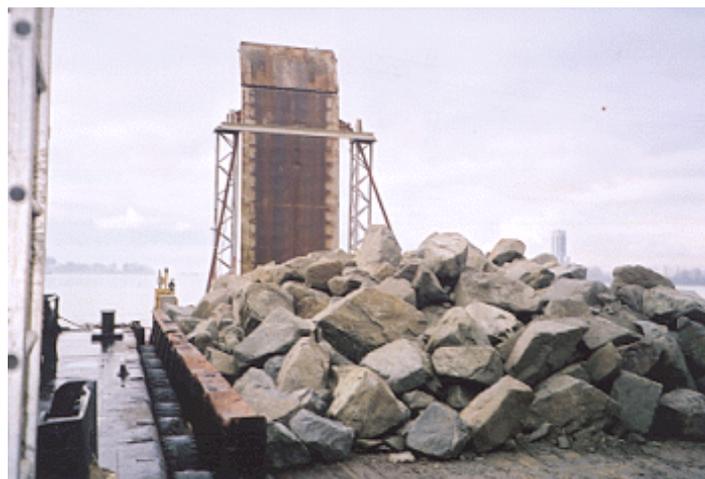
Barges Miller 201 & Miller 206

Both barges of steel construction, are flat decked, non-self-propelled and unmanned. The *Miller 201* (See Photo 2) is fitted with a hydraulically-operated stern ramp. In the stowed position, the ramp has a vertical height of 12 m, and requires the Pitt River Highway Bridge to be swung open to enable transit.

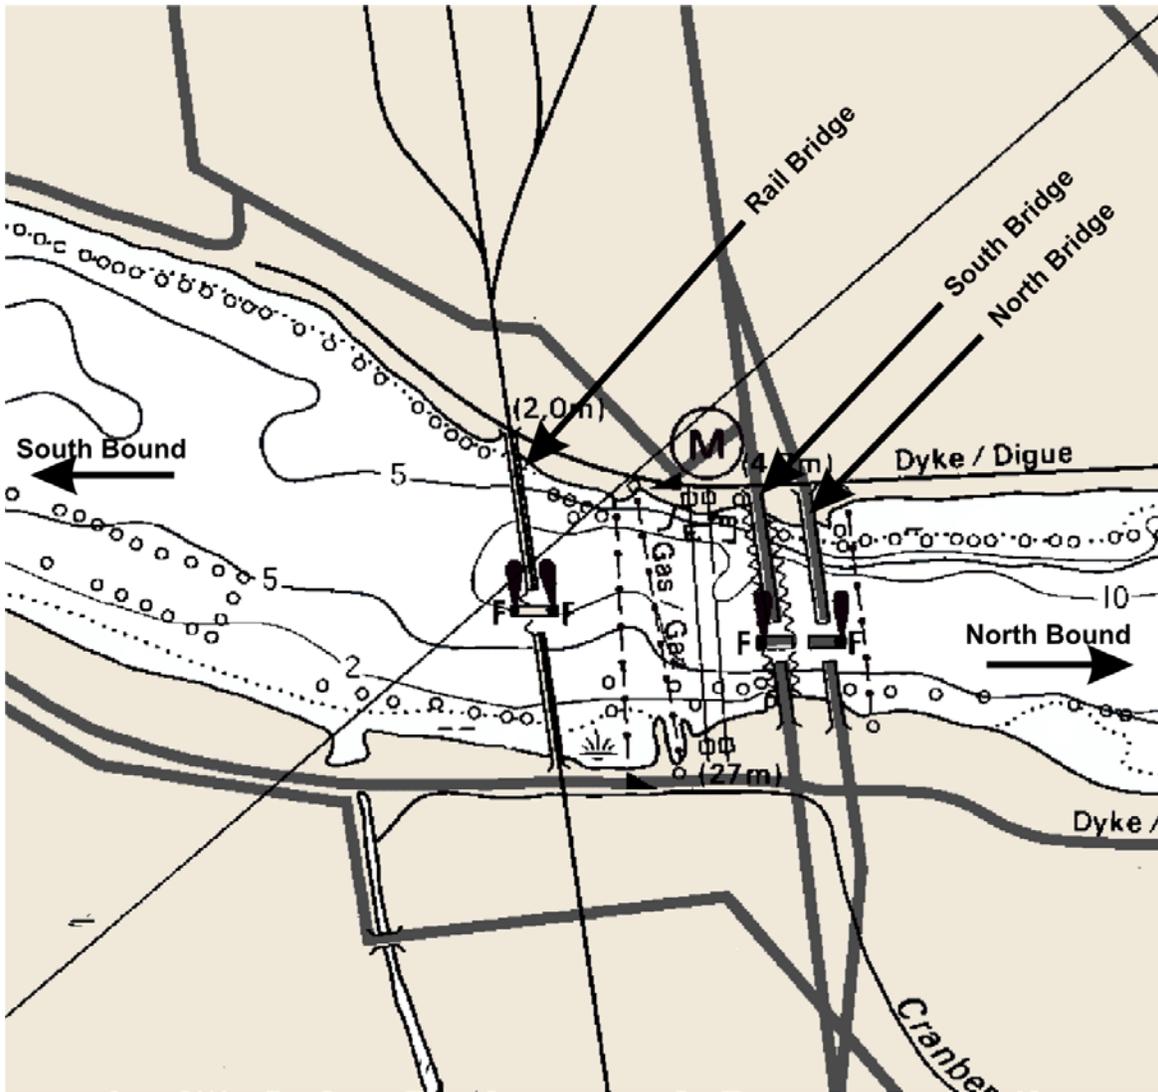
Appendix A - Sketch of Pitt River Rail and Highway Bridges

There are three bridges spanning the Pitt River at Chatham Reach, British Columbia. The Pitt River Railroad Bridge is operated and controlled by the Canadian Pacific Railway Company (CP). Approximately 305 m to the north is the Pitt River Highway Bridge which is operated by the provincial Ministry of Transportation.² The highway bridge consists of two bridge spans 76 m apart. They form a part of the Lougheed Highway connecting the City of Port Coquitlam to the Municipality of Pitt Meadows, British Columbia (See Appendix A).

The Highway Bridge spans are fitted atop elliptically shaped concrete piers which have protection piers extending approximately 53 m both up and down stream. The protection piers are constructed of wood pilings, with cross and diagonal timber bracing bolted to the pilings. Each protection pier has a protective abutment, constructed of wooden pilings and fir timber sheathing.
