MARINE INVESTIGATION REPORT

M02W0061

MALFUNCTION OF AUTOMATIC STEERING CONTROL
FOR RIGHT ANGLE DRIVES

BOWEN QUEEN

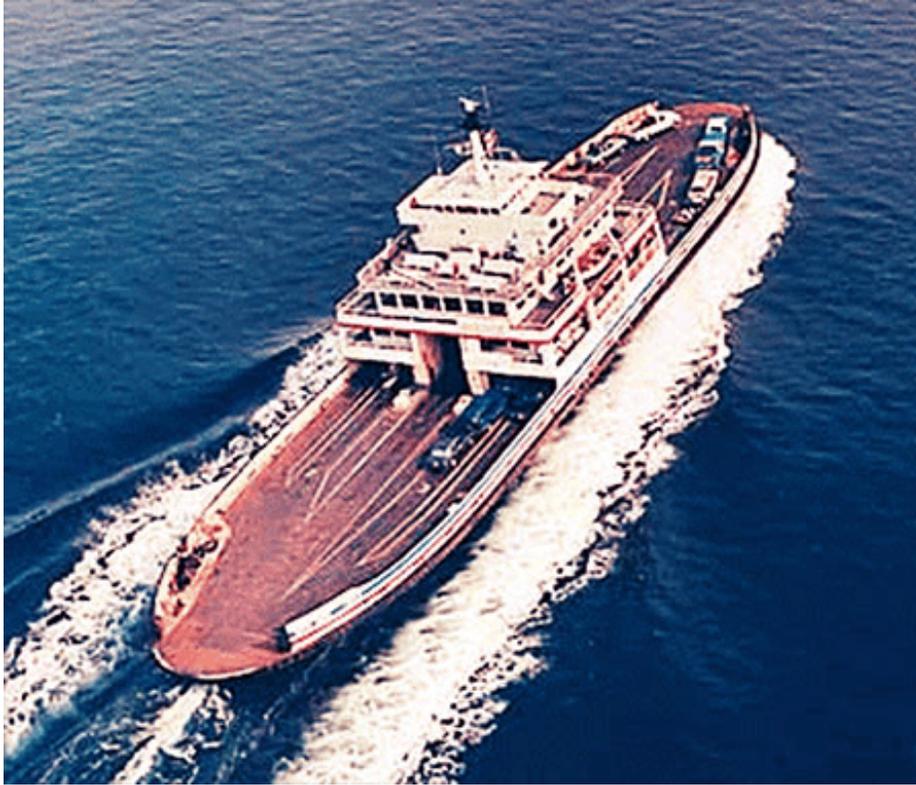
The *Bowen Queen* is a double ended ro-pax coastal ferry, designed to carry 70 cars on one main deck and 387 foot passengers on two upper decks (see Figure 1). Propulsion and steering is by means of four right-angled drive (RAD) units, one at each corner of the hull. The RADs are of the azimuth turning type, free to rotate through 360° and are independently powered by unidirectional diesel engines, via fluid couplings. They can be directly controlled from two locations in the wheelhouse or from the engine room. When in regular service, the RADs are controlled from the wheelhouse.

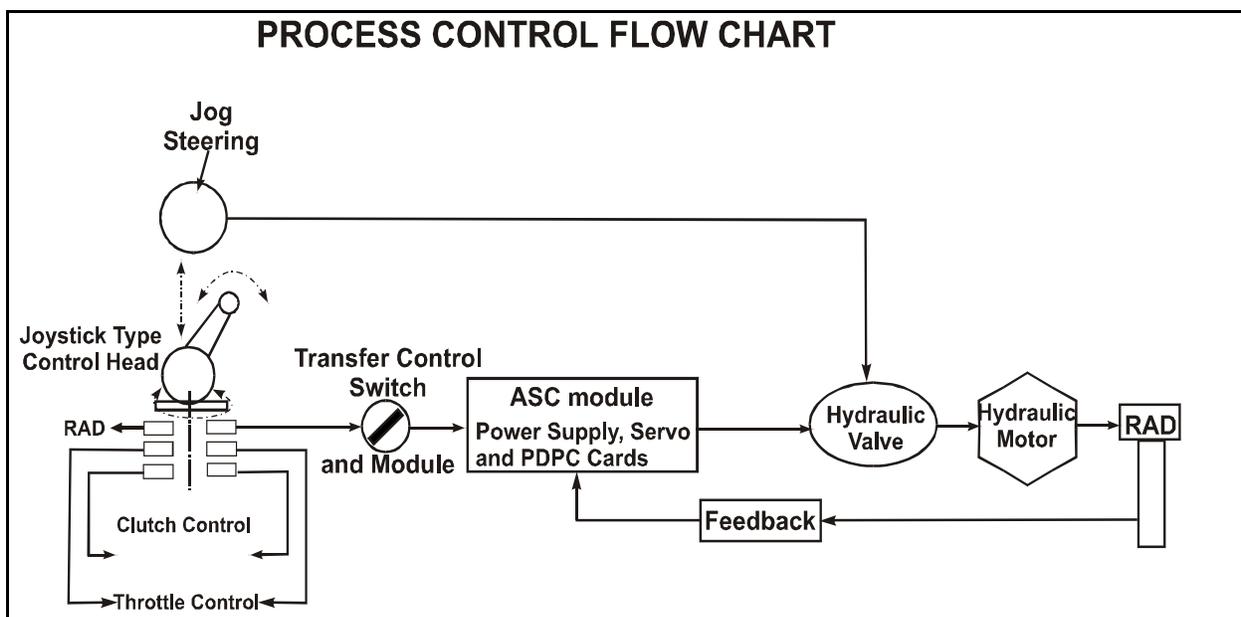
In this mode, the automatic steering control unit is bypassed and the hydraulic valve is directly controlled by the 'Jog' steering switch (see Figure 2). Each RAD leg has its own jog switch and the switch itself has three positions - the centre position being 'zero' or neutral, while the two positions at either side of the centre rotate the RAD either clockwise or counterclockwise. This rotation is sustained as long as the switch is held in position. The switch is spring loaded to return to its centre, 'neutral' position upon release. This effectively stops further rotation of the RAD.
