## MARINE INVESTIGATION REPORT

M03W0237

### GROUNDING

CONTAINER VESSEL *CIELO DEL CANADA*

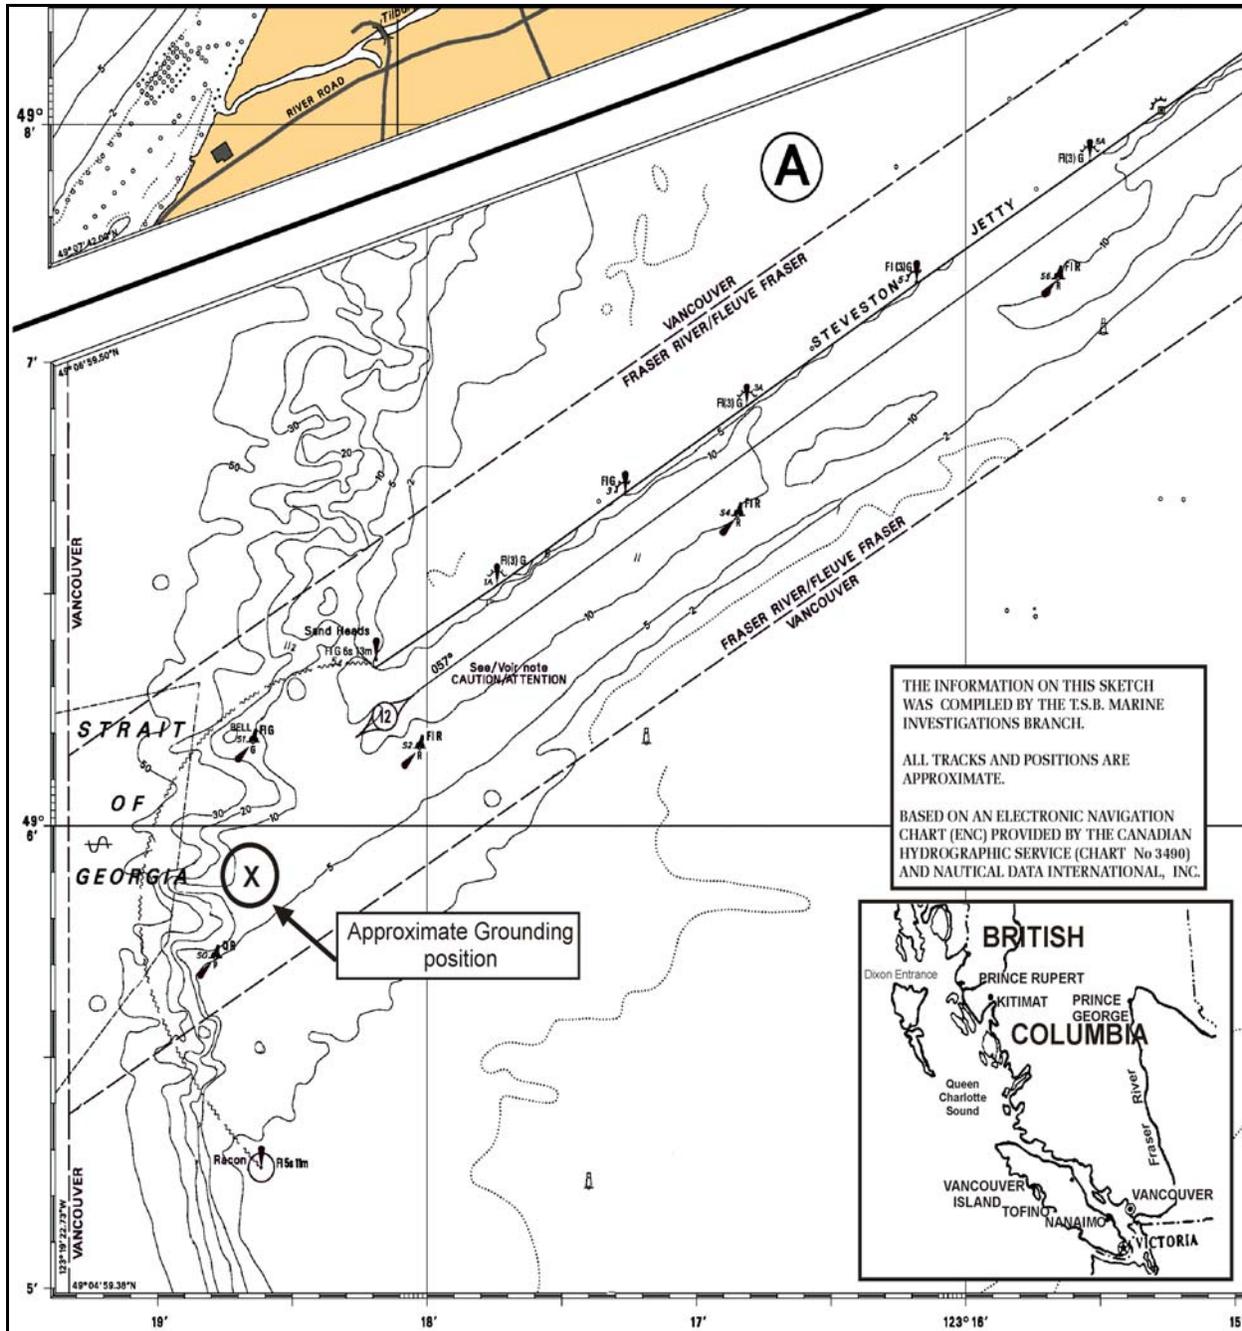
Figure 1. Area of grounding

The vessel ran aground in a position inside the marked buoyed channel between buoys S2 and S0 (as shown on CHS chart No. 3490, see Figure 1), an area where a bar had been reported to be extending into the dredged channel for the past three years. The river soundings dated 17 September 2003, which were available to the river pilot, gave a depth of 6.3 m at chart datum where the vessel ran aground. The tidal assist for that time was 3.5 m, giving an available depth of water of 9.8 m. This depth, however, falls short of 10.25 m, the maximum draft of the *Cielo del Canada*.

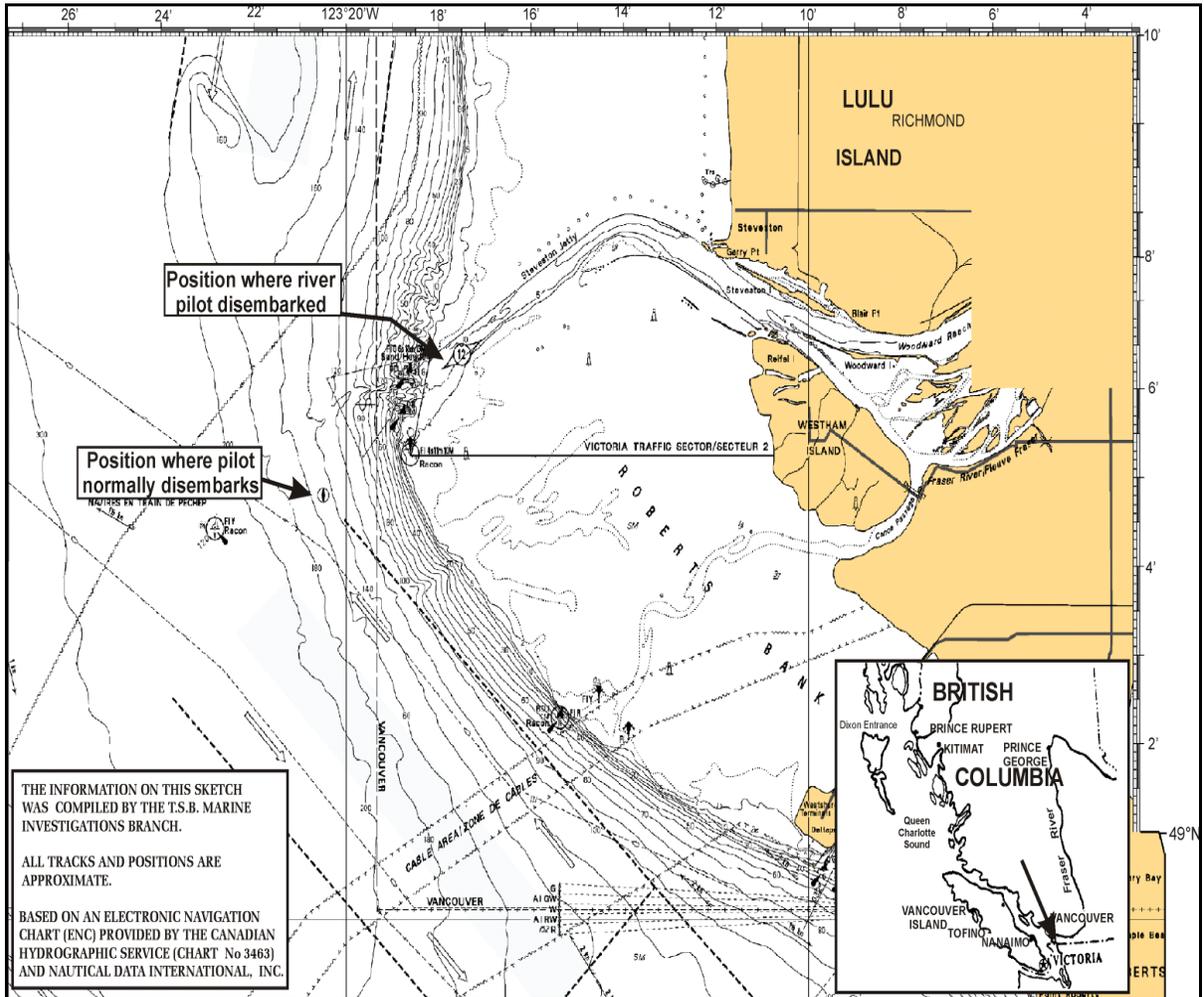
# Appendix B – Pilot Embarkation/Disembarkation Area

There is conflicting information as to the exact location where the handover took place. According to one source, the handover took place between buoys S2 and S4, whereas according to another source the handover took place while the vessel was abeam of Sand Heads lighthouse. In any event, the handover of the vessel took place within the designated compulsory pilotage area for the river pilot while the vessel was still within the buoyed channel.

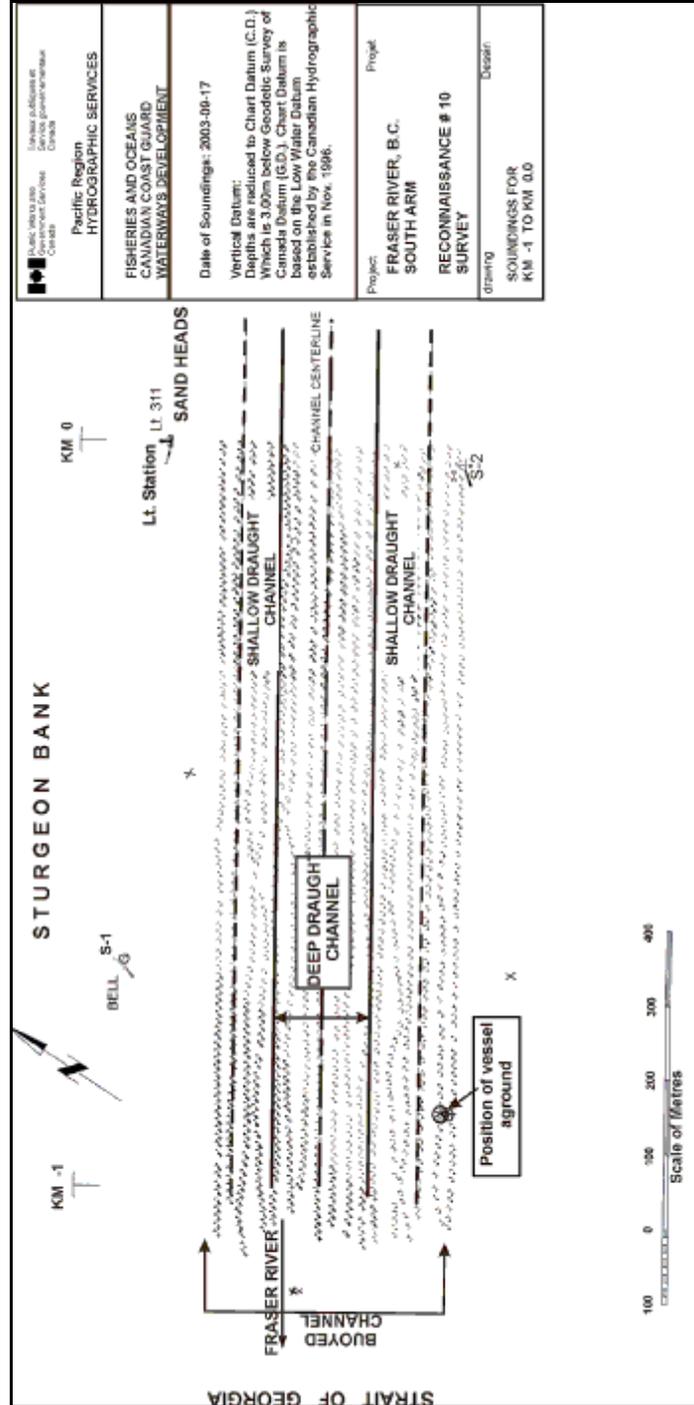
# Appendix C – Sounding Chart of Vessel Grounding Area (Public Works and Government Services Canada)

The data sheet showing the river depths at the site of the grounding of the *Cielo del Canada*, used by the river pilot on 08 November 2003, was based on a survey conducted on 17 September 2003. The depths shown around the grounding site are between 6.2 to 6.3 m above chart datum.

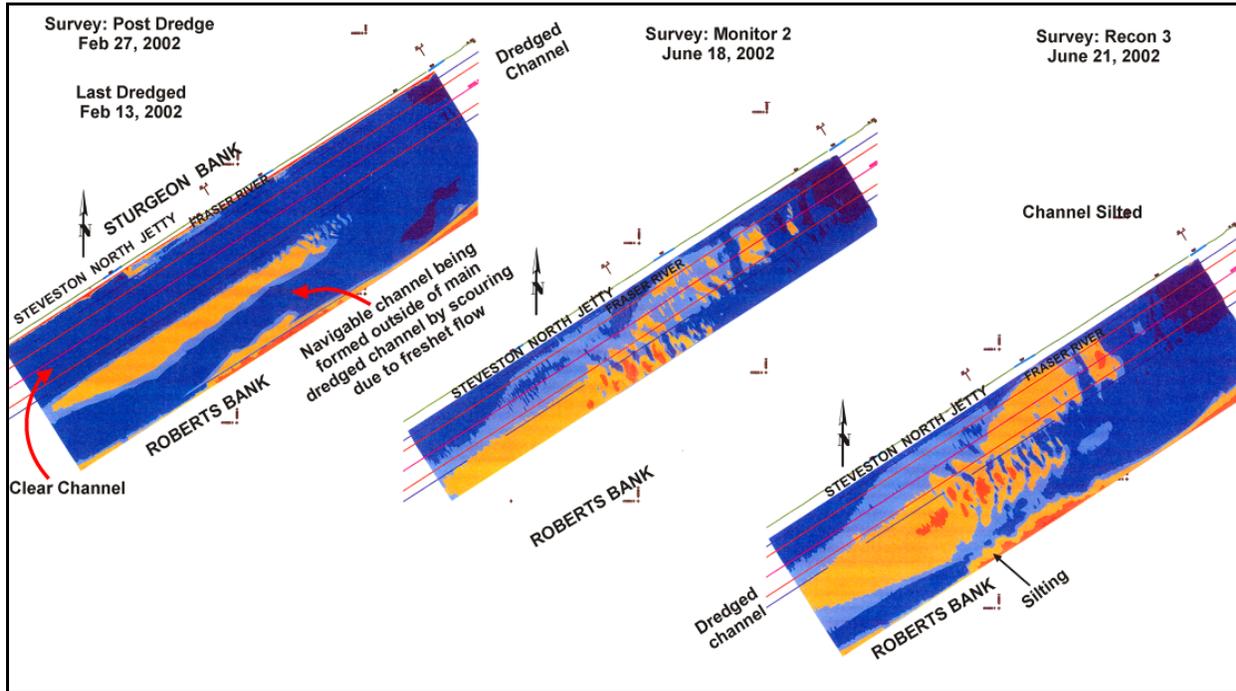
## Appendix D – Figure Showing Freshet Infill

**Note:** Rapid change in channel.

Area showing deep-water channel created outside of the main channel.
