MARINE INVESTIGATION REPORT
M08M0062

CAPSIZING

FIREBOAT 08-448B
HALIFAX HARBOUR, NOVA SCOTIA
17 SEPTEMBER 2008

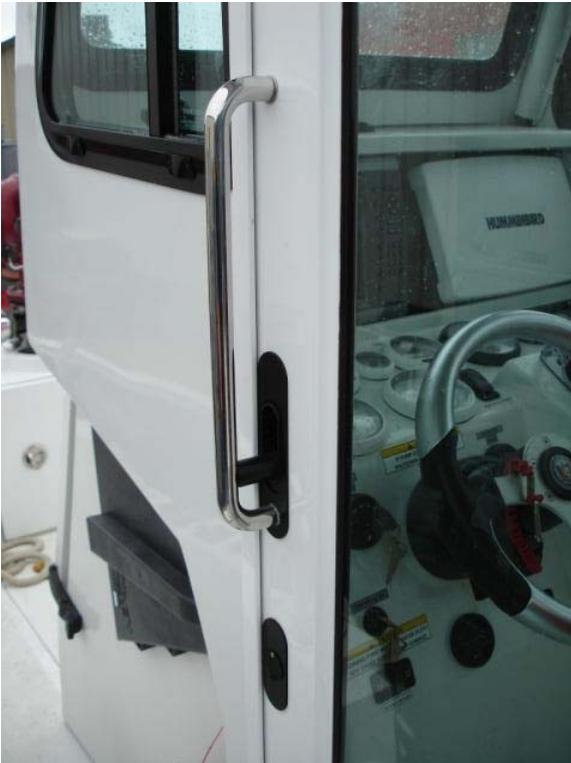
The two pilot house doors could be opened from the outside. They could also be opened from the inside via a flush-mounted door latch. To operate the latch, a user was required to place one or more fingers in a slot measuring 19 mm by 55 mm and push down (see photos 4 and 5). The starboard door, however, had been installed upside down; its latch therefore worked in the opposite direction—to open it, the user had to apply pressure upward. In addition, the lock for each door was adjacent to the finger slot. The lock switch was a left/right toggle requiring little effort to manipulate.¹¹ Once the lock switch was engaged, there was no sign or other visible indication that the door was locked.

Photo 2. Looking forward at the port door handle and latch

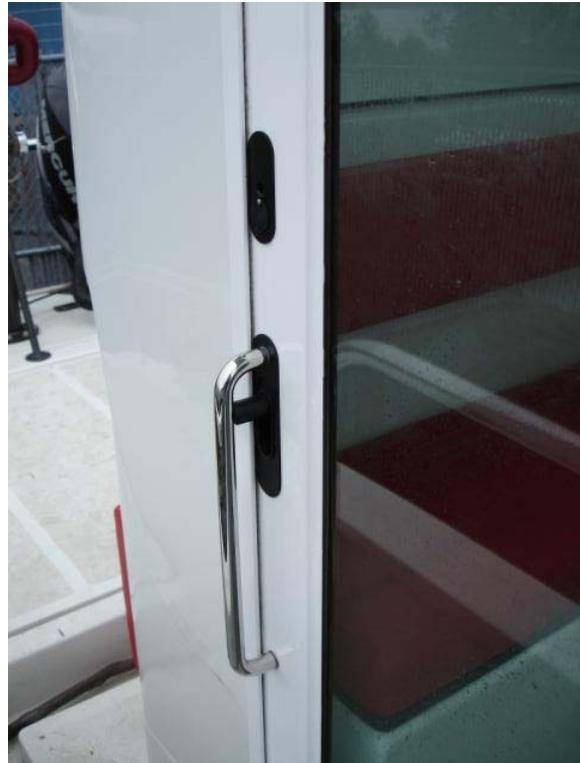
During the pre-departure orientation session, crew members were not instructed on the use of the door latch system nor notified that the starboard door had been installed upside down.

Photo 3. Looking aft at the starboard door handle and latch (installed upside down)

Following the capsizing, crew members within the pilot house found it difficult to locate the door latch and open the starboard door. Whether this was due to the upside-down installation, difficulty in locating the relatively tiny finger slot, a lack of familiarity with its use, or because the door had been inadvertently locked is impossible to ascertain.

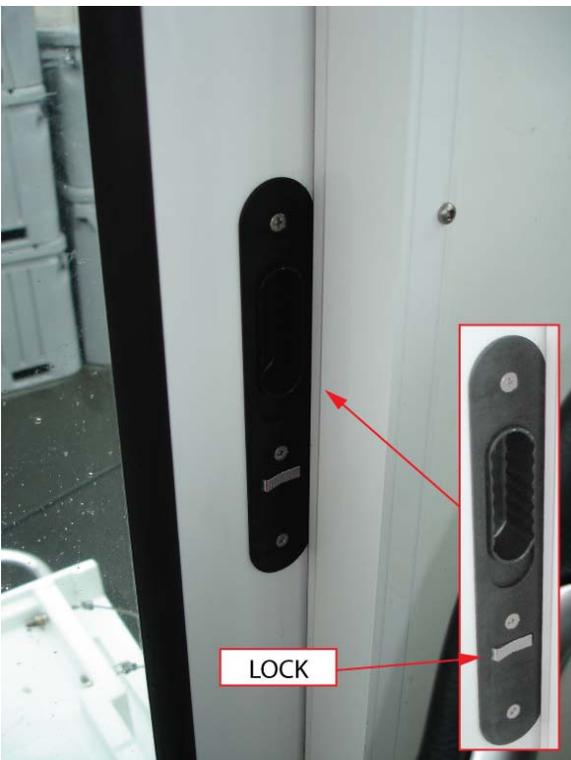
Photo 4. Port door interior latch

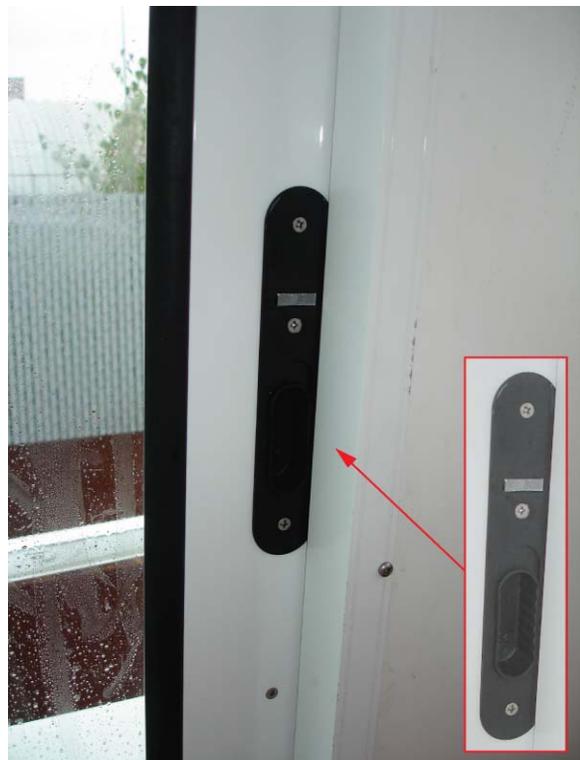
Photo 5. Starboard door interior latch (note position difference from port door latch)

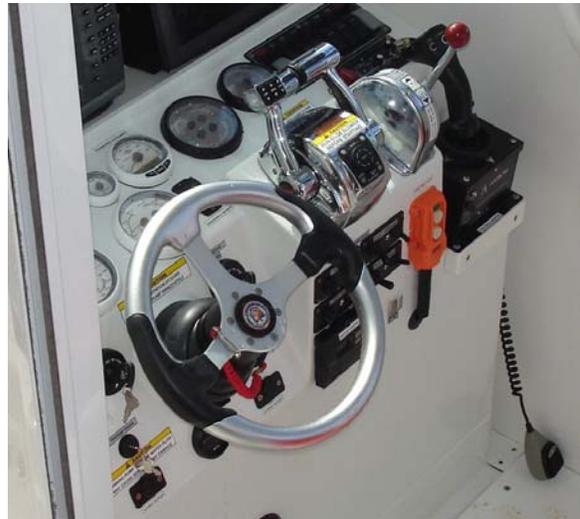
The engine kill switch (also known as the “dead man’s lanyard”) was not attached to the operator (see Photo 6). The purpose of such a lanyard is to stop the engines if the operator leaves the controls. Although the lanyard had been used during the training sessions earlier in the week, because the seas were calm on the morning of the accident, it was not used. Moreover, although in this occurrence both engines stopped immediately upon capsizing, not using this safety device could lead to a situation where engines continue to run with no operator.

Photo 6. Kill switch and throttle position (note lanyard draped over steering wheel)

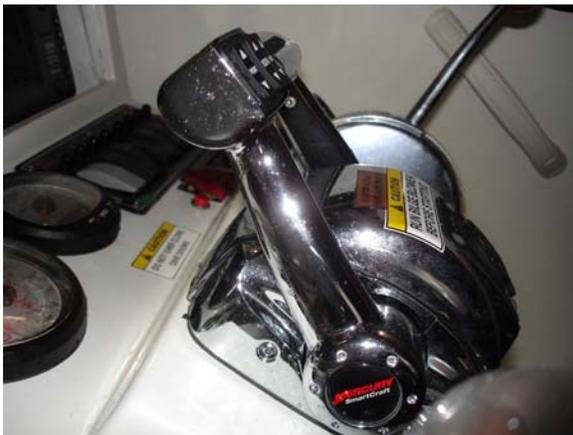
When the vessel began to heel to port, the instructor told the operator to increase throttle. This may explain why the three-quarter throttle setting (see Photo 7) and the amidships motor position conflict with reports that the vessel was in the midst of a slow, relatively tight turn at the time of the capsizing. It is also possible that the throttles were inadvertently pushed forward as the vessel decelerated while capsizing. The clutches were electrically controlled, and the investigation concluded that the port engine disengaged during the capsizing.

Photo 7. Throttle position (after capsizing) at three-quarters ahead

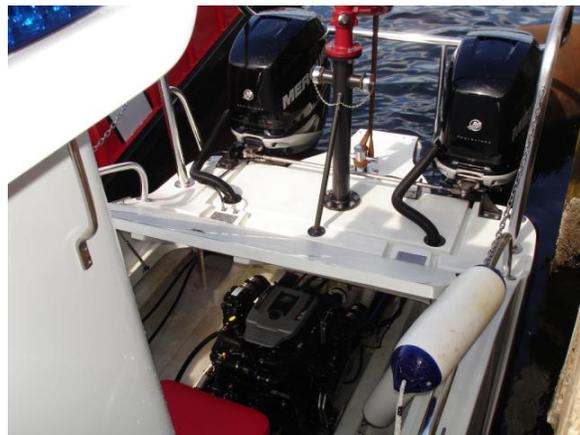
Photo 8. Engine compartment hatch

Upon recovery of the vessel, the inboard engine compartment, which had been closed but not properly secured (see Photo 8), was observed to be open. Such a practice can compromise the watertight integrity of the hull as water is shipped on board during heavy weather or aggressive manoeuvring.
