# MARINE INVESTIGATION REPORT

## M17A0004

### Grounding

Bunkering tanker *Arca 1*  
Little Pond, Nova Scotia  
08 January 2017

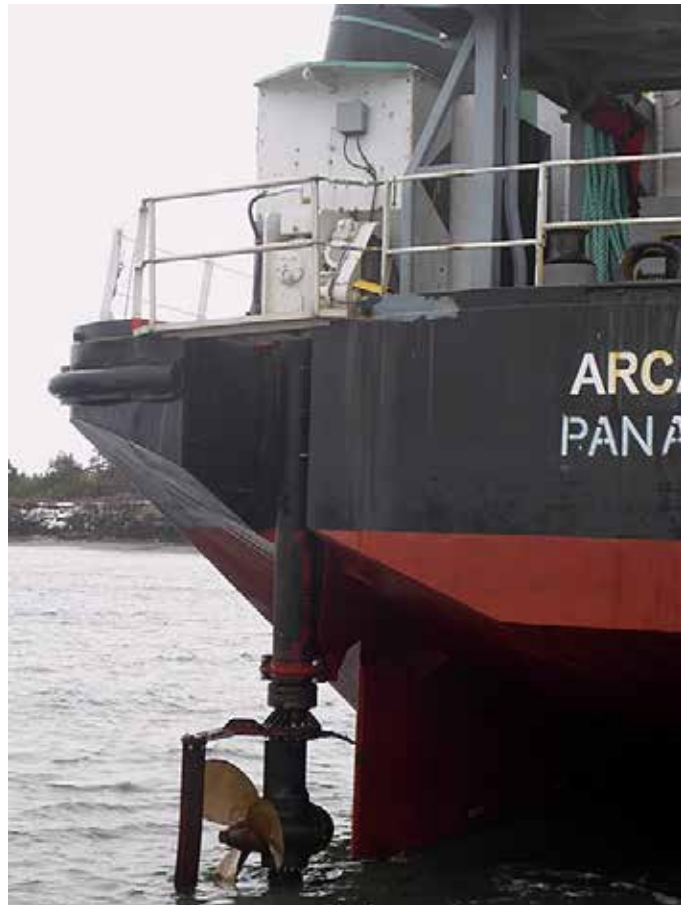
Figure 2. Port Z-drive

During the occurrence, the friction plate on the port propulsion clutch arrangement slipped, which caused overheating and led to the failure of the clutch.

1. The tension on the main propulsion clutch was not checked and adjusted before or during the voyage as per the original equipment manufacturer's recommendation. As a result, clutch slippage occurred and caused the loss of port propulsion.
