MARINE TRANSPORTATION SAFETY INVESTIGATION REPORT M21C0265

CAPSIZING

Rescue boat 1864
Off Île au Diable
Montréal, Quebec
17 October 2021

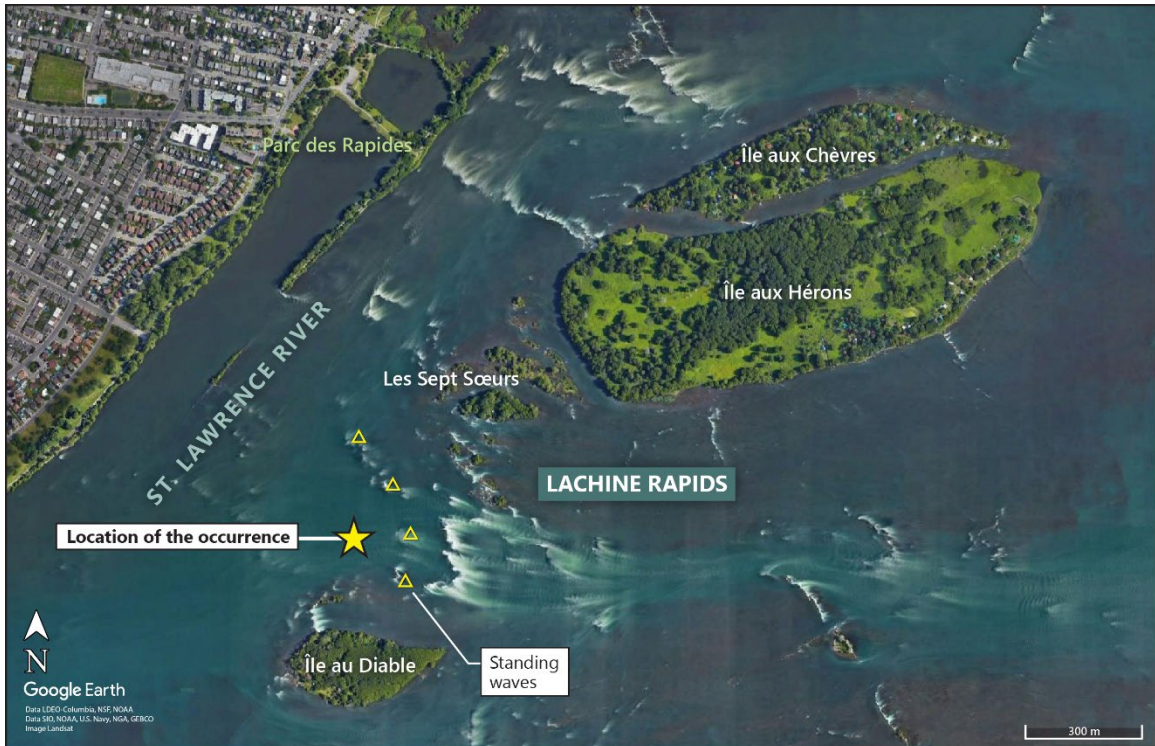
As rescue boat 1864 reversed, it lost power. Seeing that the vessel was approaching the standing wave, the coxswain turned to starboard and applied forward thrust to escape the rapids. Lookout 2 released the tensioned rope. Rescue boat 1864 then struck the pleasure craft hard on the port side. The bow of rescue boat 1864 was caught in the wave, and the boat began to list to starboard. The water flooded the boat, and this flooding, combined with the current and eddies, caused the vessel to capsize rapidly, throwing lookout 2 into the rapids. The other three firefighters were trapped under the hull of rescue boat 1864. The force of the impact pushed the pleasure craft past the standing wave.

Figure 5. Map showing the area of the occurrence just before capsizing and of the standing waves in the Lachine Rapids (Source: Google Earth, with TSB annotations)

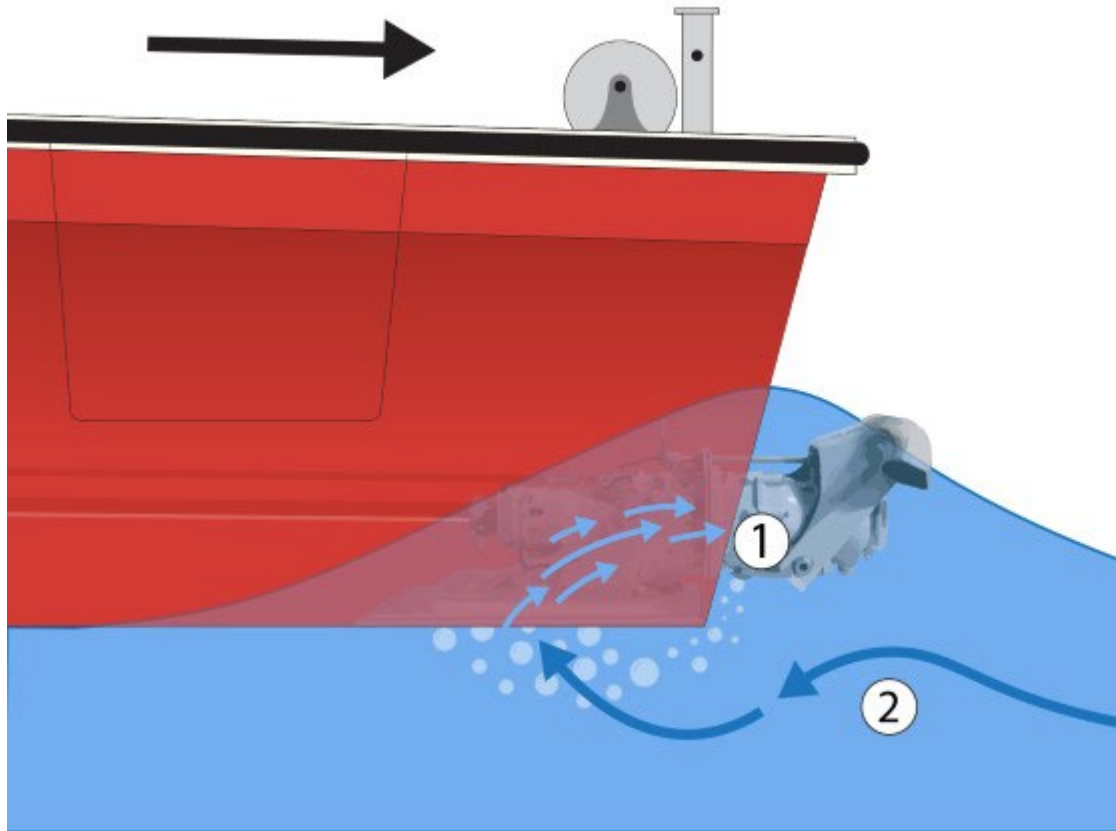
- Control of the vessel diminishes with reduced speed (lower power).
- At high speeds, this type of propulsion generates more noise.
- Backward propulsion power is up to 60% less than forward propulsion due to cavitation¹⁶ in the water intake caused by air bubbles and/or exhaust gases (Figure 7).

Figure 7. Diagram of a boat with reverse propulsion, showing exhaust system gases (1) mixing with water flow (2) (Source: TSB).

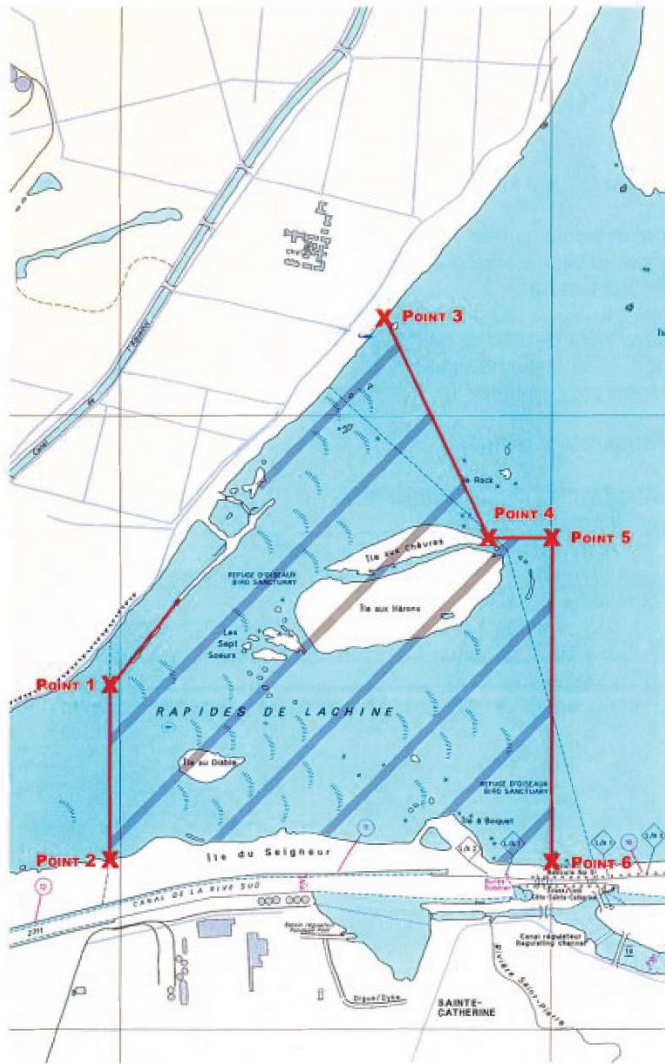
The Lachine Rapids nautical exclusion zone was not saved in the SIM GPS units, nor was it mentioned in the participants' handbooks.

Figure 11. Diagram of nautical exclusion zone in the Lachine Rapids (Source: Service de sécurité incendie de Montréal, Rapport chavirement de l'unité 1802 le 25 mars 2010 (February 2011))
