PIPELINE INVESTIGATION REPORT

P07H0040

CRUDE OIL PIPELINE – THIRD-PARTY DAMAGE

TRANS MOUNTAIN PIPELINE L.P.

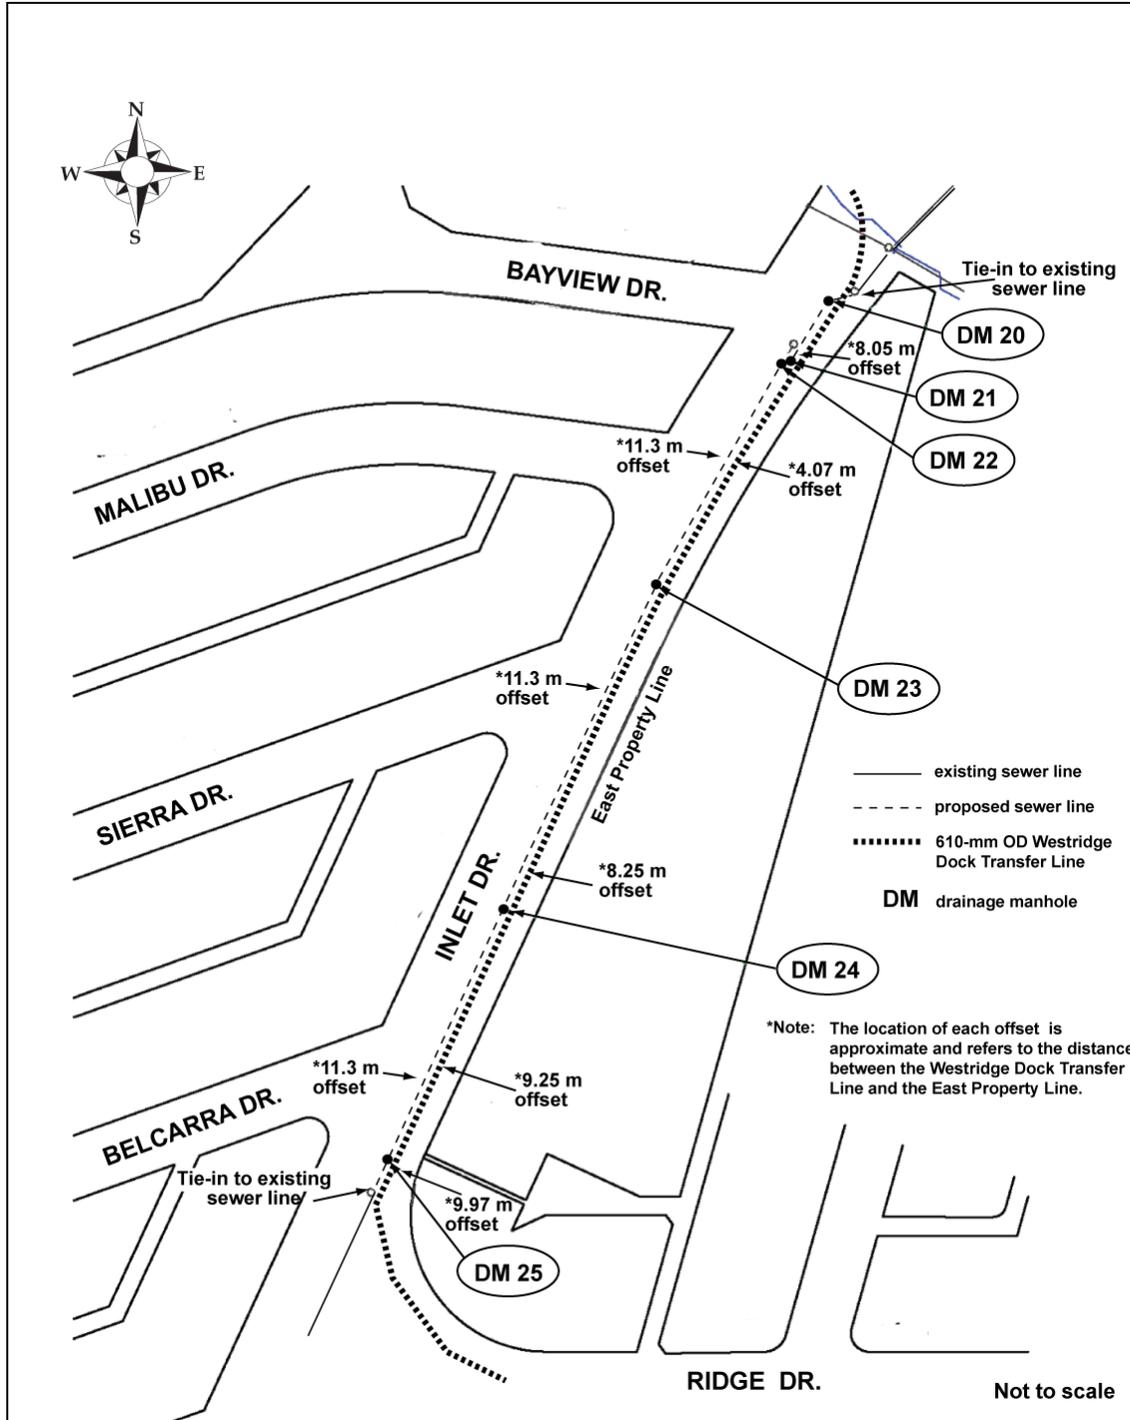
Appendix B – Westridge Dock Transfer Line – Inlet Drive, Burnaby, British Columbia (Source: TSB Illustration)

On 01 March 2007, KMC returned the approved crossing agreement and the design drawings, annotated by KMC, to the consultant. The agreement set out a number of conditions to be met before work could commence in the 30 m safety zone (see Appendix B). The crossing agreement¹ was executed between Burnaby and KMC. The following conditions formed part of the agreement:

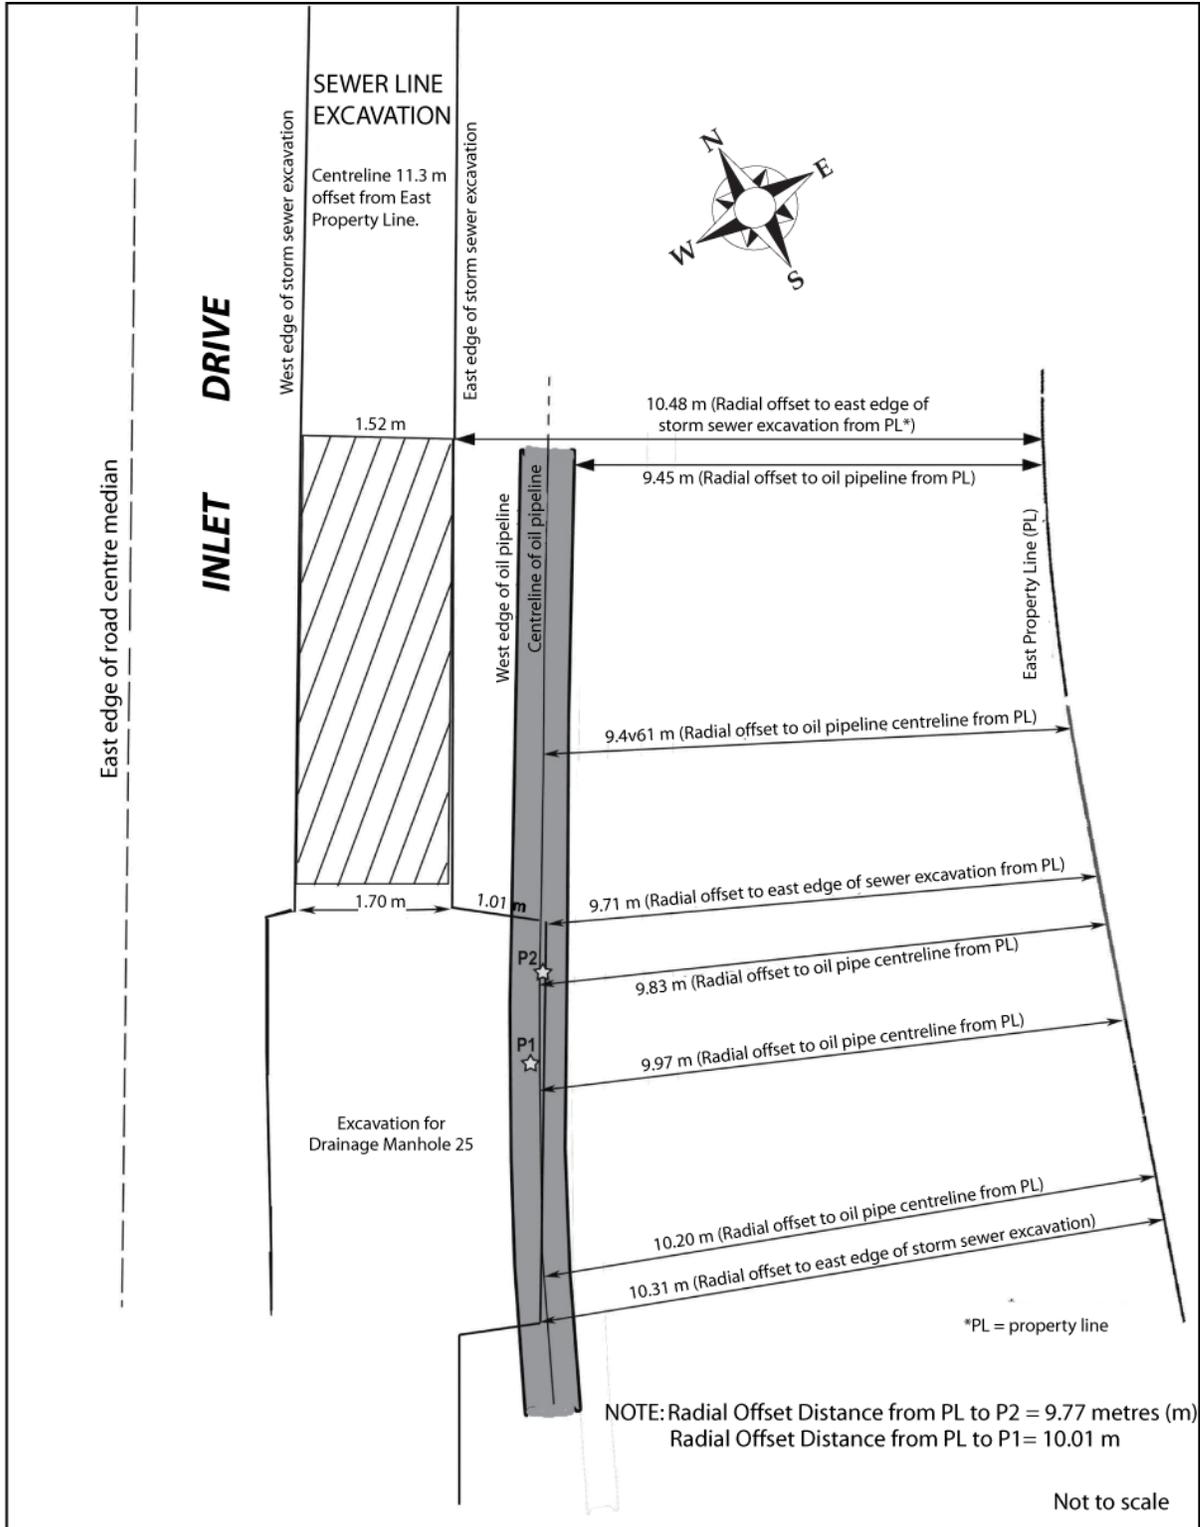
Appendix C – Westridge Dock Transfer Line – Inlet Drive, Burnaby, British Columbia – Post-Occurrence As-Built Survey (Source: TSB Illustration)

A post-occurrence site survey revealed that the offset location of the Westridge Pipeline varied from 4 m to 9.8 m from the east property line of Inlet Drive, instead of the constant 8.5 m offset that had been shown on the design drawings. The survey also showed that the sewer trench was excavated according to the design offset of 11.3 m. At the rupture site, the survey revealed that the Westridge Pipeline was only 1.5 m from the centreline of the sewer trench, instead of the 2.8 m separation that had been shown on the design drawings Rev. 1 and Rev. 2 (see Appendix C).

Since the actual offset of the Westridge Pipeline at DM 25 was closer than anticipated to the design offset of the sewer line, there was an alignment conflict and the Westridge Pipeline was struck by the excavator bucket while the trench was being dug for the sewer line. This alignment conflict would have been discovered if the depth and location of the Westridge Pipeline had been verified before construction, as required by the terms of the crossing agreement and the applicable NEB crossing regulations.

1. The field location of the Westridge Pipeline was not accurately indicated on design drawings, which were based on a 1957 drawing, resulting in an alignment conflict with the trench of the proposed sewer line.
