RAILWAY OCCURRENCE REPORT

R97C0147

RUNAWAY/DERAILEMENT

CANADIAN PACIFIC RAILWAY

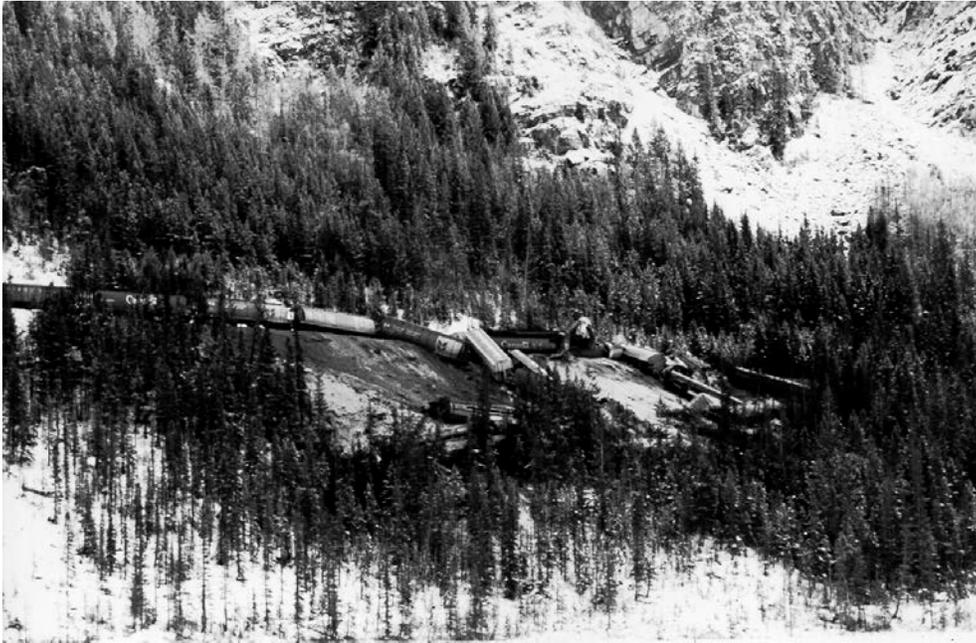
The 16 derailed cars at the first derailment site completely blocked the Upper Spiral Tunnel. At the second derailment site (Figure 2), cars were scattered down the steep embankment that sloped towards the Kicking Horse River.

About 1,500 feet of track was destroyed in the Upper Spiral Tunnel, and 1,000 feet at the second derailment site. Sixty-four of the 66 derailed grain hopper cars were destroyed. Approximately 10,200 tons of grain was spilled, about 9,000 tons of which was recovered.

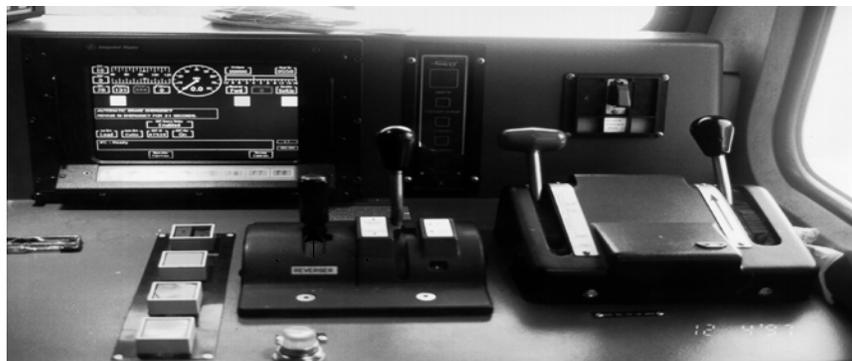
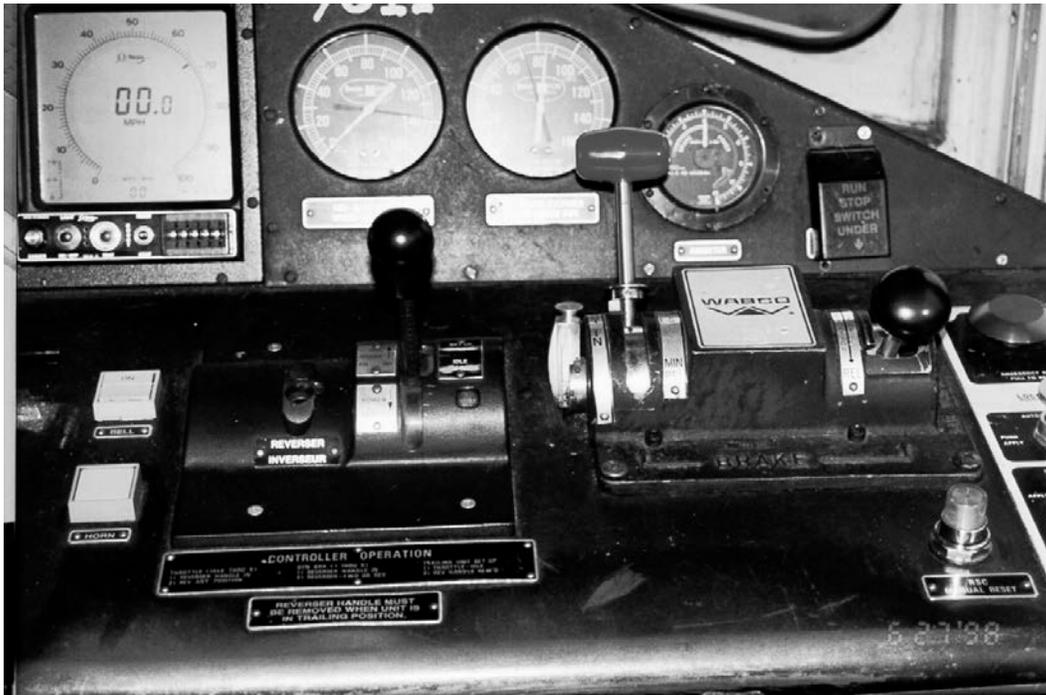
CPR's SD40-2 and SD40-2F (9000 series) locomotive fleet was equipped with locomotive engineer control stands of three different configurations. The earlier SD40-2 models had a GM Electro-Motive Division (EMD) control stand that used a single throttle lever, or combined controller, to control power and dynamic brake. Later models used an Association of American Railroads (AAR) control stand that had separate control levers for power and dynamic brake operation. The SD40-2F (9000 series) has a control console (desk type) with a combined power/dynamic handle on a master controller similar to that on a GE AC 4400 locomotive (see Figures 3 and 4).

Locomotive functions on most GM SD40-2F and SD40-2 locomotives are displayed by lights and gauges at a number of locations within the cab (see Figure 4). The PC light is shown in red on most GM locomotives.

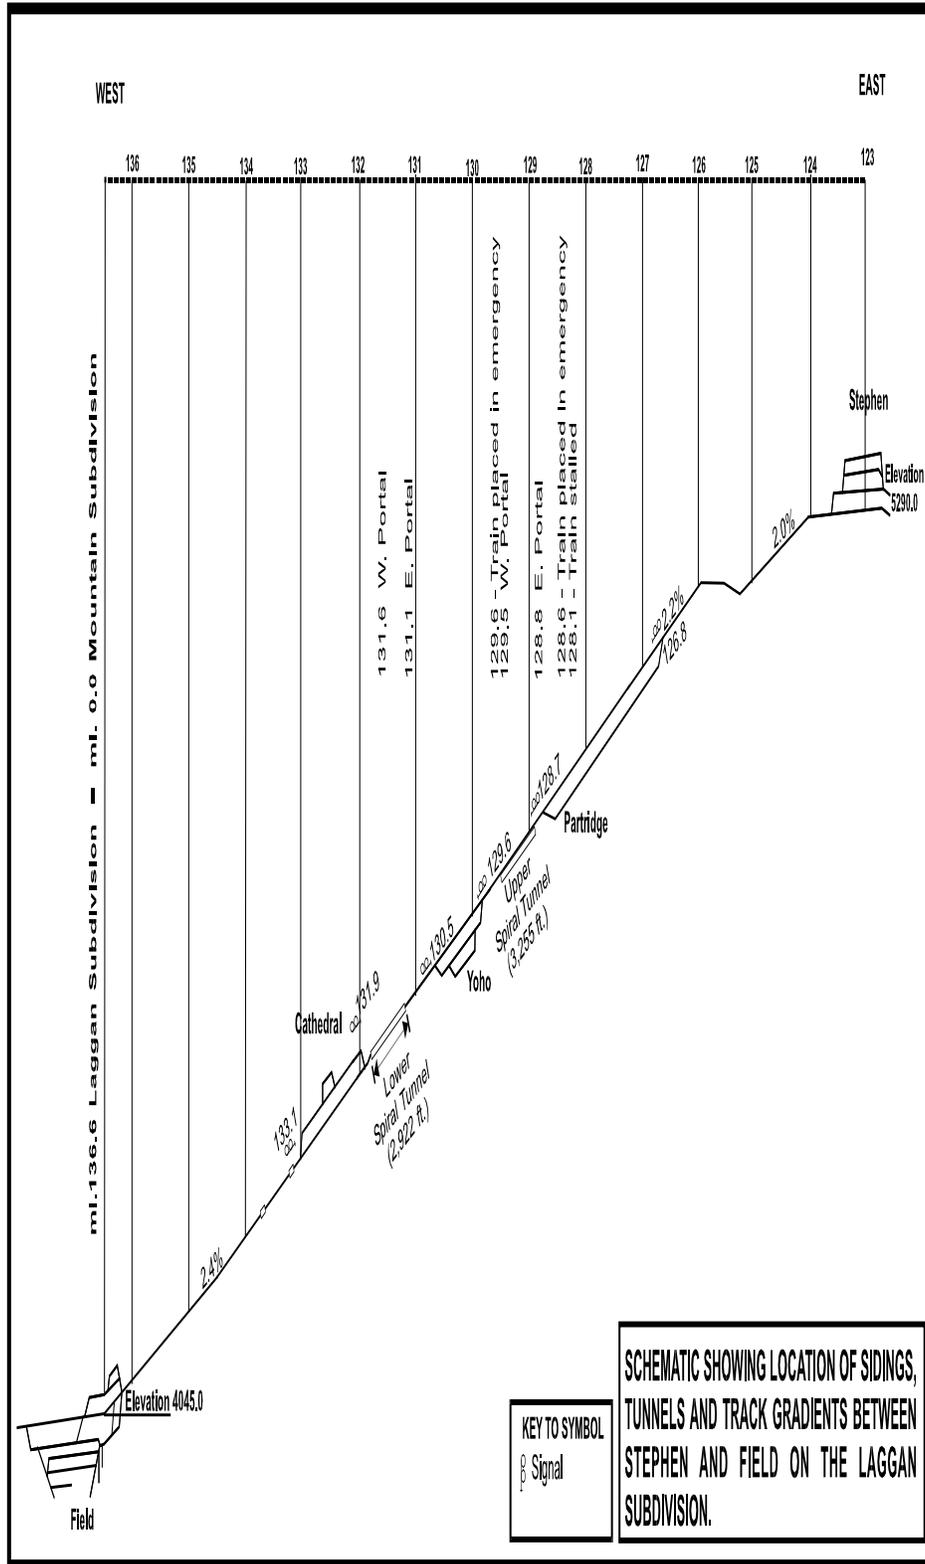
Appendix A - Sketch of the Track in the Occurrence Area

The portion of the subdivision from Stephen to Field, known as Field Hill, is single main track, with two designated sidings. The average descending grade is 2.2 per cent⁵ in the westward direction. There are sharp curves and several tunnels, including two spiral tunnels (see Appendix A).
