RAILWAY INVESTIGATION REPORT

R99T0017

TRAIN PASSED A SIGNAL INDICATING STOP

VIA RAIL CANADA INC.

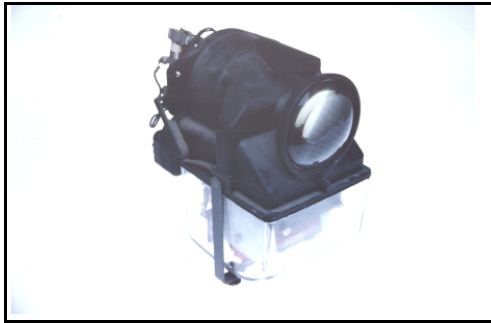
A known problem with this type of assembly is that it could freeze in place, when the temperature is below freezing, should moisture be present in the mechanism and the three-disc assembly come in contact with the

metallic housing. Should this occur, the signal may not display the desired indication. Under such conditions, the fail-safe feature would not function.

The searchlight signal, located at the top of the signal arrangement for signal 2352S at Trenton Junction, was examined at the TSB Engineering Branch Laboratory to determine if a malfunction could have occurred when VIA 52 approached and passed it. Representatives from Alstom, the manufacturer, as well as the regulator, Transport Canada (TC), attended. The mechanism was dismantled, and the parts were examined. No sign of malfunction was discovered and no sign of moisture was observed inside the assembly.

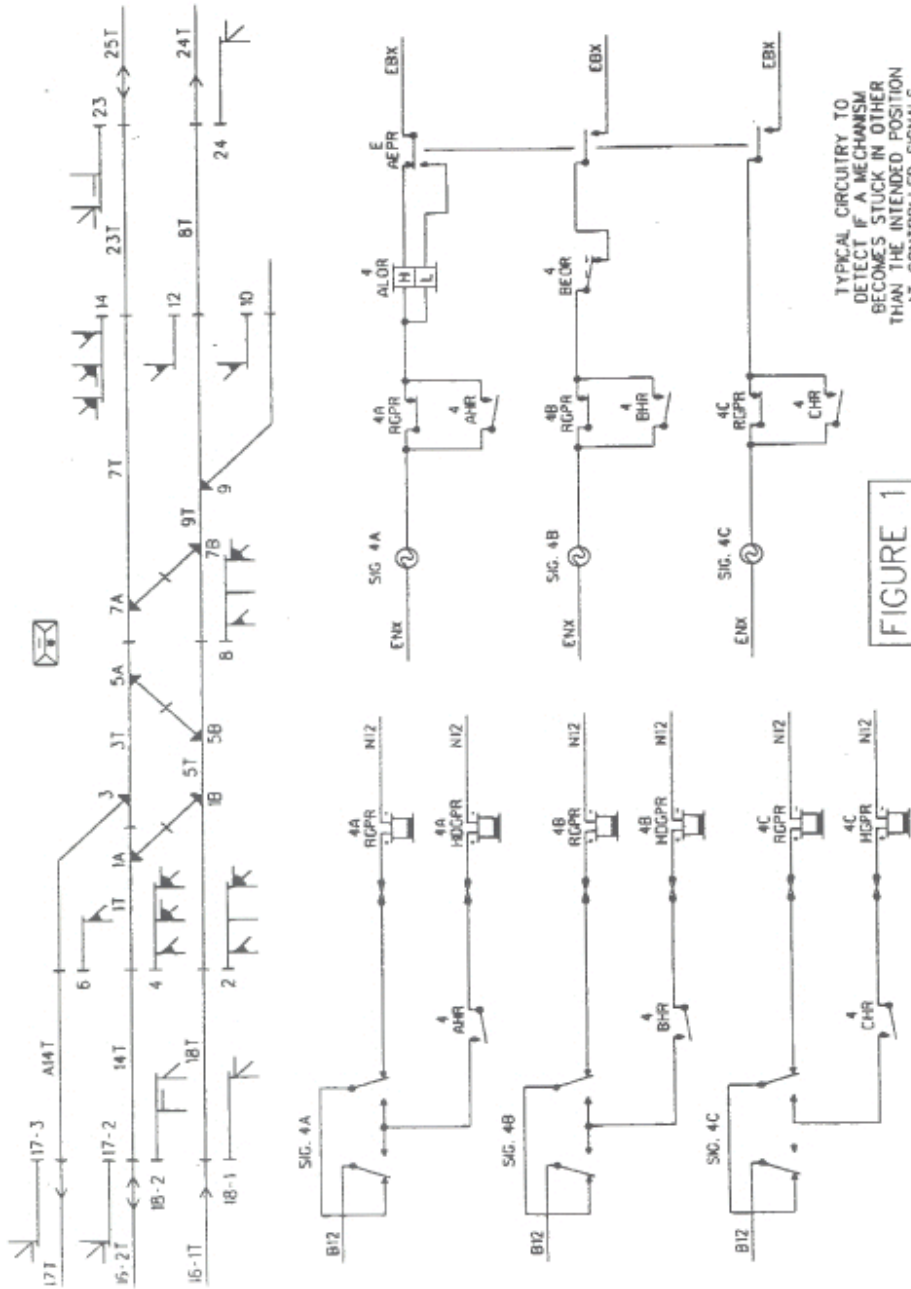
FIGURE 1

TYPICAL CIRCUITRY TO
 DETECT IF A MECHANISM
 BECOMES STUCK IN OTHER
 THAN THE INTENDED POSITION
 AT CONTROLLED SIGNALS

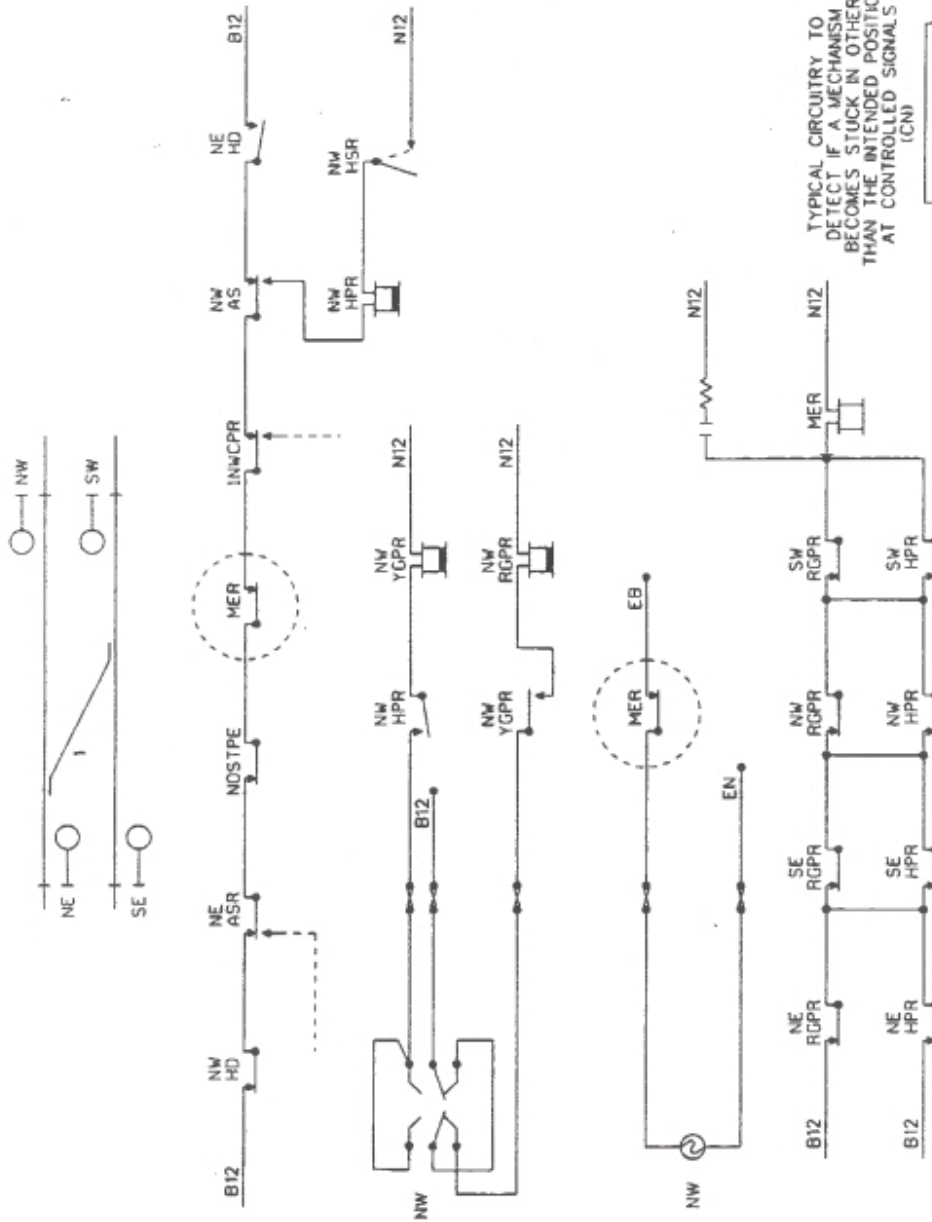
FIGURE 3

TYPICAL CIRCUITRY TO
 DETECT IF A MECHANISM
 BECOMES STUCK IN OTHER
 THAN THE INTENDED POSITION
 AT CONTROLLED SIGNALS
 (CN)
