**RAILWAY INVESTIGATION REPORT**  
**R08T0158**

**CROSSING COLLISION AND DERAILMENT**

**VIA RAIL CANADA INC.**  
**TRAIN NUMBER 60**  
**MILE 138.21, KINGSTON SUBDIVISION**  
**MALLORYTOWN, ONTARIO**  
**15 JULY 2008**

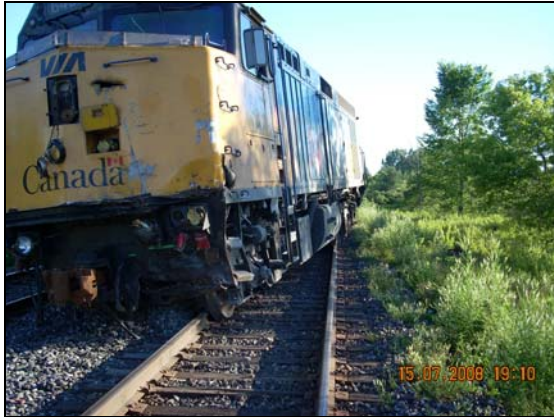
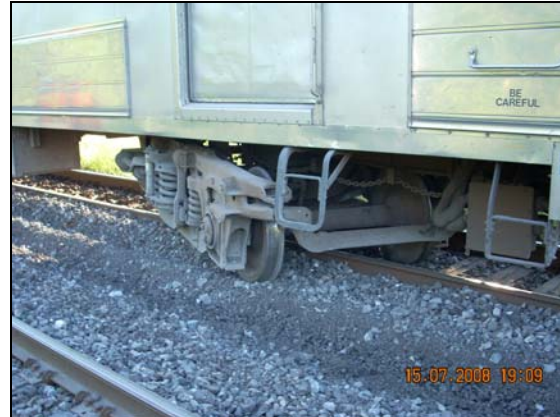
Photos 6a and 6b. Damage to rail equipment

Approximately 2500 feet of the north main track was damaged, resulting in the replacement of around 600 ties. The locomotive sustained severe damage to its front end, and its running gear (see Photo 6a). The baggage car sustained damage to its lead truck (see Photo 6b) and to its interior flooring.
