RAILWAY INVESTIGATION REPORT
R08W0219

EMPLOYEE INJURY

CANADIAN NATIONAL
MILE 150.70, SPRAGUE SUBDIVISION
SYMINGTON YARD, WINNIPEG, MANITOBA
22 OCTOBER 2008

Report Number R08W0219

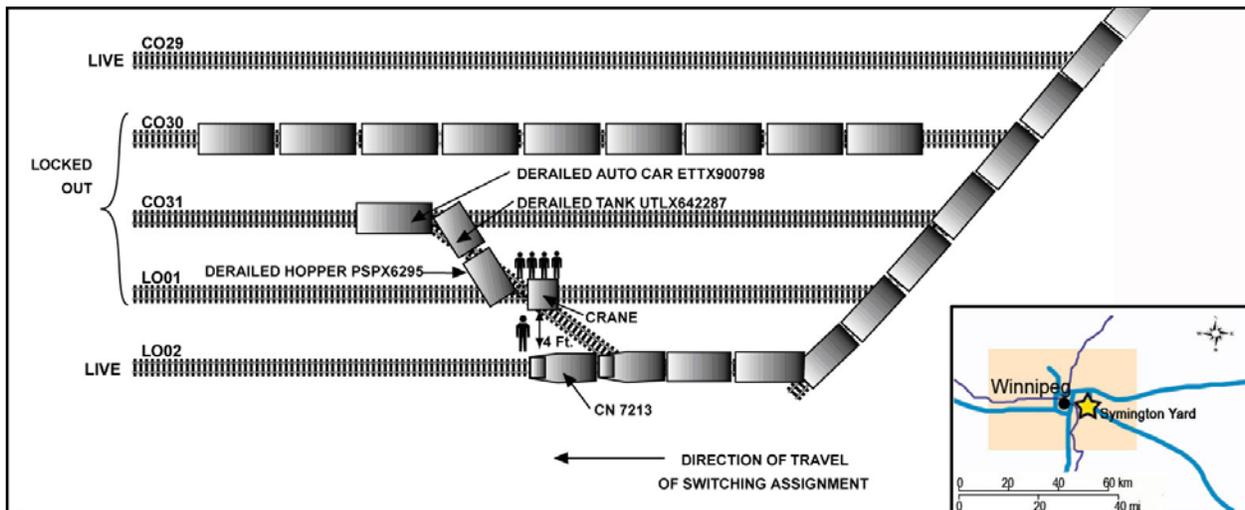
Figure 1. Accident site diagram

On 21 October 2008 at approximately 1400,¹ a three-car derailment occurred at the Canadian National (CN) Symington Yard, located in Winnipeg, Manitoba, near the centre of the hump yard at the crossover between track LO01 and track CO31 (see Figure 1).

As the wrecking crane was preparing to lift the east end of the derailed car (PSPX6295), it was in close proximity to a live switching lead. The outrigger for the crane was within four feet of the north rail of track LO02. Under these circumstances, occupancy, access to, and exit from the worksite were confined by the positioning of equipment and the live tracks. From where the injured employee was positioned, the employee was unable to move a safe distance from the car being lifted without encroaching upon live tracks.

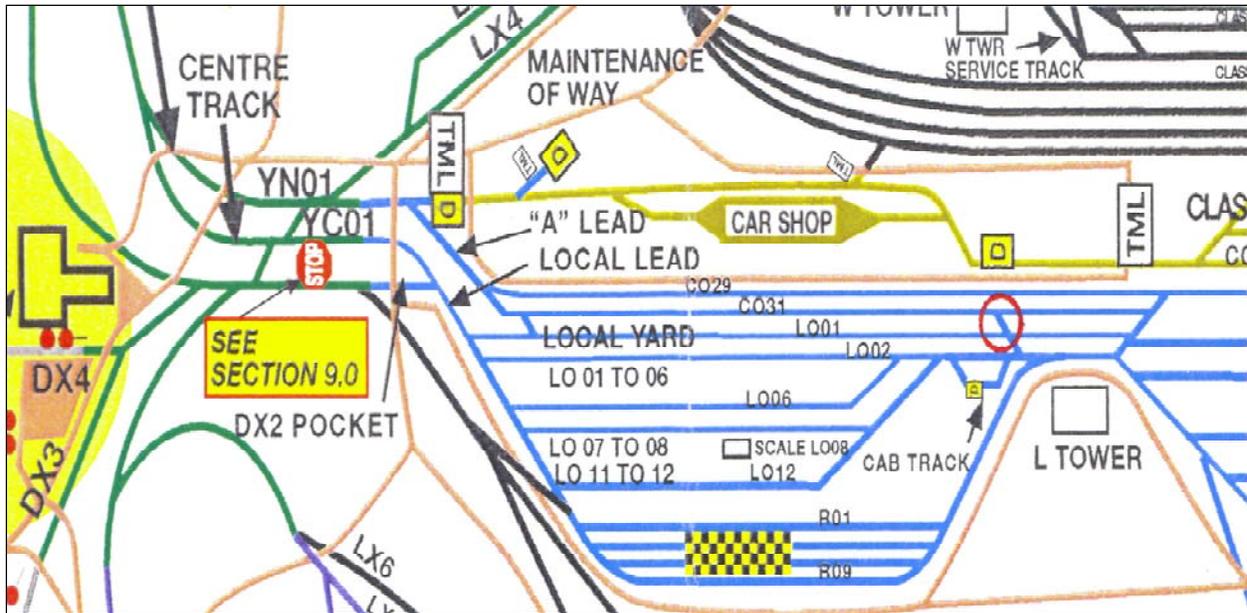
Figure 2. Partial track schematic of Symington Yard

During wrecking operations, tracks CO29, CO30, CO31, and LO01 were initially locked out² from switching activity. However, tracks LO02 and R09 were not locked out because these were the only switching leads left that could access a majority of the local classification tracks (see Figure 2).

Track R09 extends from track LO02 just east of the derailment area and was available to be used as an alternate route to conduct switching operations. During wrecking operations, tracks CO30, CO31, and LO01 were locked, while tracks LO02, CO29, CO30, and R09 were not.
