RAILWAY INVESTIGATION REPORT
R10C0016

NON-MAIN-TRACK DERAILMENT

CANADIAN PACIFIC RAILWAY
FREIGHT TRAIN 292-02
MILE 0.0, BROOKS SUBDIVISION
MEDICINE HAT, ALBERTA
03 FEBRUARY 2010

Report Number R10C0016

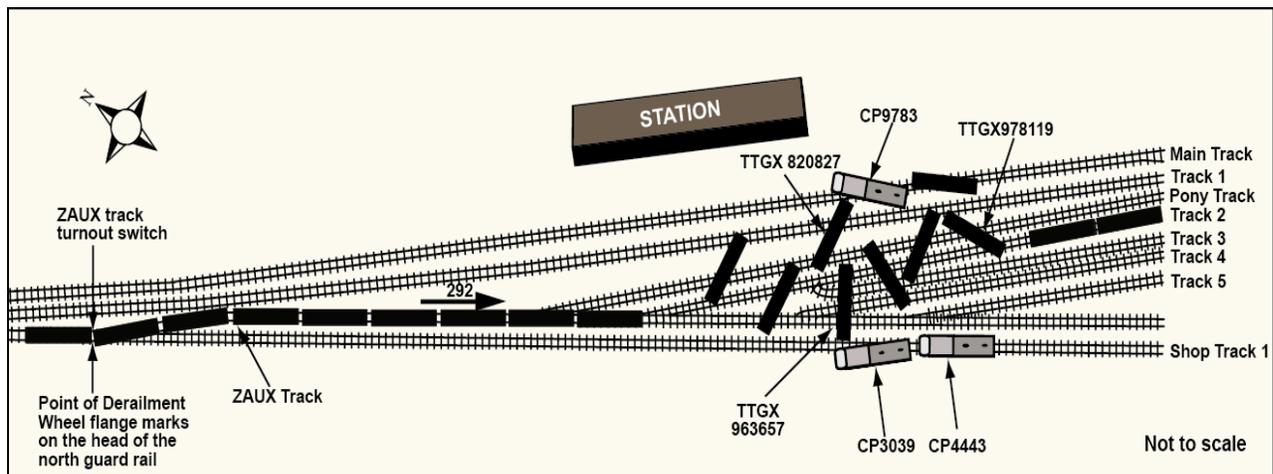
Figure 2. Medicine Hat Yard accident site diagram

The first car, TTGX 978119, had its rear truck derailed; the following 6 cars had all of their trucks derailed. The 16th car, TTGX 963657, derailed southward from track 2, striking and derailing yard service locomotive CP 3039 which was stationary on shop track 1. As a result, the fuel tank of CP 3039 punctured and diesel fuel spilled onto the ground. The yard assignment locomotive engineer, who was in the cab, was not injured.

The 17th car on train 292, TTGX 820827, derailed northward from track 2 and struck the head-end of train 103 on the main track. The impact caused lead locomotive CP 9783 and the first car, an empty auto carrier, to derail. The fuel tank on CP 9783 punctured and diesel fuel spilled onto the ground. The conductor, who was in the cab of the locomotive, was not injured.

During site examination, the first wheel flange marks in the vicinity of the derailment were found on the head of the north guard rail of the frog in the Number 11 - 100 lb left-hand turnout between the west shop track 1 and the ZAUX track.

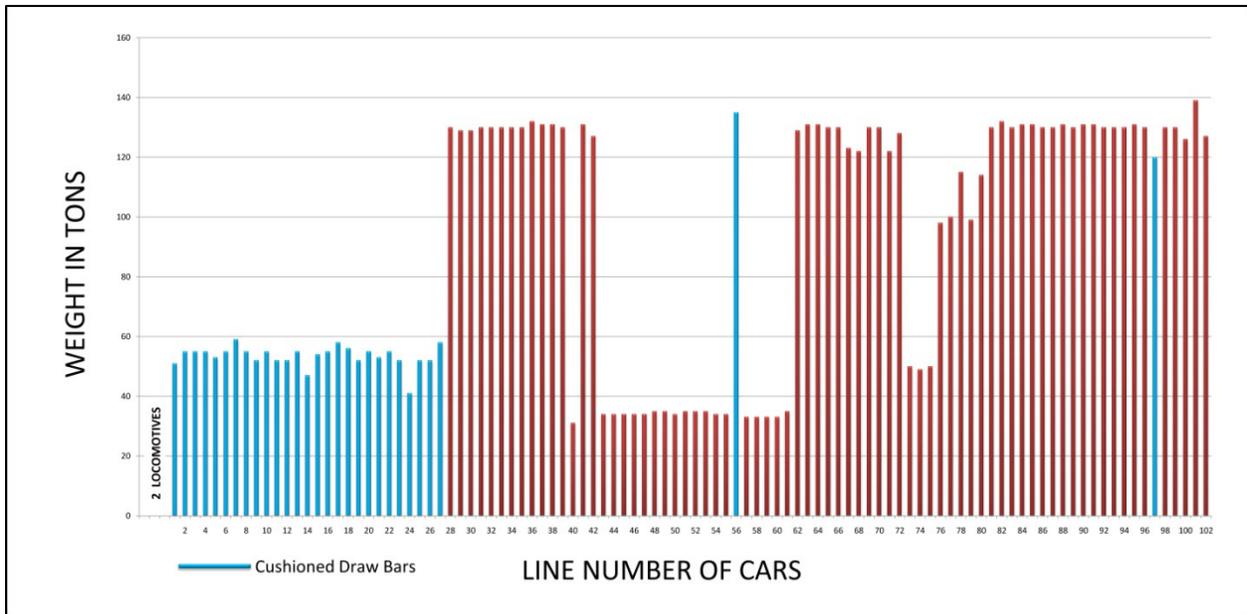
Figure 3. Tonnage Profile for Train 292 (Note: The locomotives weigh 210 tons each)

The rear 4500 feet of train was heavier and on a steeper grade than the lighter 2800 foot long head-end portion. Although not a TrAM violation, marshalling of the long and lighter empty multi-level auto carrier cars ahead of the heavier rear portion of the train made it vulnerable to the large in-train buff forces generated when attempting to control train speed using DB only. The buff forces compressed the EOCCD draft gear, producing high transformed lateral forces due to the wide angle couplers. These cars when empty are more than 50% heavier than empty conventional cars and TrAM considers them to be loads. Had they been placed on the tail end of the train behind heavier loaded cars, the risk of derailment would have been reduced. While it may seem appropriate to apply the TrAM load threshold of 45 tons to empty long cars with wide angle couplers and pre-loaded EOCCD draft gear, marshalling them ahead of heavier loaded cars increases the risk of derailment during heavy braking events.

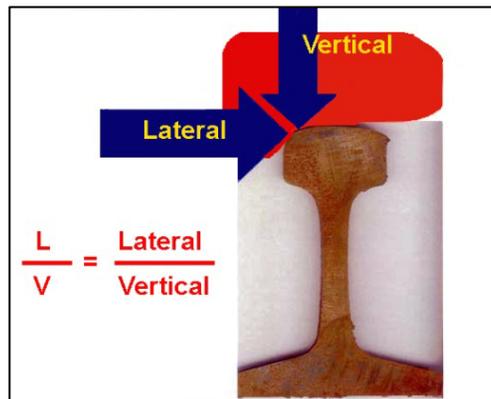
Figure 4. L/V Forces

All railcar draft gears have some longitudinal travel or “slack” designed into them which can be a significant factor in a long train with many cars. When head-end braking occurs, the train becomes bunched. The draft gear and cushioning devices become compressed and compression or “buff” forces result. The buff force generated can be high, especially during the transition from a stretched to a bunched state when the trailing cars impact against the cars ahead. When high buff forces act on cars on curved track, where the drawbars have taken an angle to each other, high lateral forces can be generated that come to bear through the wheel flange against the gauge side of the rail. The run-in of slack and the continued build-up of buff force during braking events must be properly managed to avoid elevated lateral versus vertical force (L/V) ratios (see figure 4).

L/V ratios quantify the relationship between the weight of the locomotive or railcar bearing down on the rail through the wheel interface (i.e., vertical force) and the force of the wheel flange pushing out on the rail (i.e., lateral force). The single wheel L/V ratio can be used to predict the risk of the wheel climbing the gauge face of the rail or lifting off the rail. Circumstances in which a car is operating with high lateral force and low vertical force can result in a wheel climb event and derailment. For normal flange/rail contact conditions, a wheel L/V ratio of 1.5 can cause wheel climb.
