**RAILWAY INVESTIGATION REPORT
R12W0165**

MAIN-TRACK DERAILMENT

**CANADIAN PACIFIC RAILWAY
CP FREIGHT TRAIN 113-26
MILE 34.3, CARBERRY SUBDIVISION
POPLAR POINT, MANITOBA
29 JULY 2012**

Report Number R12W0165

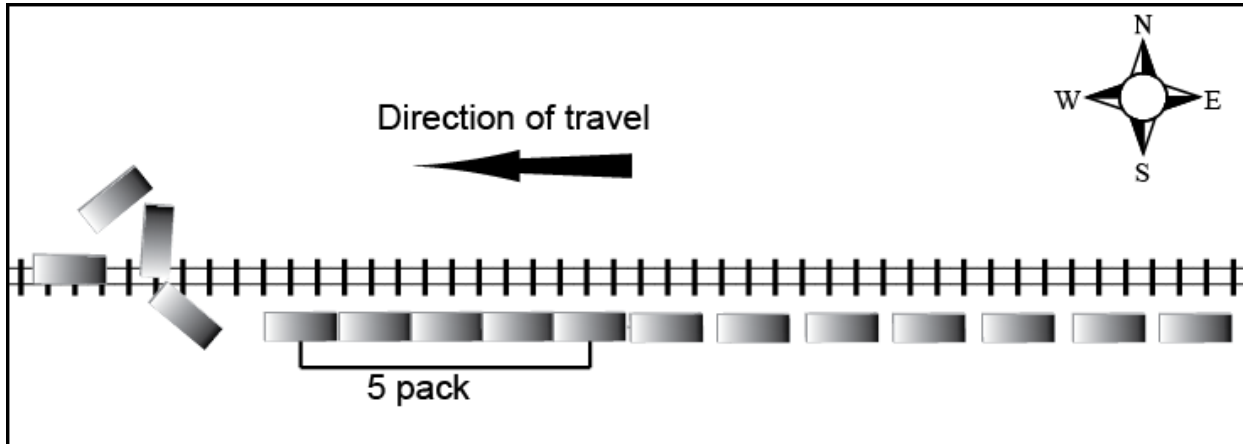
Figure 2. Site diagram (Not to scale)

The first car to derail was a single well container (single well) car. This was followed by 3 more single well cars, a “5-pack” (5 car bodies) articulated multi-well container (multi-well) car and 7 single well cars. Each of the 16 car bodies were loaded with 2 empty double-stacked containers (2 containers stacked one on top of one another). Thirteen of the car bodies derailed to the south side of the track (see Figure 2).

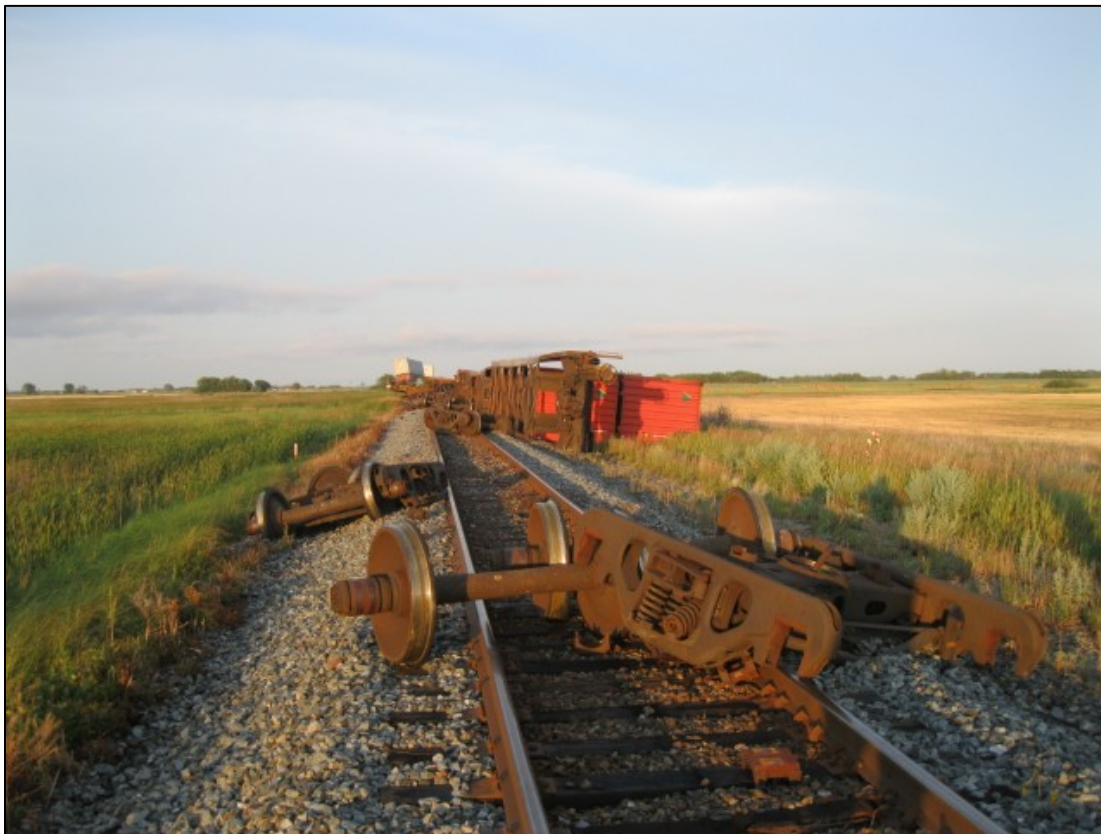
Most of the cars remained in line connected together and derailed onto their sides with the double-stacked containers still locked in place. The corresponding trucks remained relatively intact, but strewn about the track (see Photo 1).

Photo 1. Derailment looking west

Starting at about Mile 34.3, wheel flange marks were observed on the ties but there were no marks observed on the rail head. The absence of any definitive marks on the rail head indicates that wheel lift had likely occurred, leading to the derailment. Most of the derailed cars had remained connected and in-line on their sides while most of the freight car trucks from the derailed cars had remained intact near the track. The positioning of the derailed equipment was consistent with the cars having been rolled or pushed over off their trucks.

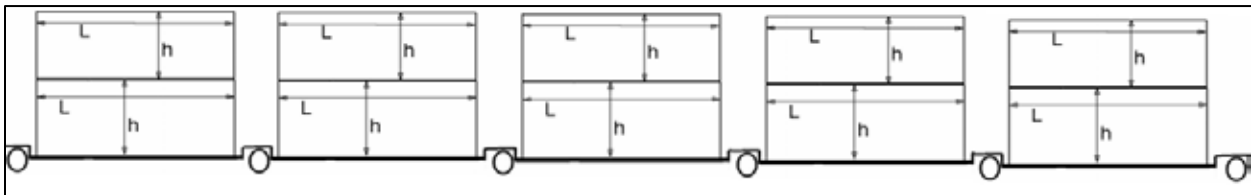
Figure 4. Representation of a 5-pack multi-well car loaded with double-stacked containers

Multi-well cars are equipped with a freight car truck at each end of the first and last platform while the platforms within the car share common trucks at each end (see Figure 4). A 5-pack multi-well car would be equipped with 6 trucks. With the multi wells full and similar-sized containers double-stacked on top, the distance between containers on adjacent car bodies would be approximately 11 feet.

When comparing a 5-pack articulated multi-well car loaded with double-stacked empty containers to a similarly loaded single well car, the area affected by wind is directly related to the number and size of the containers. However, for the 5-pack articulated multi-well car, the space between the containers, the overall number of trucks and the weight of the car are reduced. When compared with a similarly equipped single well car, a 5-pack articulated multi-well car loaded with empty double-stacked containers has a higher potential for wheel lift during high wind conditions.
