**RAILWAY INVESTIGATION REPORT
R14C0142**

MAIN-TRACK TRAIN DERAILMENT

**CANADIAN PACIFIC RAILWAY
FREIGHT TRAIN 205-25
MILE 82.1, LAGGAN SUBDIVISION
BANFF, ALBERTA
26 DECEMBER 2014**

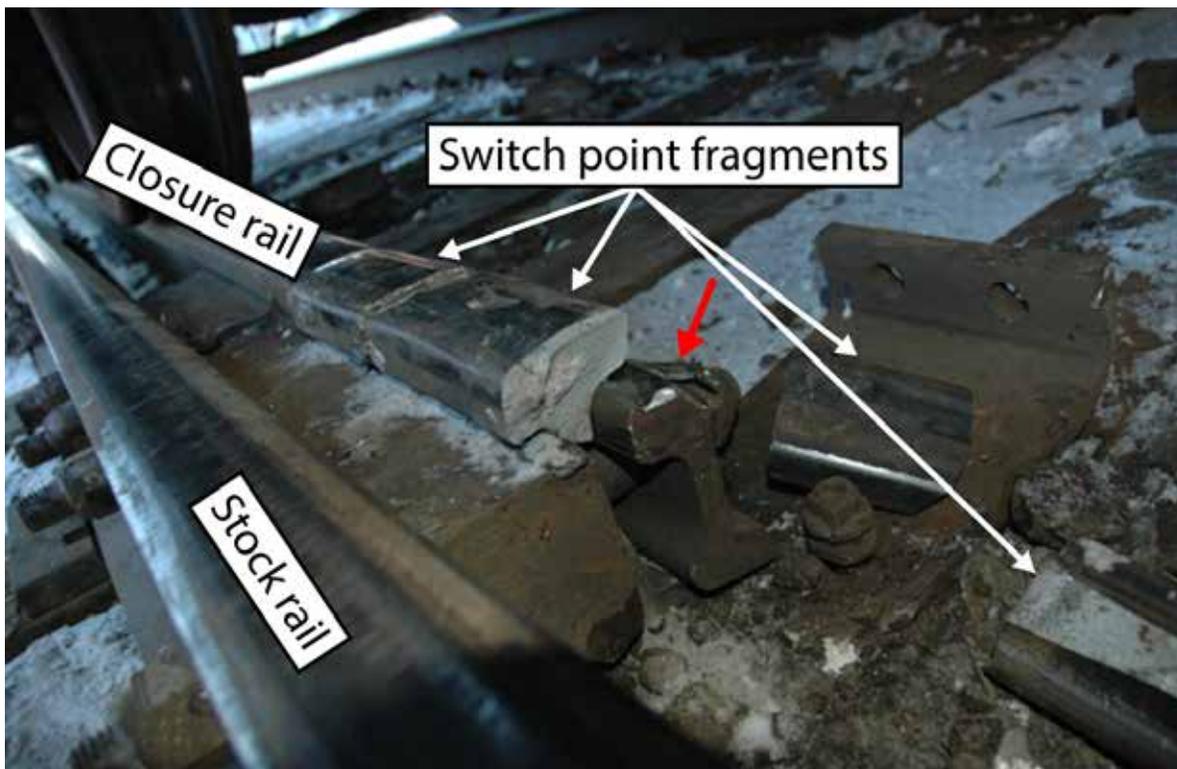
65-foot through-plate girder ballast deck bridge. The switch points and the switch heater at the west switch of Banff siding were destroyed.³ The point of derailment was determined to be at the north closure rail of the switch heel block assembly, where there were several pieces of broken rail. The heel of the switch point rail had broken into several pieces at the heel casting (Photo 1). The heel casting and joint bars were undamaged.

Photo 1. Heel block assembly on the north rail (Note: The red arrow points to the heel block joint bar.)

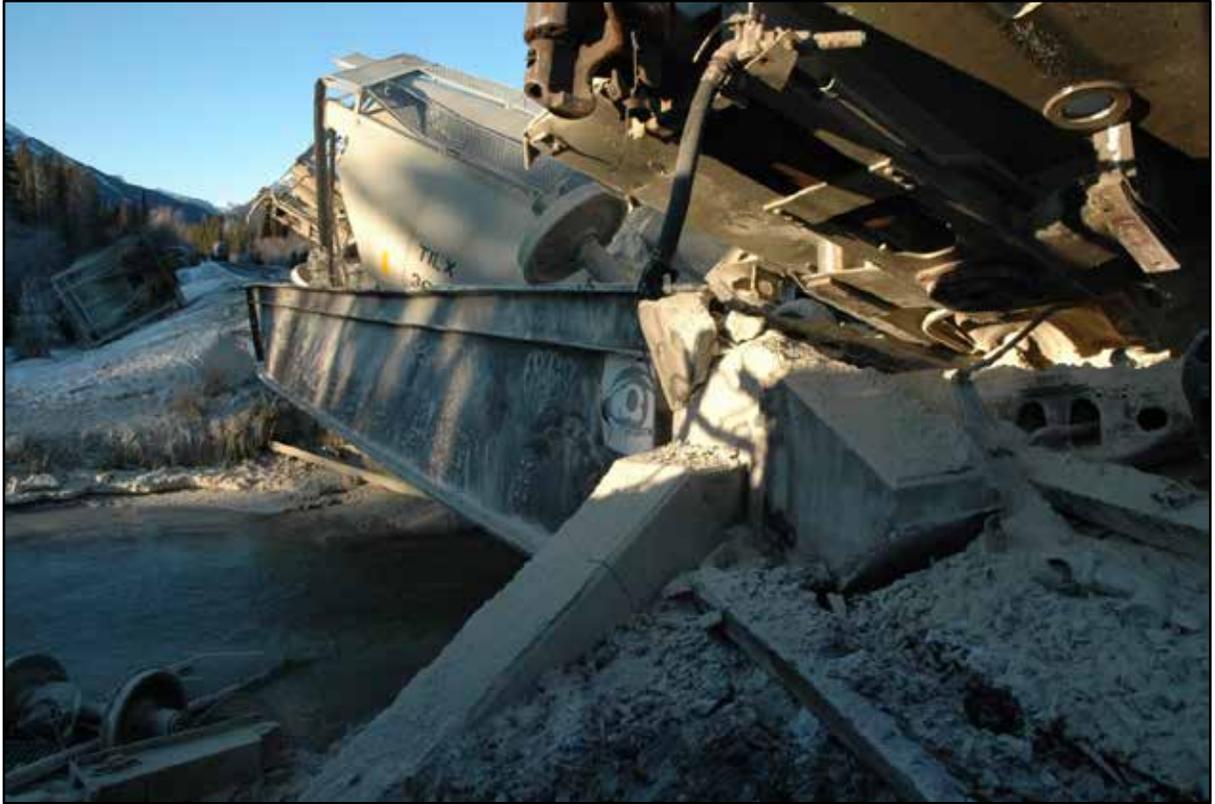
Fifteen cars derailed: 1 empty gondola, 9 covered hoppers loaded with fly ash, 1 covered hopper car of lentils, and 4 covered hopper cars loaded with soybeans. The trailing truck of the 39th car, DME 80060, was the first to derail. The 40th car and the 41st car remained upright on the roadbed. The 42nd car came to rest on its side, west of the bridge on the south side of the track. The 43rd to the 48th cars came to rest, derailed in jackknife fashion on the bridge on top of the north girder (Photo 2 and Photo 3).

Photo 2. Derailed cars on the bridge

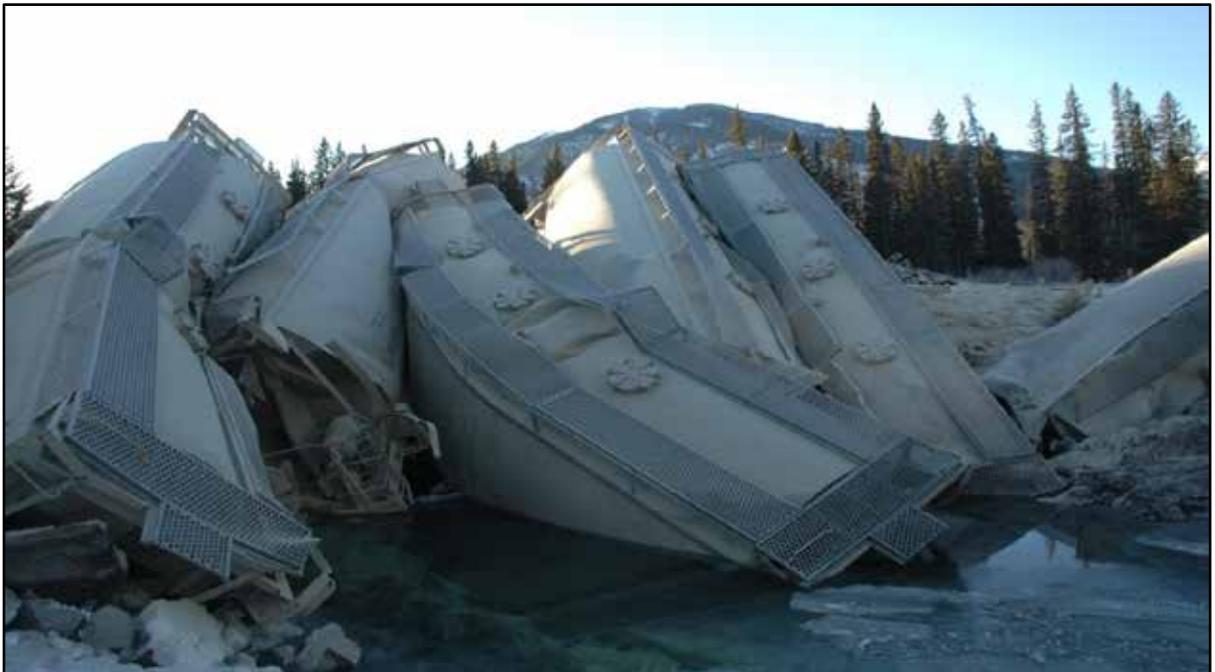
Photo 3. Derailed cars stacked on the bridge

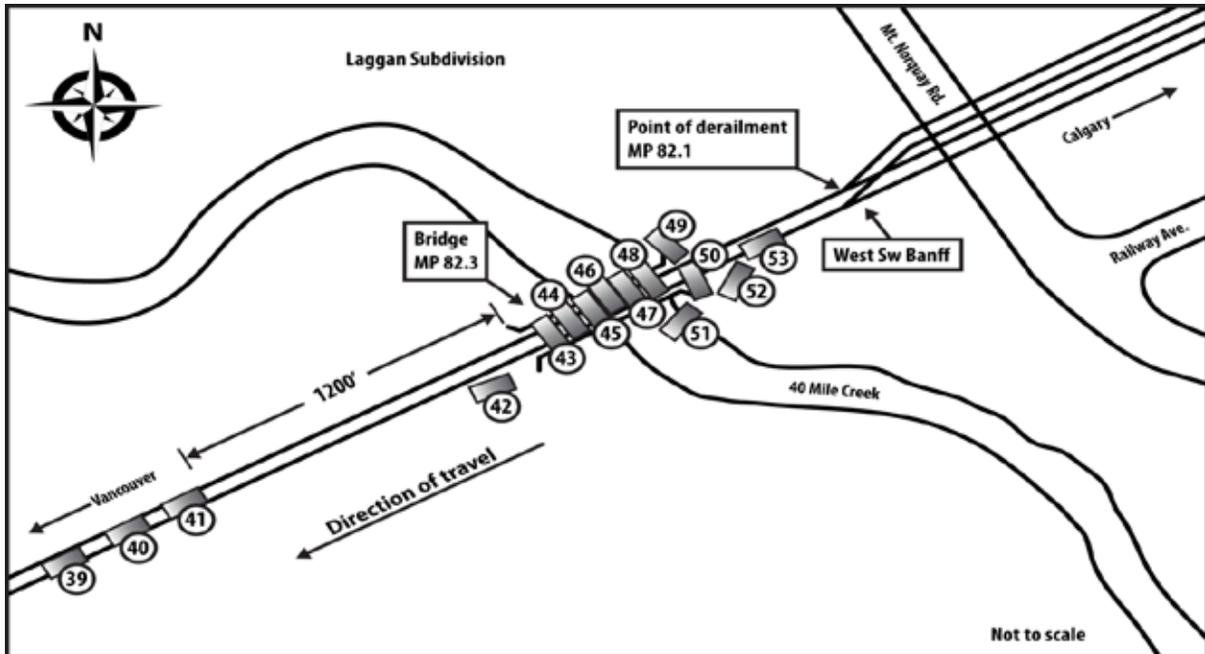
Figure 2. Site diagram

The 51st and 52nd cars came to rest on their side, on the south side of the track and east of the bridge, with the 51st car partially submerged. The last derailed car, the 53rd car, remained upright with the leading truck derailed (Figure 2).

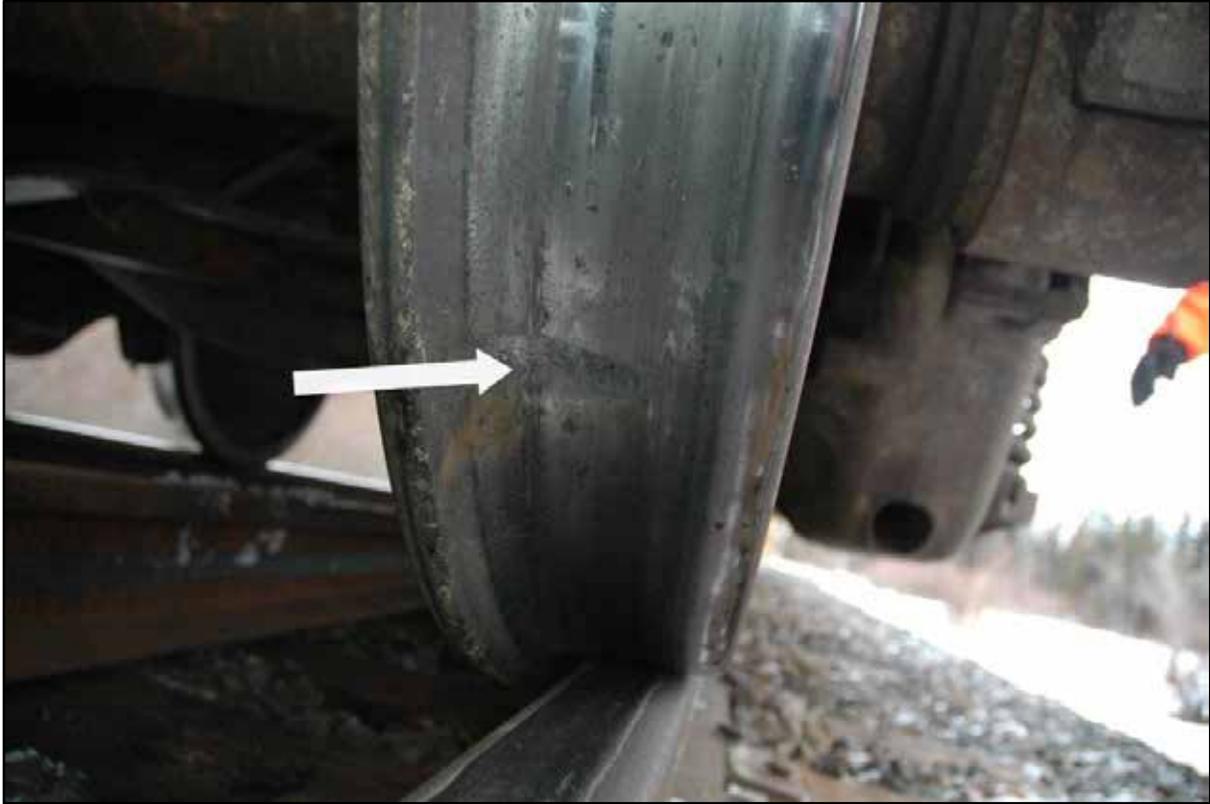
Impact marks on the wheel tread, consistent with contacting a broken rail, were present on some of the north wheels of cars on the head-end portion of the train which had not derailed. These impact marks were first observed on car 35, and became progressively more pronounced on cars 36, 37, and 38 (Photo 4).

Photo 4. Wheel tread impact mark on car 38

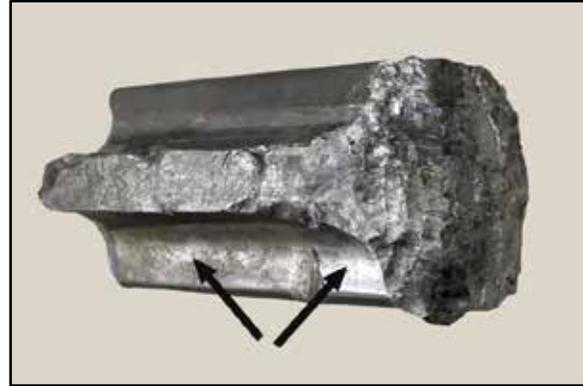
The fishing surfaces in the under-head fillets displayed metal-on-metal rubbing (burnishing⁷) against the joint bar on the gauge side and against the heel block on the field (stock rail) side (Photo 7). The fishing surface on the rail base which was under the joint bar also exhibited rubbing (Photo 8). This rubbing was the result of relative movement of the heel components, indicating that there was some looseness in the joint.

Photo 7. Burnishing under the head of the north switch point rail

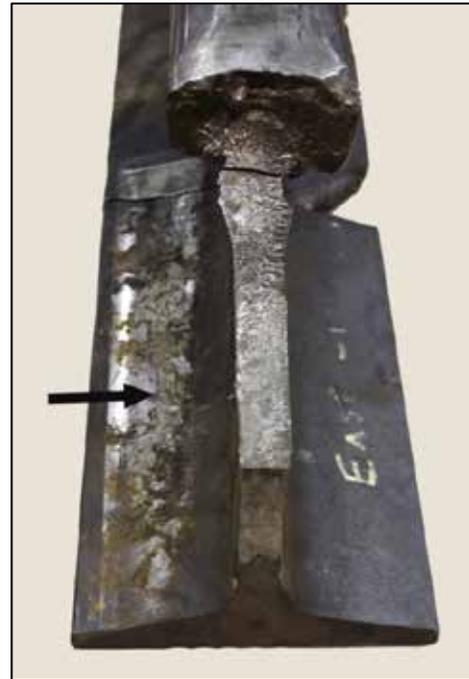
Photo 8. Burnishing on the base of the north switch point rail

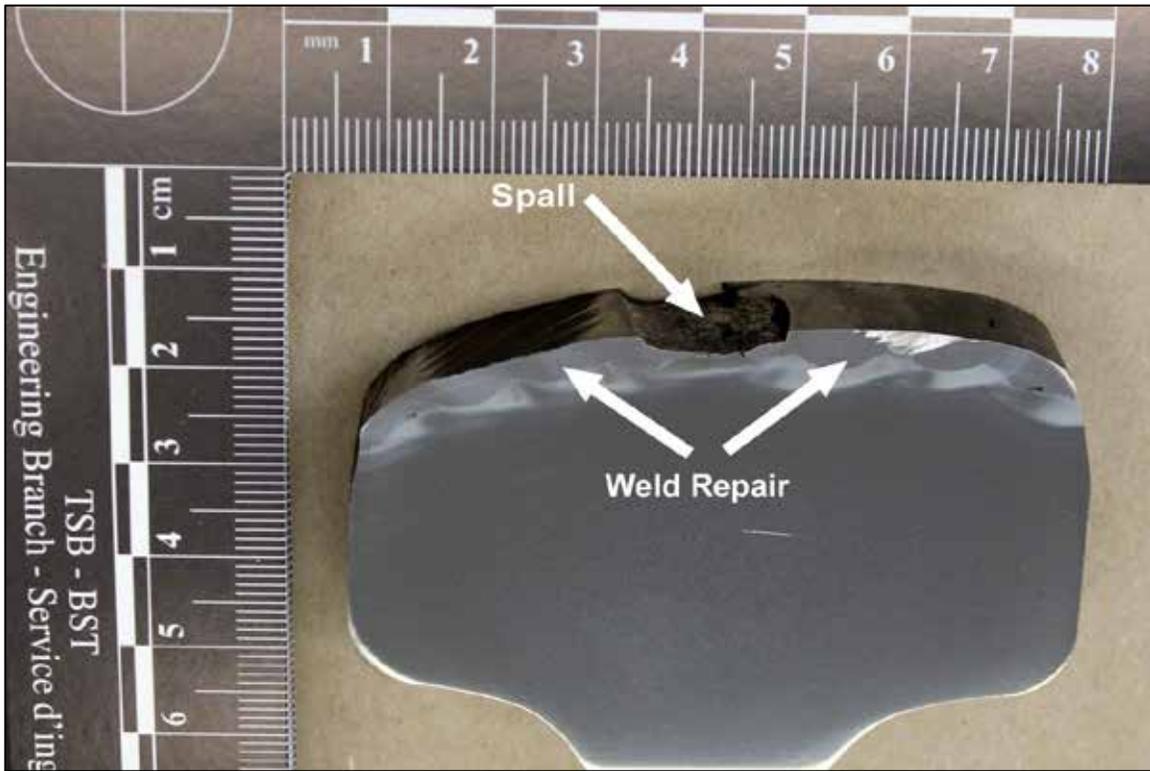
The running surface on the switch point rail had been weld-repaired in the vicinity of the heel block assembly. Spalling, as well as other smaller cracks,⁸ had developed in the welded area (Photo 9).

Photo 9. Weld repair and spall

The running surface of the switch point rail in the area of the heel block joint had been welded some time prior to the track failure in an attempt to lift the joint. Although this was an acceptable repair option, low joint surface conditions are normally corrected by tamping and lifting the joint.
