RAILWAY INVESTIGATION REPORT R16W0004

Main-track train derailment

Canadian National Railway Company

Mile 13.45, Redditt Subdivision

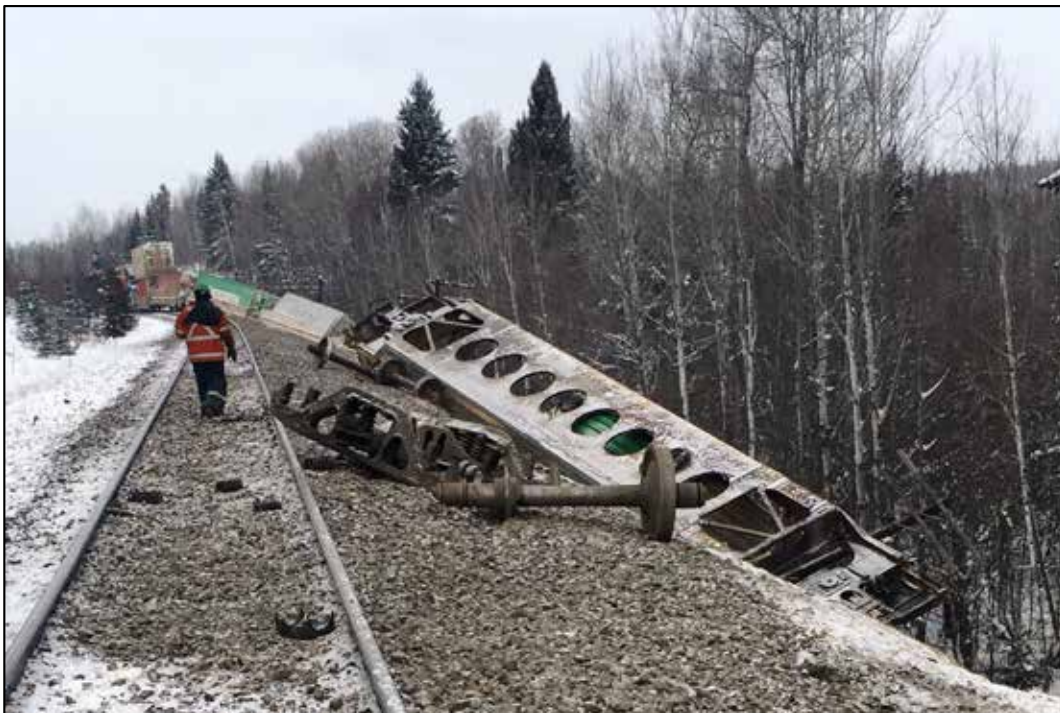
The 2nd car from the head end was loaded intermodal car DTTX 469967. A wheel set with a broken 33-inch wheel was located on the north side of the track adjacent to the overturned car (Photo 1). The broken wheel was from the L1 position of the leading B-end truck of car DTTX 469967.

Photo 1. First 2 derailed cars and broken wheel set (Source: Canadian National Railway Company)

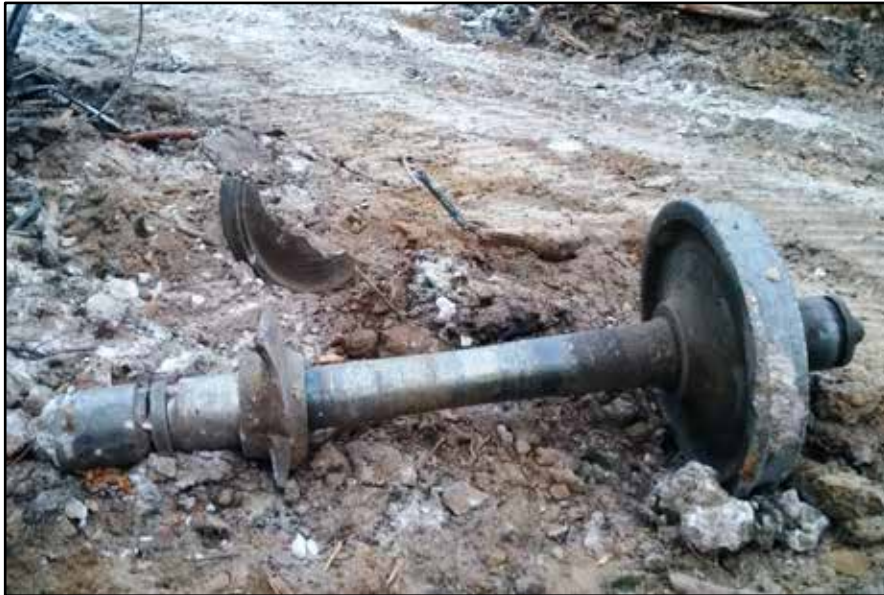
- there were several wheel tread separations;
- the hub of the fractured wheel was still on the axle, but it had moved inward off of the axle wheel seat (Photo 2); and
- the mate wheel tread displayed mechanical damage consistent with having been in contact with the ground for an extended period of time (Photo 3).

Photo 2. Wheel set with failed L1 wheel (Source: Canadian National Railway Company)

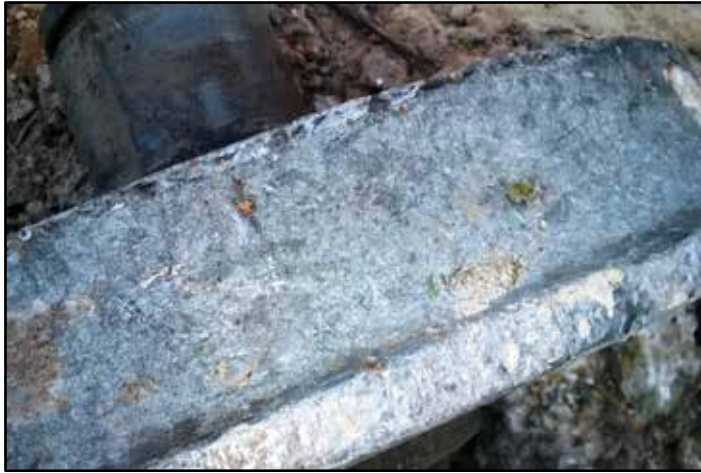
Photo 3. Tread surface of R1 wheel (Source: Canadian National Railway Company)

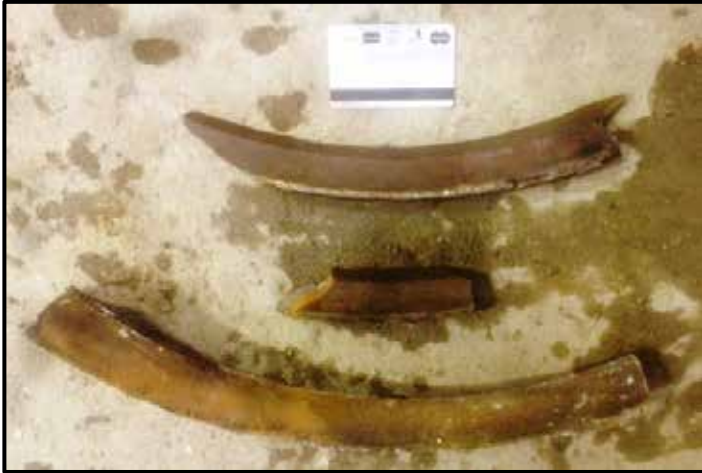
Photo 4. Outboard rim pieces located at Mile 13.35 (Source: Canadian National Railway Company)

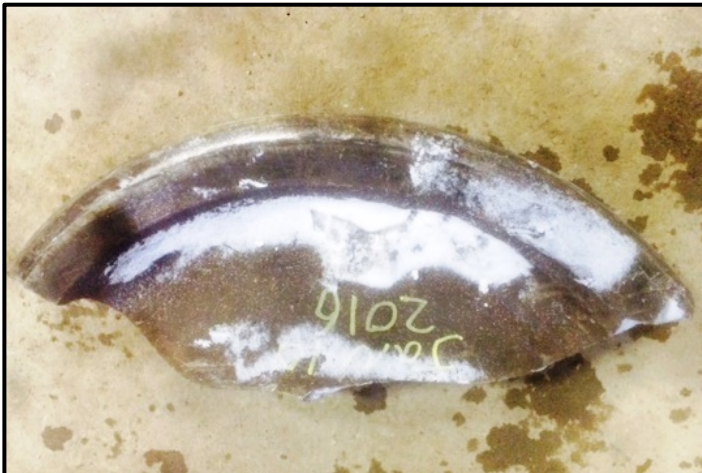
Photo 5. Tread section with plate located at Mile 13.45 (Source: Canadian National Railway Company)

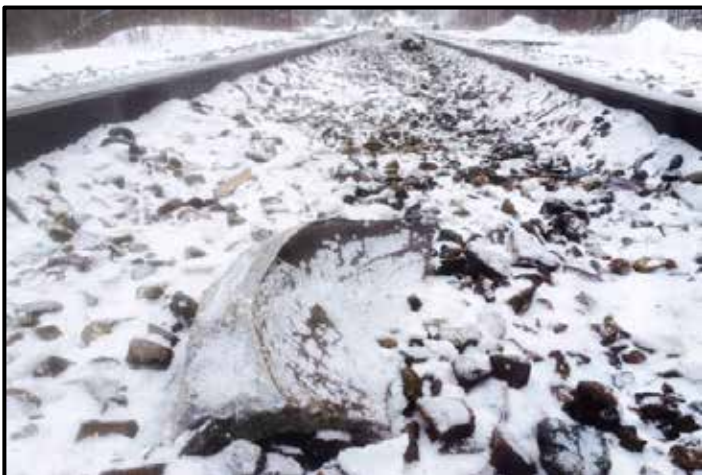
Photo 6. Tread section with plate located at Mile 20.55 (Source: Canadian National Railway Company)

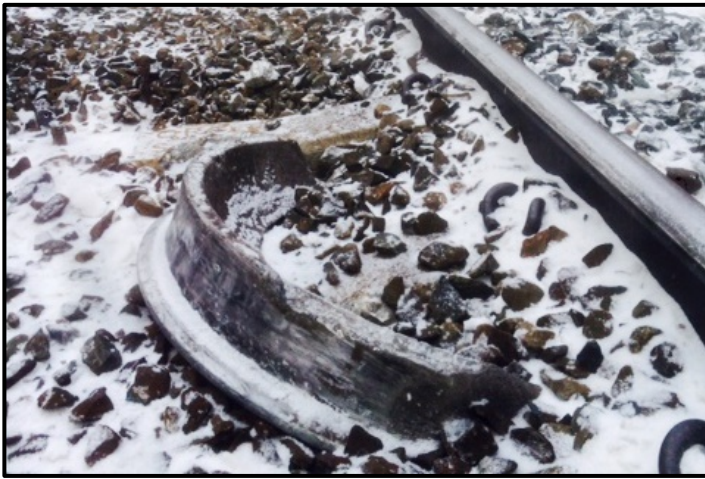
Photo 7. Tread section with plate located at Mile 21.00 (Source: Canadian National Railway Company)

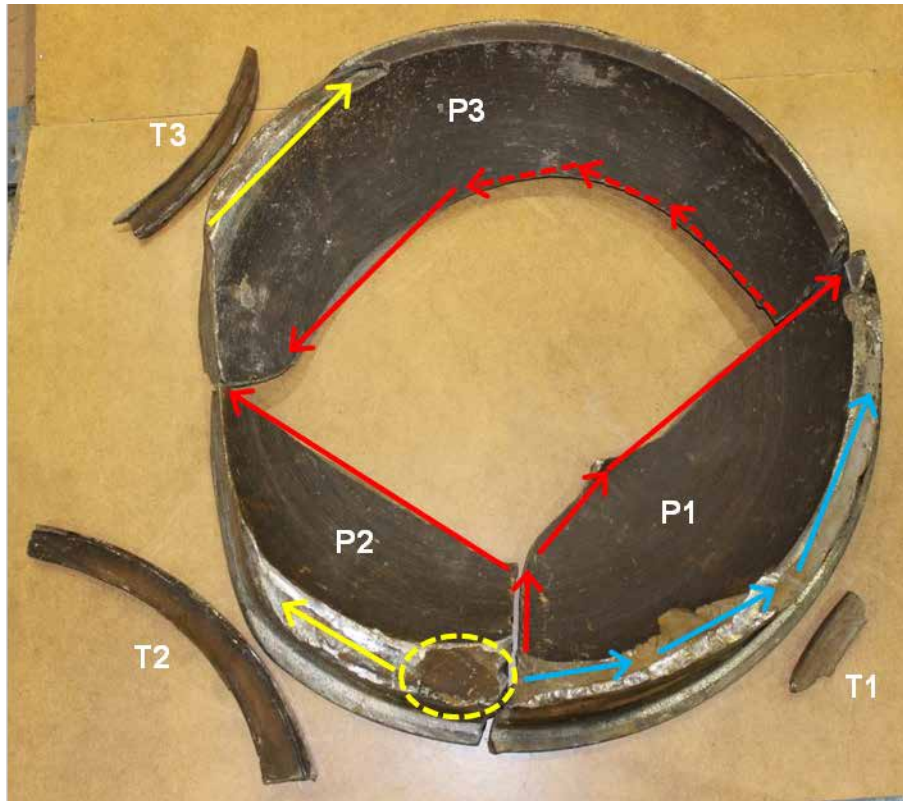
- The failure of the wheel was facilitated by the presence of a vertical split rim (VSR) that had originated below the tread surface. The VSR extended approximately $43\frac{3}{4}$ inches around the wheel circumference (Figure 3).

Figure 3. Recovered pieces of the 33-inch wheel (Note: The propagation directions observed on the plate [red arrows] and vertical split rim [yellow arrows] fracture surfaces are indicated. The area containing the vertical split rim fracture origin is circled in yellow. The blue arrows on P1 indicate the portion of the tread face fracture that was overstress in nature.)

- At some point before the occurrence, VSR cracking initiated about $\frac{1}{2}$ inch below the wheel tread. Identification of the origin was not possible due to significant post-failure damage.
- The VSR crack subsequently propagated down into the rim toward the wheel plate.
- A piece of tread face corresponding to the initial VSR fracture likely separated from the wheel before Mile 13.35 but was not recovered.
- The VSR crack propagated circumferentially away from the initial fracture, in a progressive mode on one side and in overstress on the other side, resulting in the separation of 3 pieces of wheel rim at Mile 13.35.
- Once the pieces of wheel rim broke off the wheel, the impact load on the wheel increased significantly, likely resulting in the overstress fracture of the plate and the separation of the piece labelled P1 in Figure 3 at Mile 13.45.

- The overstress fracture propagated to the wheel bore, which caused the wheel hub to lose its interference fit with the axle and move inboard of the rail. In addition, the mating wheel likely moved inboard of the rail at about this time.
- The remaining portion of the L1 wheel was dragged over the ties and ballast, causing the wear pattern observed on the tread of the pieces labelled P2 and P3 in Figure 3. These pieces eventually separated and were recovered at Mile 20.55 and Mile 21.00, respectively, near where the derailed cars came to rest, at Mile 21.86.
