RAILWAY INVESTIGATION REPORT

R16T0162

Main-track train collision and derailment

Mile 3.3, North Toronto Subdivision

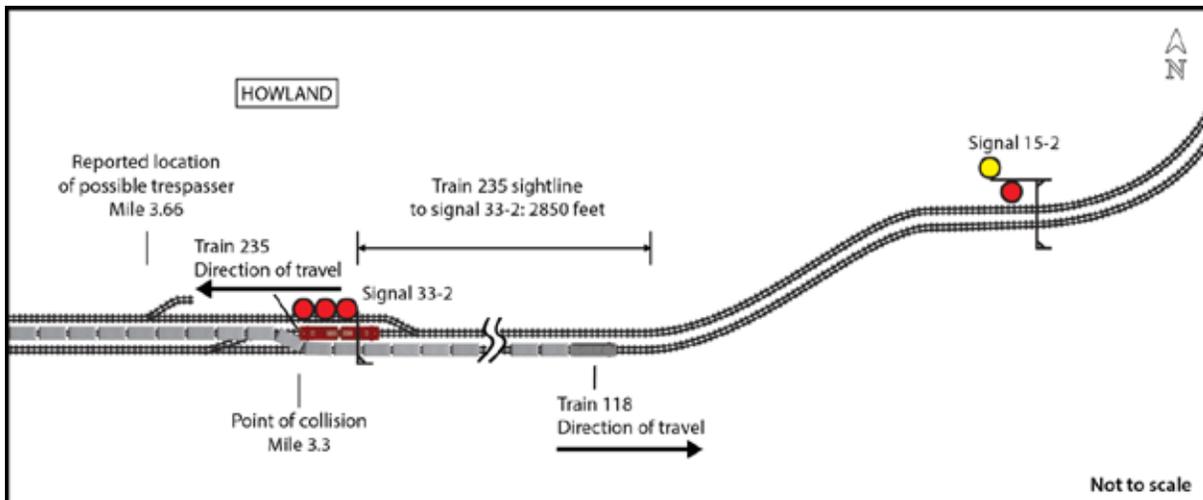
Figure 2. Site diagram

After passing the head end of train 118 and while operating at 46 mph, the LE of train 235 restored the headlights back to full power. Shortly thereafter, as the crew of train 235 observed the side of train 118 and searched for a possible trespasser, the LE noticed that signal 33-2, ahead, was displaying a stop indication. The LE immediately placed the train into emergency. The crew of train 235 then noticed that train 118 was operating over the crossover at Mile 3.3 with its tail end still occupying the north track. At 0516, the lead locomotive of train 235 struck the 4 tail-end cars of train 118 (involving 10 platforms), starting at the fouling point of the crossover switch (Figure 2).

The 2 locomotives on train 235 derailed upright. After the train came to a stop, the LE followed the emergency procedures and made the required radio broadcasts. Despite injuries sustained during the accident, the conductor of train 235 detrained, performed a damage assessment, and extinguished a number of small fires involving spilled locomotive fuel.

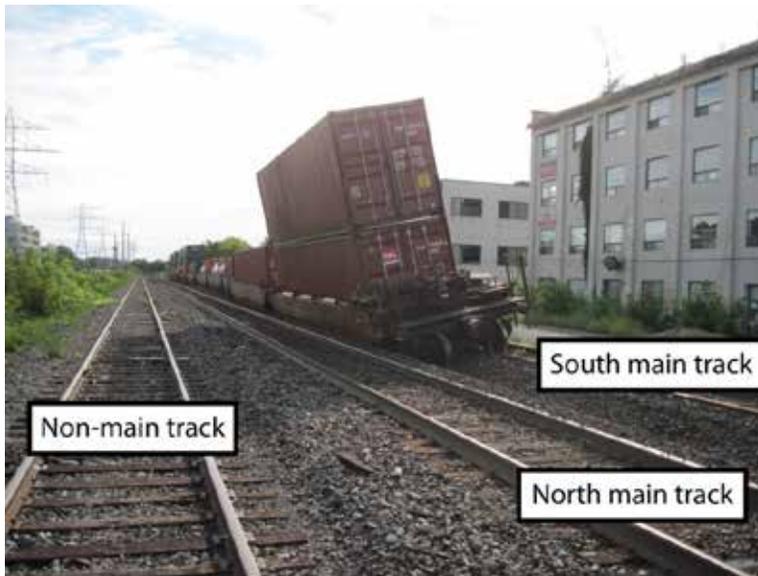
Figure 3. Derailed cars on train 118 (looking east)

Ten platforms of the tail-end 4 cars on train 118 were damaged. Scrape marks were present on the north side of each platform. In addition, some of the ladders and trucks on the platforms were damaged.

The cars remained coupled together and came to rest on the south track. Four of the platforms had derailed and were leaning upright and straddling the north rail (Figure 3). One platform of the first of the 4 cars, DTTX 788542, was derailed. Three platforms of the last car, DTTX 743830, were also derailed.

Platform D of DTTX 743830 was transporting containers, some carrying dangerous goods (UN3164, UN1066, UN1950). None of these containers was damaged. Platform E of DTTX 743830 was transporting alcoholic beverages (UN3065) in 2 containers. The jackets on both containers were torn, but no product was released.
