RAILWAY INVESTIGATION REPORT R16V0195

Employee injury

BCR Properties Ltd.
Roberts Bank Yard
Mile 16.8, Port Subdivision
Delta, British Columbia
18 December 2016

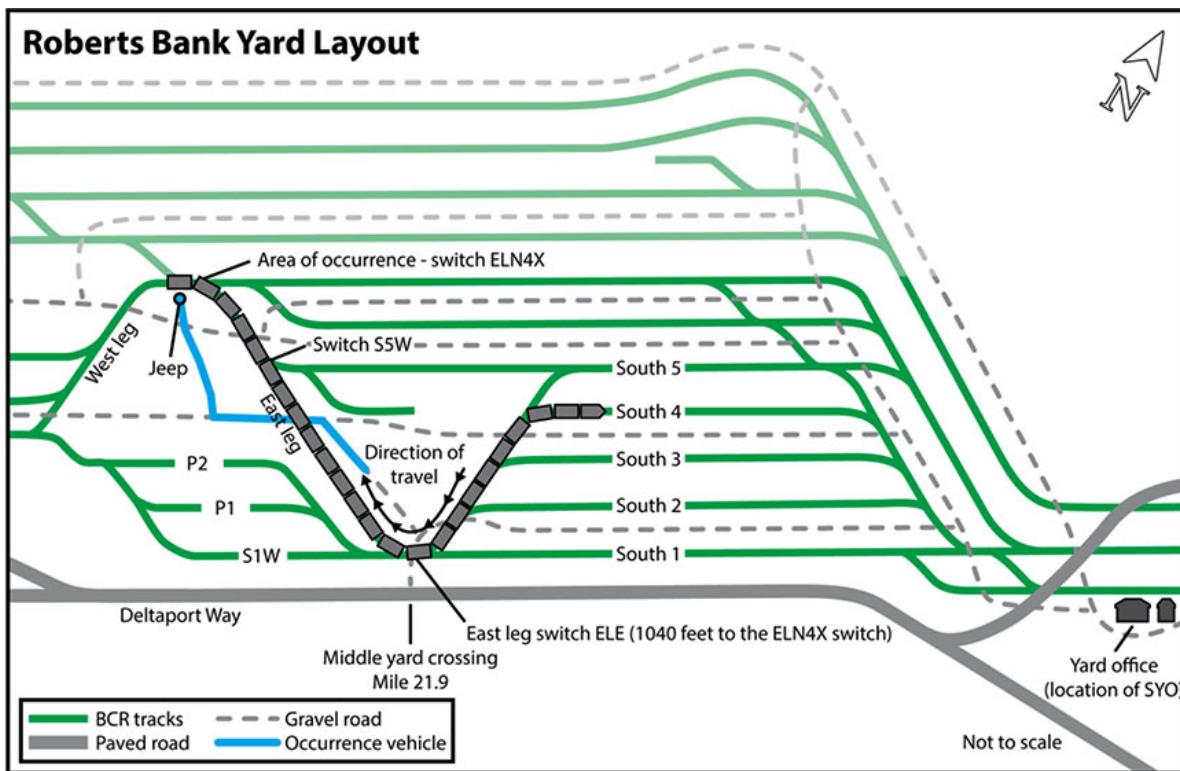
Figure 2. Site diagram

At about 1154, while performing switching activities in track P2, the conductor noticed some track workers in the vicinity of the ELN4X switch on the east leg track (Figure 2).

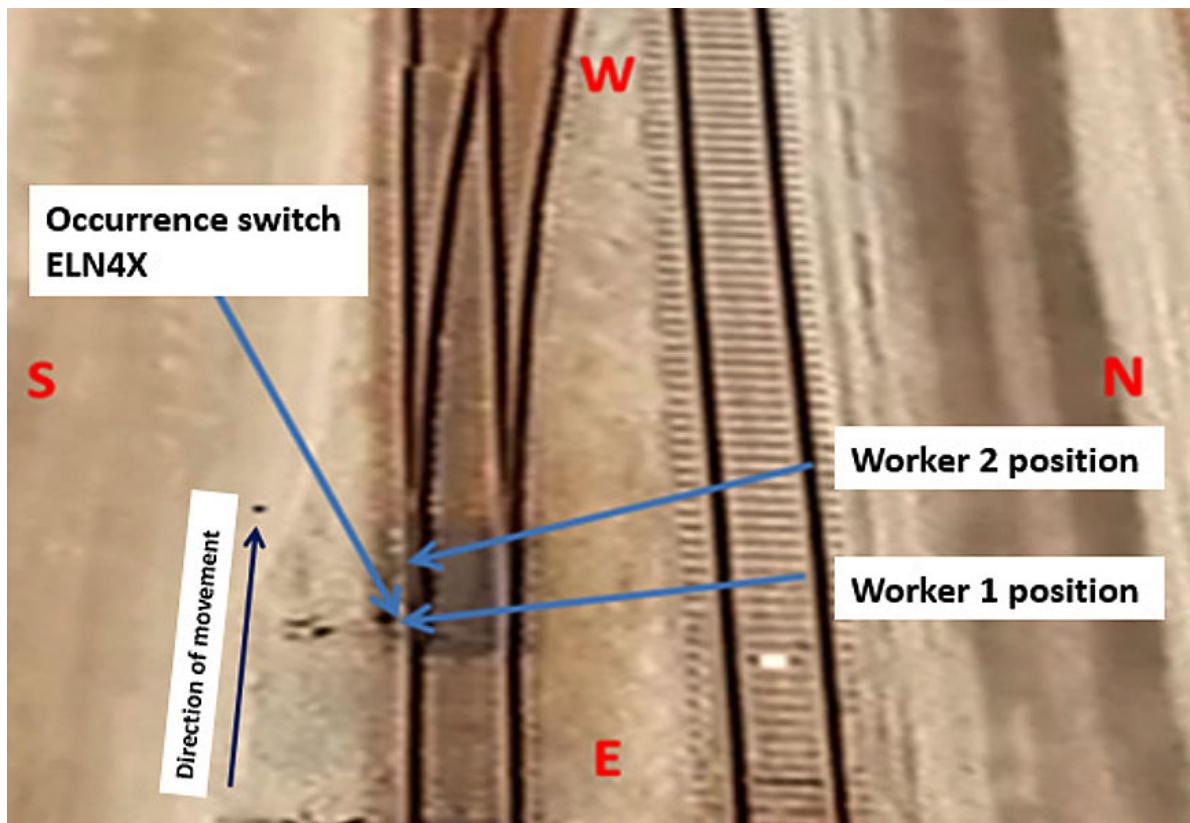
Figure 3. Position of workers at occurrence switch

At about 1159, the lead hand departed for a health break while the 2 track workers began their work on the switch. One worker (track worker 1) shovelled snow from under the switch adjustment rod that connects the switch points to the switch stand. The other worker (track worker 2) swept snow from the switch points (Figure 3).

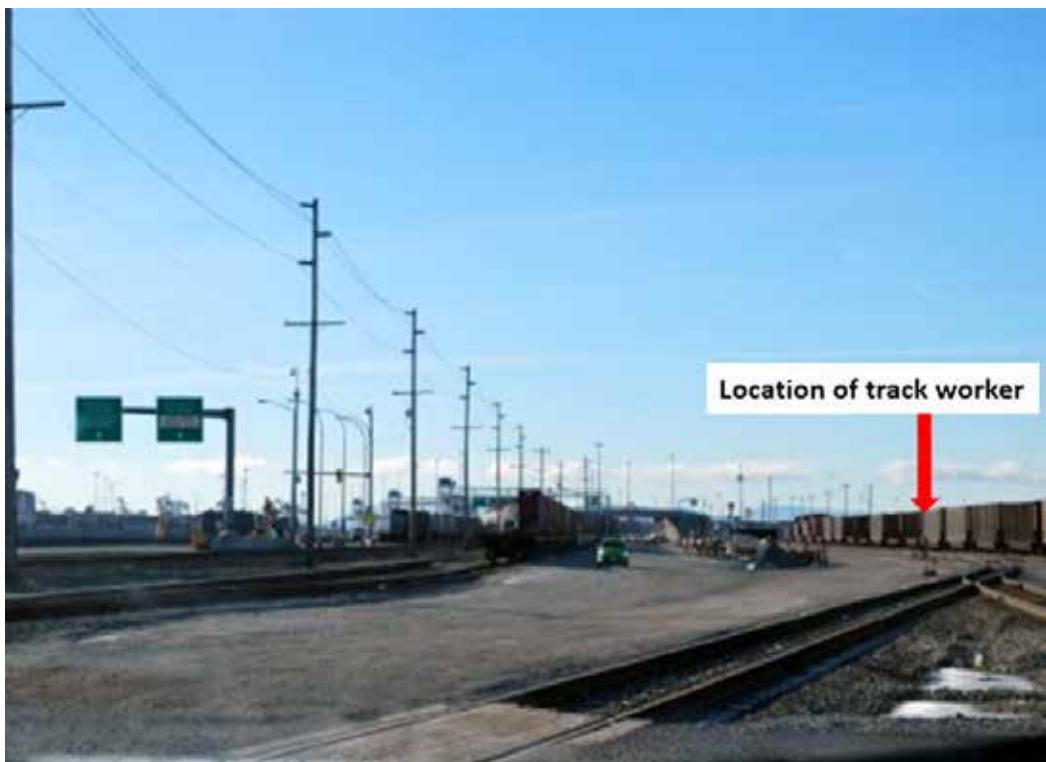
Figure 4. View of track worker location (ELN4X switch) from the east leg crossing (554 feet)

At about 1200, with the tail end of a 66-platform³ movement (4000 feet in length) stopped just east of the east leg switch (ELE), the conductor lined the switch for the east leg track and instructed the LE to shove back. No specific distance was specified. The LE acknowledged the instruction to back up and began shoving the cars westward. The crew's intention was to continue shoving until the leading 22 platforms cleared the S5W switch. From his position at the controls of a vehicle travelling ahead of the leading car of the movement, the conductor had an unobstructed view of the ELN4X switch about 1040 feet to the west.
