RAILWAY INVESTIGATION REPORT

R17Q0061

Uncontrolled movement of railway equipment

Quebec North Shore and Labrador Railway

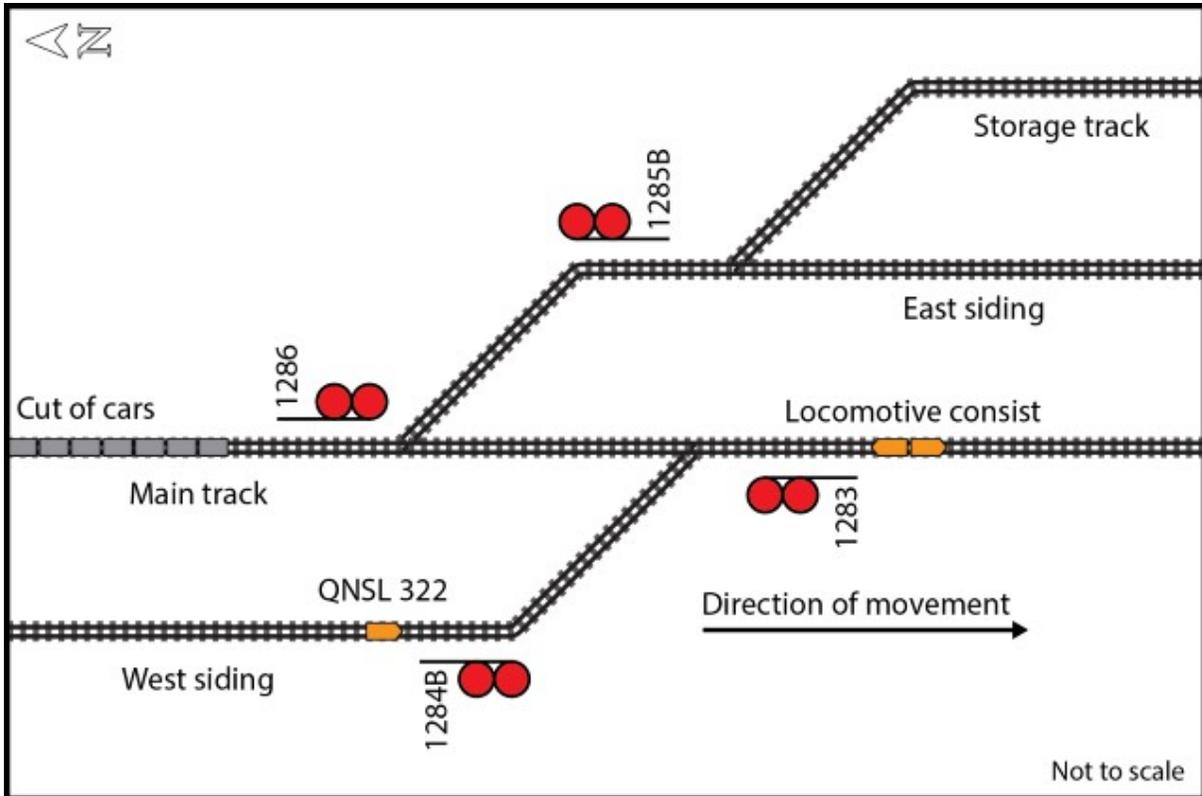
Figure 2. Occurrence area

From his position south of Signal 1283, the LE could see the signal indication and reverse the locomotive consist toward locomotive QNSL 322, which was on the west siding.

After uncoupling the locomotive consist from the cut of cars, the LE moved the locomotives forward, south of Signal 1283. While the LE was waiting for the signal indication to change in order to reverse toward the west siding, the signal displayed a restricting indication and, a few seconds later, a stop indication. The LE, having observed the successive changes of the signal indications, tuned his radio to the appropriate channel to communicate with the RTC and contacted the RTC to inform him of the situation. According to the RTC display panel, rolling stock had passed Signal 1286, which blocked all the signals in that location to a stop indication. In spite of the information displayed on the RTC panel, the LE confirmed to the RTC that the cut of cars was secured on the main track, north of Signal 1286. Therefore, the RTC issued an authority for the LE to pass Signal 1283 and reverse toward the west siding. After writing down the authority, the LE tuned his radio to the channel for train communications. At that moment, the relief LE informed the LE that the cut of cars had rolled uncontrolled and passed Signal 1286 before it was stopped.

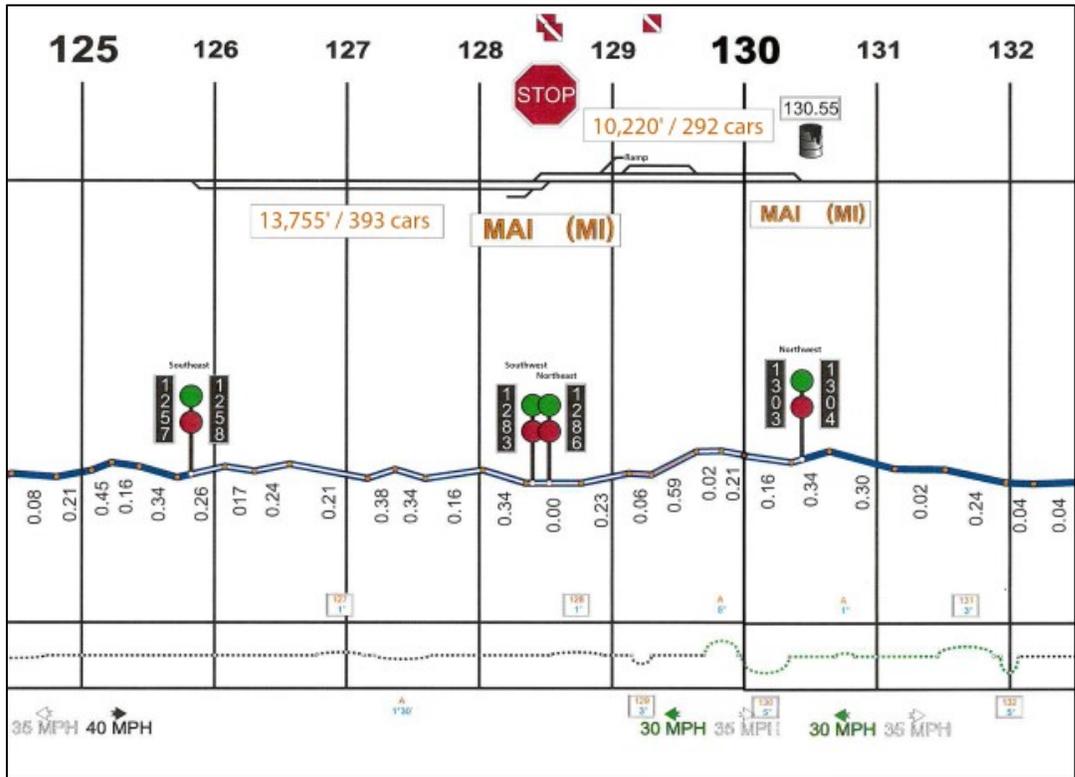
Figure 3. Layout of the track in Mai (Source: Quebec North Shore and Labrador Railway)

The Mai Station is located about midway between Sept-Îles, Quebec, and Labrador City, Newfoundland and Labrador. QNS&L has a base camp for engineering teams and for train crew changes in Mai. The station is approximately 4.5 miles long and comprises a single main track and 2 sidings, one on each side of the main track. Each siding has a spur track. Between the northern end and the southern end of the station, QNS&L has identified 16 areas where the track grade changes at irregular intervals as well as grades of up to 0.59%. Between Mile 129.7 and Mile 128.6 (Signal 1286), the main track has a downward grade of about 0.4% toward the south (Figure 3).

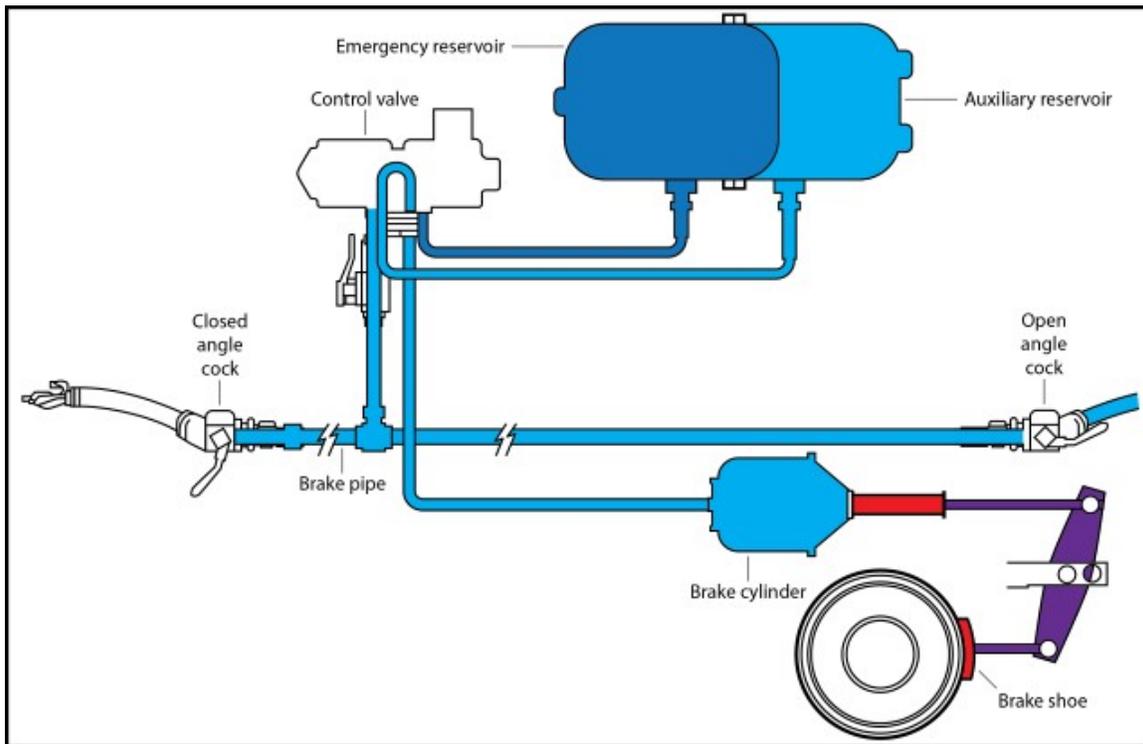
Figure 4. Rail car air brake system

A rail car air brake system comprises 4 main components: the brake pipe, the control valve, the air reservoirs and the brake cylinder (Figure 4). The brake pipe interconnects the cars to each other up to the lead locomotive. It supplies compressed air to the reservoirs on the rolling stock and signals the control valve to apply or release the brakes.

If the airflow within the brake pipe is interrupted and air is bottled in the brake pipe, the gradient will self-correct due to the equalization principle, which can cause the air brakes on the entire train to release.
