Rail Transportation Safety Investigation Report R18D0067

MAIN-TRACK DERAILMENT

Canadian Pacific Railway
Mile 35.83, Adirondack Subdivision
Delson, Quebec
09 July 2018

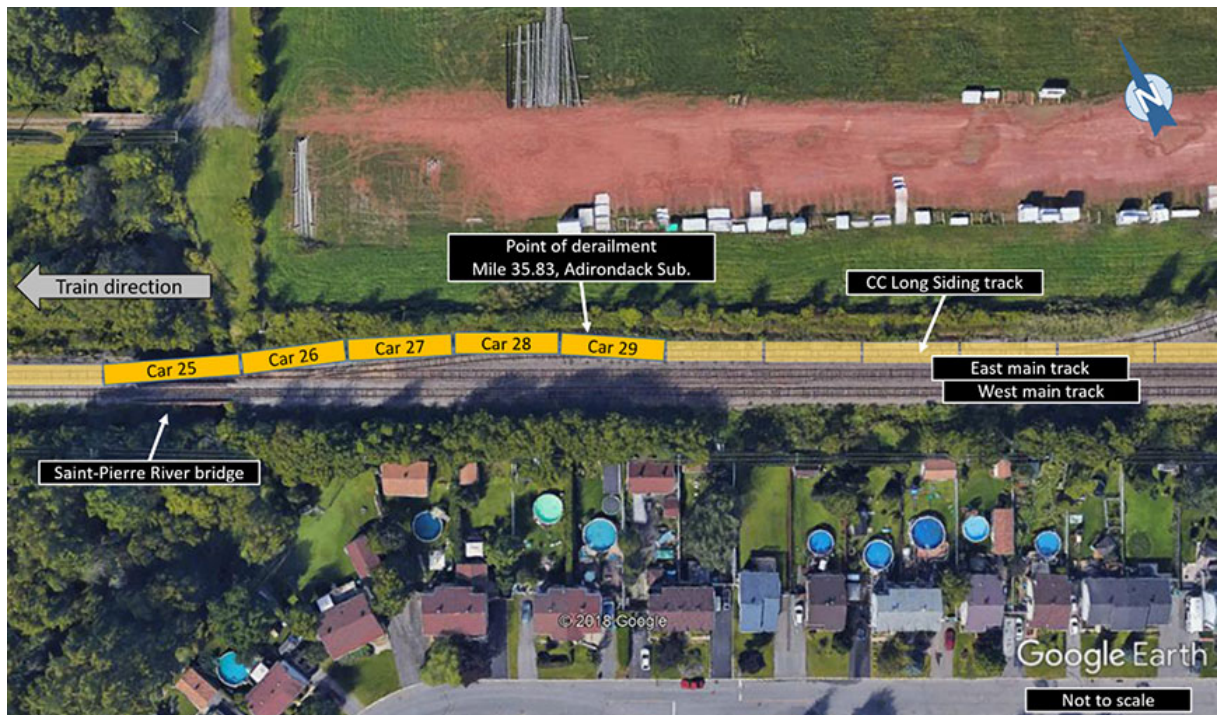
The conductor, who was on the ground to handle a switch, observed sparks coming from the wheels of one of the cars. The conductor then radioed the LE to instruct him to stop the train. The LE applied the emergency brakes and made an emergency broadcast. Once the train came to a stop, the crew noted that an 81-foot-long flat car loaded with lumber (Car 25) and 4 gondola cars transporting steel coils (cars 26 to 29) had derailed (Figure 2). The conductor was trapped under the cover of one of the derailed gondola cars.

Figure 2. Derailed cars at the north end of the CC Long Siding track at Delson, Quebec (Source: Google Earth, with TSB annotations)

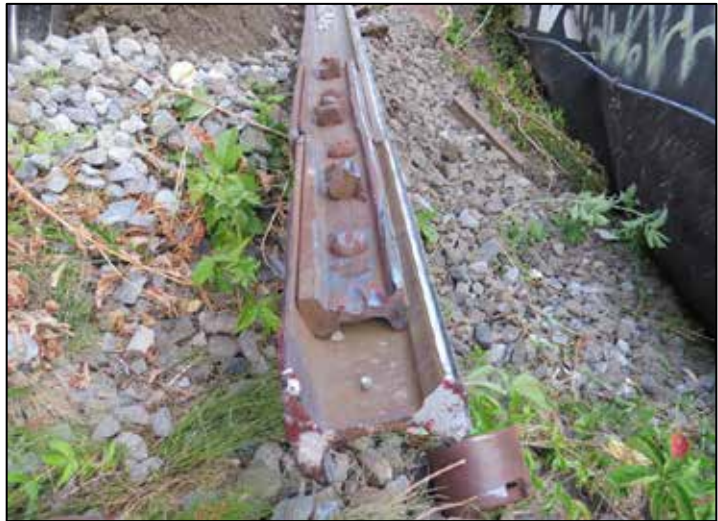
- The lead locomotive had stopped near Mile 36.19, to the north of the Saint-Pierre Street public level crossing, blocking it for several hours.
- The east rail had partially rolled over and ruptured at Mile 35.83, a few inches before a compromised splice bar (Figure 3). The rail was of the head-free rail type.⁵

Figure 3. Ruptured rail on the CC Long Siding track

³ Rail that has been manufactured using the Martin process (the open-hearth process) has a known propensity for propagating cracks and entrapping inclusions. The Martin process is no longer used and has been replaced by more modern steel-refining methods that provide better quality control.

⁵ Head-free rail has a profile that tapers inward toward the web from about 1 inch below the wheel surface, as compared with the conventional design.

Based on the tie condition and the damage at the occurrence site, the ties were unable to withstand the lateral forces exerted by the rolling stock when the train negotiated the turnout curve. A section of the outside rail rolled over when the 25th car went through, resulting in its derailment and the sudden rupture of the east rail. Unable to withstand the weight of the derailed rolling stock, the ties delaminated, causing the derailment of the other cars and the destruction of the infrastructure.

Internal rail defect testing was performed during remediation of the CC Long Siding track and turnout. Several rail sections and about 400 wood ties, spread along the CC Long Siding track, were replaced.

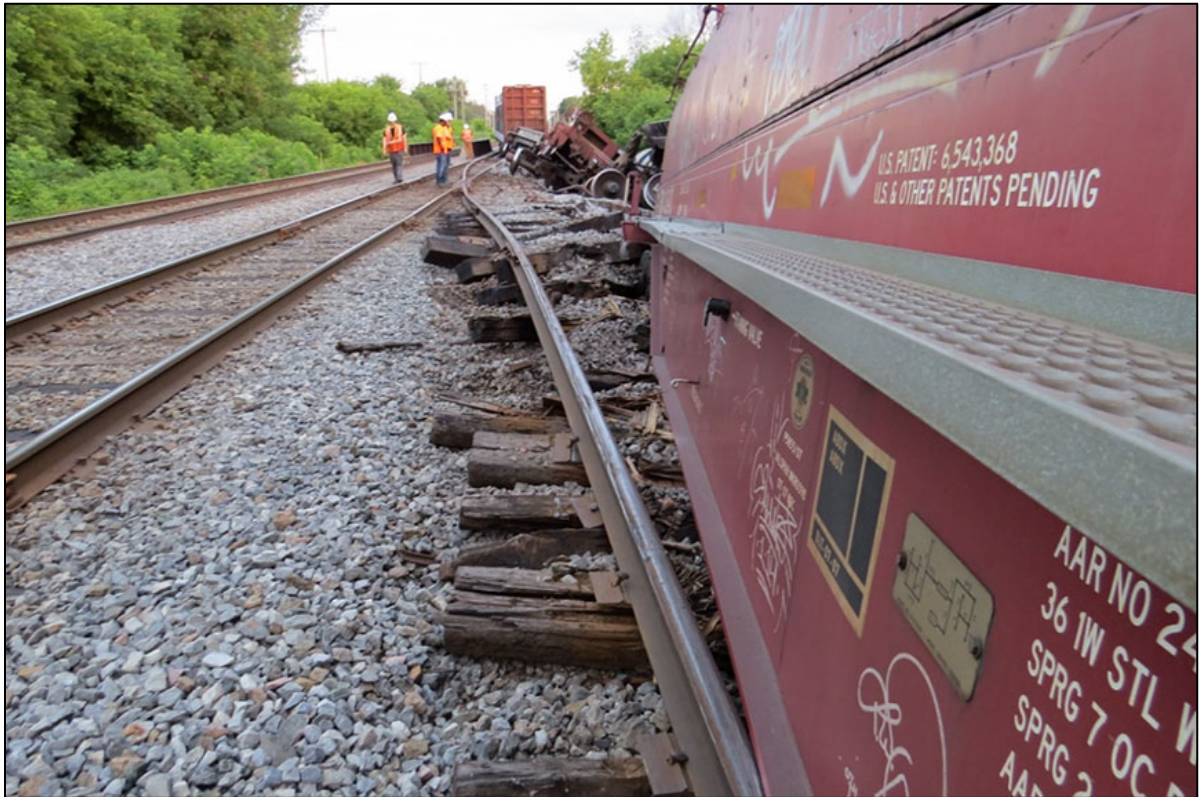
- The next 3 cars (the 26th to the 28th cars) derailed, but remained coupled together. They had rolled over into the ditch on the east side of the track. The last derailed car (the 29th car) came to rest upright, between the rails.
- Examination of the derailed cars did not identify any pre-derailment mechanical defects.
- A section of approximately 300 feet of track was damaged or destroyed, including the north turnout of the CC Long Siding track (Figure 4).

Figure 4. Damage looking north, at the north end of the CC Long Siding track

The east rail of the CC Long Siding track had shifted outwards, and several spikes were lifted on the inside of the rail. Numerous marks were present along the rail base. The CC Long Siding track infrastructure showed no wheel marks to the south of the derailed cars. The ties in the curve at the north end of the CC Long Siding track leading to the main track were destroyed. Several of the ties were shattered, with the wood fibres on the top surface shredded by the wheels. Deep grooves were visible on other parts of the ties, and the wood was deteriorated on many of the ties.
