Rail Transportation Safety Investigation Report R19D0065

MAIN-TRACK TRAIN DERAILMENT

Canadian National Railway Company
Freight train M36921-23
Mile 117.40, Joliette Subdivision
L'Assomption, Quebec
24 April 2019

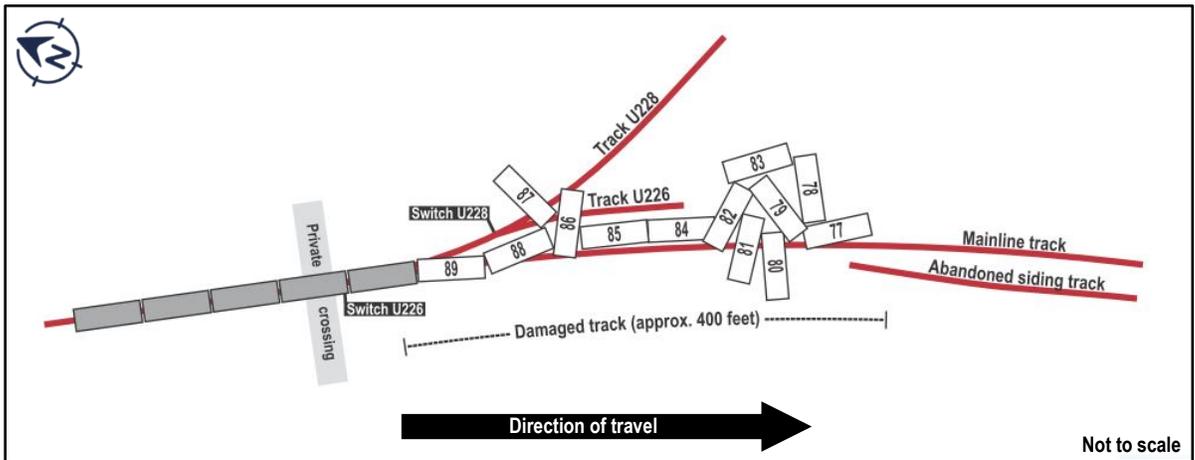
The 77th car (OCAX 6416) was lying on its side, outside of the curve (Figure 2). The next 11 cars (the 78th to the 88th cars) had derailed in an accordion-type manner. The 89th car (TOBX 889054) was upright with only the front truck wheels derailed. The last 5 cars behind the 89th car were on the rail.

Figure 2. Schematic of the derailment site (Mile 117.40 of the Joliette Subdivision) showing the positions of the derailed cars (Source: TSB)

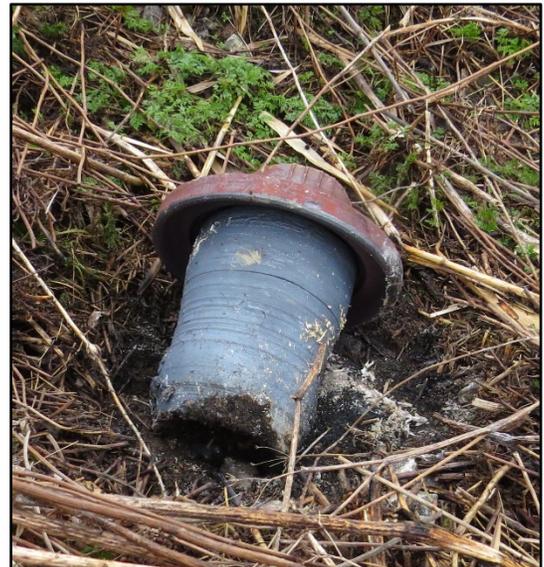
A burnt-off axle journal stub (Figure 3) and several broken roller bearing components were found in the grass on the east side of the track, beginning at Mile 116.85. The overheating components burned the vegetation around them. The components were sent to the TSB Engineering Laboratory for examination to determine the cause of the bearing failure.

Figure 3. Overheated burnt-off axle journal stub (Source: TSB)

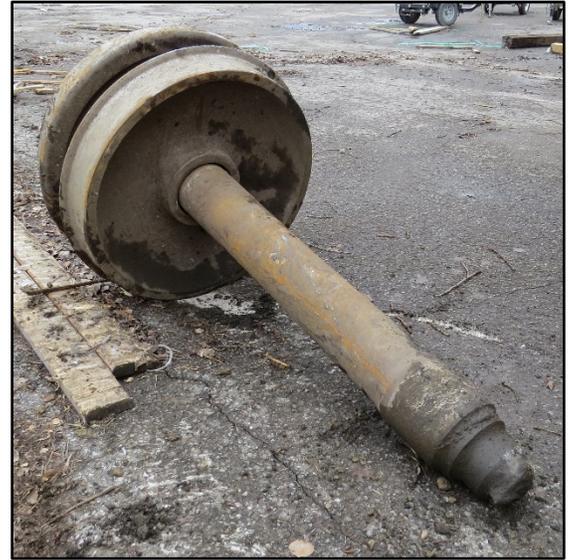
TR 405202 (the 78th car), a boxcar loaded with paper, was the first to derail. The No. 1 wheelset of the B-end truck was found under the pile of cars. The right wheel (R1) of the axle had separated and shifted laterally against the left wheel. The end of the axle had melted, and the axle journal of the right wheel and the entire roller bearing assembly were missing (Figure 4).

Figure 4. Melted wheelset and wheels of car TR 405202 (Source: TSB)

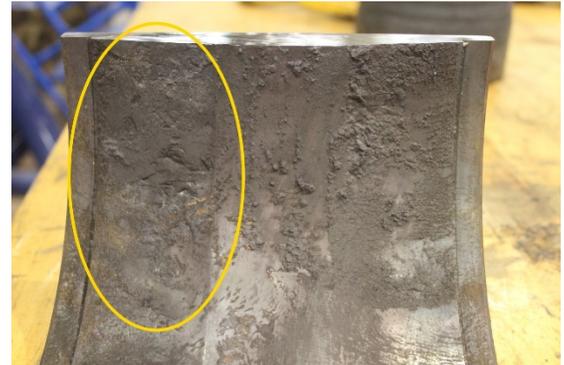
The R1 roller bearing was destroyed, with all its components showing discoloration, smearing, and plastic deformation. The TSB's examination revealed that the cup raceway showed signs of spalling about 6 inches in circumference on the inner face (Figure 5). This wear most likely led to the gradual failure of the bearing cage and the seizing of the tapered rollers (Figure 6), resulting in the overheating of the assembly, the breaking of the axle and the derailling of car TR 405202.

Figure 5. Spalling on the inner face of R1 bearing cup (Source: TSB)

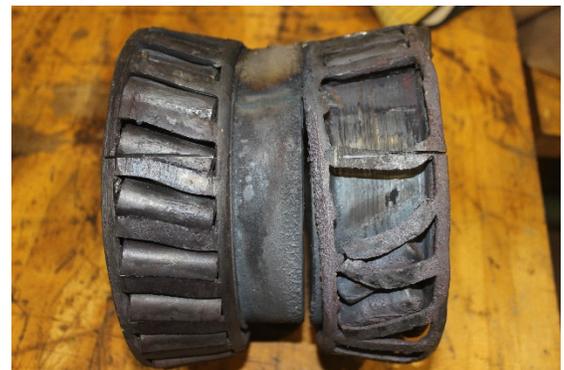
Figure 6. Deformed R1 bearing cage and rollers (Source: TSB)
