Rail Transportation Safety Investigation Report R19W0236

CROSSING COLLISION

Canadian Pacific Railway

08 August 2019

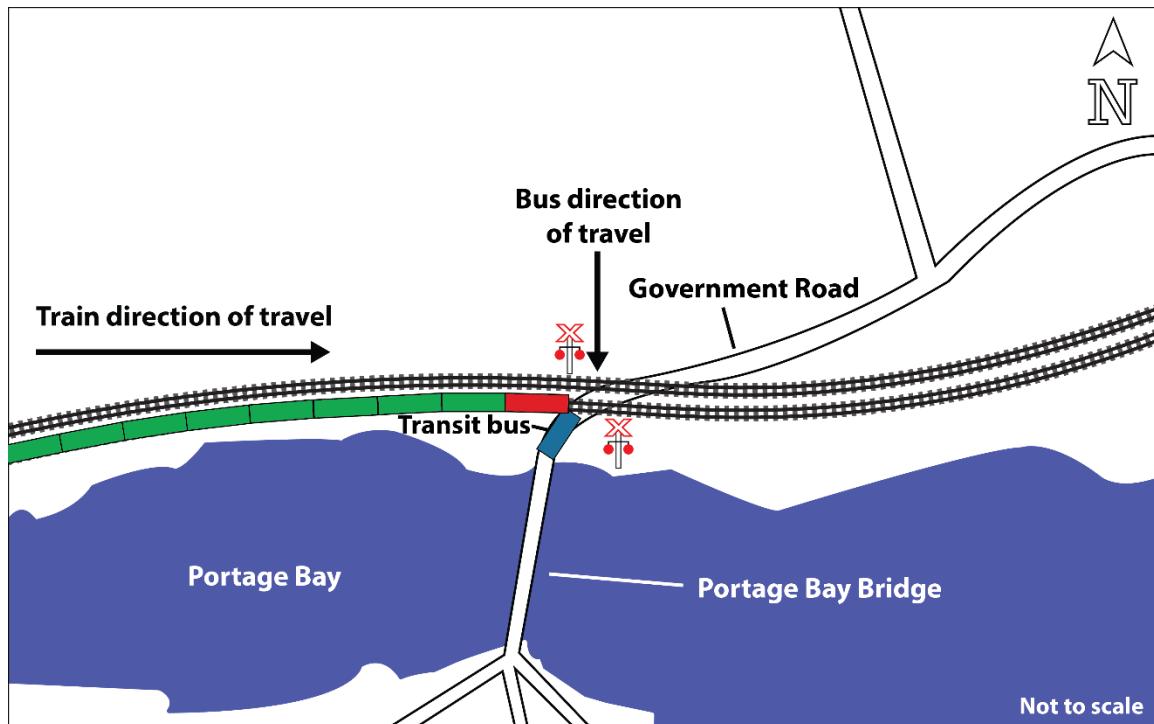
At 0934, while proceeding at 37 mph on the south main track,² the train collided with the rear end of a City of Kenora transit bus, operating on the Keewatin bus route. The collision occurred at the Government Road public railway crossing in the City of Kenora, located at Mile 3.15 of CP's Keewatin Subdivision (Figure 2). The crossing was protected by grade crossing warning devices (GCWD), which consisted of automated flashing lights, bell and gates. After traversing the crossing, the transit bus had stopped on Government Road with the right rear corner of the bus foul of the south main track.

Figure 2. Occurrence site diagram (Source: TSB)

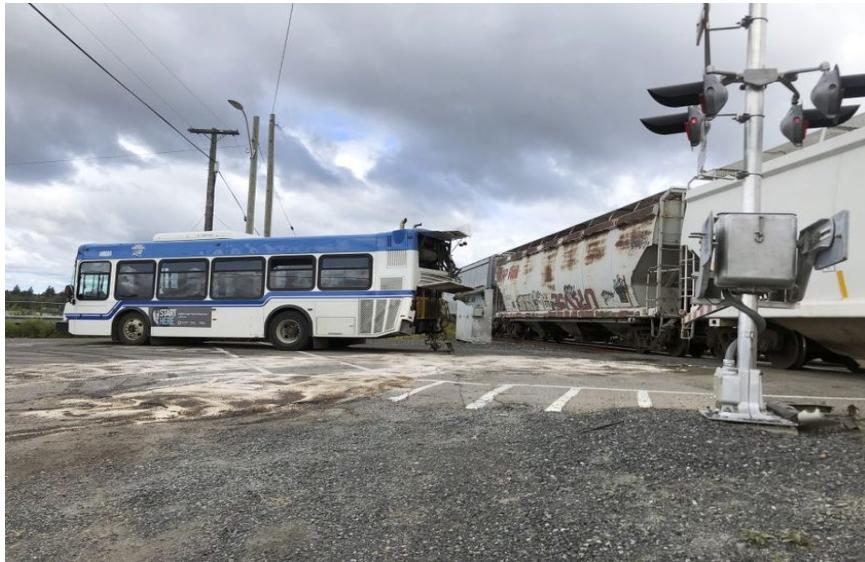
The bus sustained extensive damage to its right rear corner, including damage to the body, frame, and motor mounts (Figure 3). The lead locomotive of the freight train sustained minor damage to the right front handrails and steps of the boarding ladder.

Figure 3. Damaged bus (Source: Kenora Daily Miner and News)

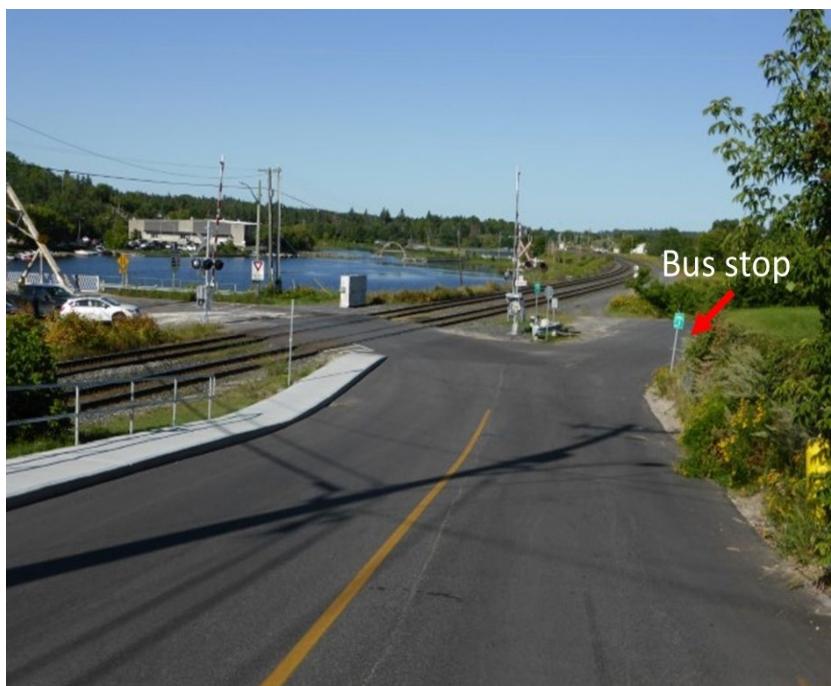
On the day of the occurrence, at about 0933, the bus was travelling south on the descending grade of Government Road approaching the city bus stop at the base of the road, just before the crossing (Figure 4). The driver observed a train approaching in the distance. The lights and bell at the crossing were activated, but the gates had not begun to descend. At that time, no passengers were waiting at the bus stop.

Figure 4. View from the bus on Government Road approaching the crossing
(Source: TSB)
