AVIATION OCCURRENCE REPORT

ENGINE FAILURE

AIRBUS A320-211 C-FFWJ

REPORT NUMBER A9500232

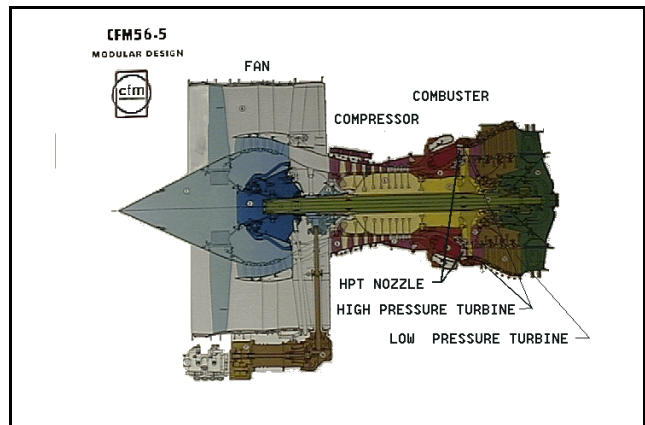
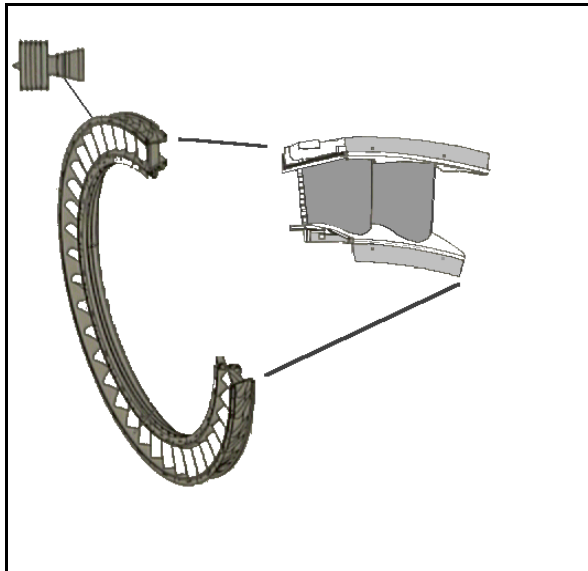
The Serviceable/Maintenance Release tags for the HPTN segments noted that the parts had been “PACH [Partitioned Alloy Component Healing] repaired” for service evaluation. Impact damage, blue heat discoloration, trailing edge cracking, and trailing edge corner breakout were noted across the trailing edges of all of the HPTN guide vanes. Cracks in the convex side and material distress were also noted on five nozzle guide vanes. One of the nozzle guide vanes had a large section missing from its aft panel (convex side adjacent to the HPT rotor), and an adjacent portion of the trailing edge of this vane had been burned and eroded away with the loss of cooling air.

Examination of the fractured surfaces of the missing section of the assembly nozzle guide vane indicated that the separation was progressive in nature and occurred during normal engine operation.

The failure of the material on the convex face of the guide vane was consistent with low-cycle fatigue related to thermal stress. When the panel was liberated, the loss of cooling air meant the trailing edge of the vane was now subjected to more heat than the material could withstand and it was subsequently burned and eroded away.

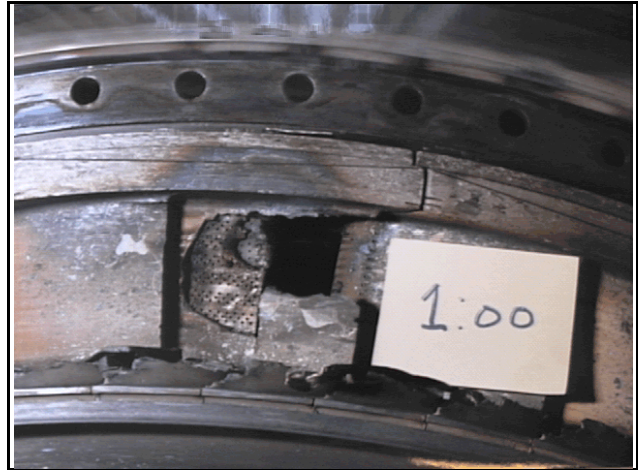
The HPT rotor assembly is a single-stage turbine with 80 air-cooled, dove-tailed blades. The failed HPT rotor blades and HPTN assembly nozzle segments were sent to the TSB Engineering Branch for metallurgical examination. All 80 turbine airfoils separated within 0.3 inches of their respective platforms. The fracture surfaces on all but one of the separations were characteristic of overload separation. The fracture surface of the remaining blade had a flat planar crack which originated at or near the trailing edge of the blade and propagated forward toward the leading edge of the blade.
