AVIATION OCCURRENCE REPORT

REJECTED TAKE-OFF/RUNWAY EXCURSION

PROPAIR INC.
BEEHCRAFT SUPER KING AIR 200 C-GCEV
SEPT-ÎLES AIRPORT (QUEBEC)
28 JANUARY 1997

REPORT NUMBER A97Q0015

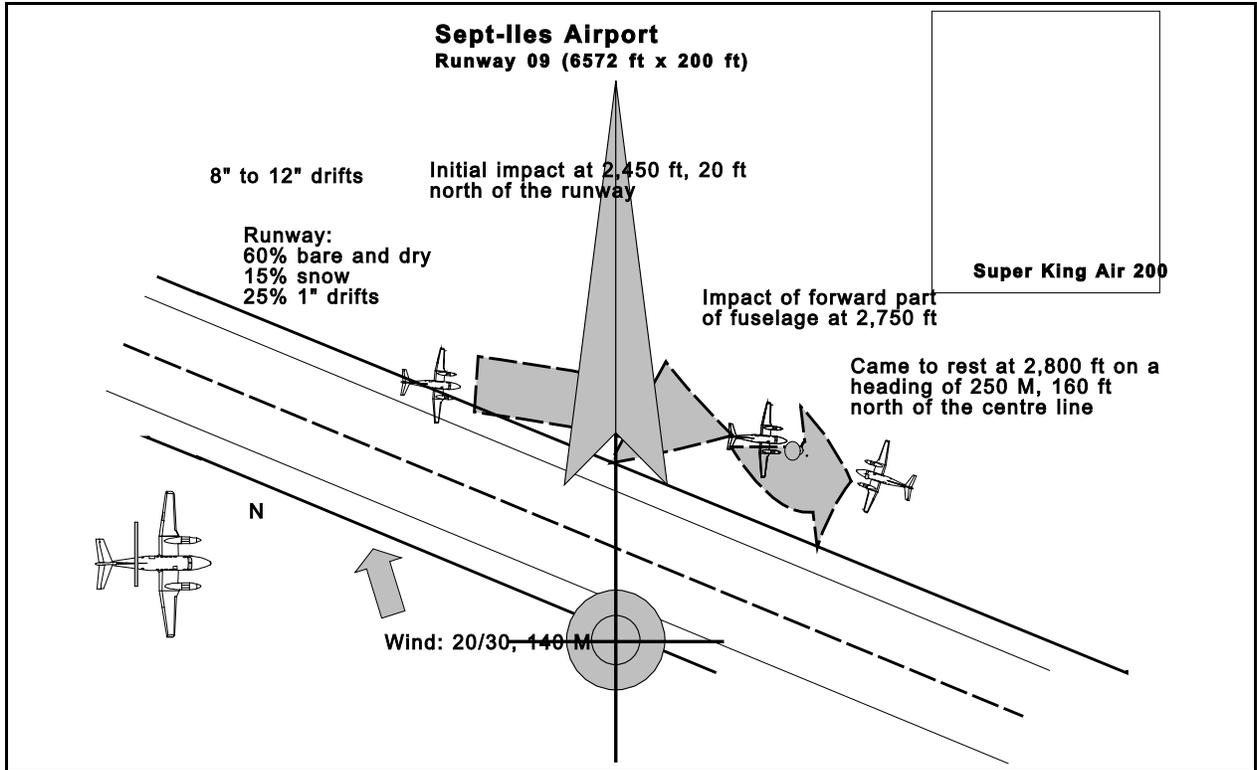
Appendix A - Take-off Process

Analysis of the site showed that the aircraft rolled for about 1,850 feet before taking off, that it flew for 500 feet on a track of 78° magnetic before striking the snow, and that it was nose-up at the moment of impact. The

aircraft's estimated performance was slightly below that published in the flight manual take-off distance table. On a dry, firm, and horizontal surface, with a V_R of 95 knots, the Super King Air could take off after a roll of 1,650 feet.
