**AVIATION INVESTIGATION REPORT
A05F0047**

LOSS OF RUDDER IN FLIGHT

**AIR TRANSAT
AIRBUS A310-308 C-GPAT
MIAMI, FLORIDA, 90 nm S
06 MARCH 2005**

Report Number A05F0047

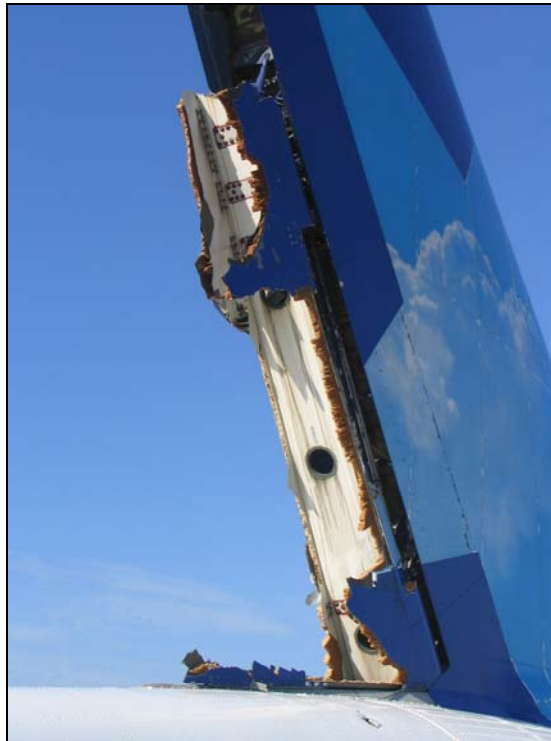
The rudder was substantially damaged (see Photo 1), and the rear attachment fittings of the vertical tail plane (VTP) were delaminated locally. There was minor damage to the tail cone.

Photo 1. Right-side view of vertical tail plane and rudder residuals

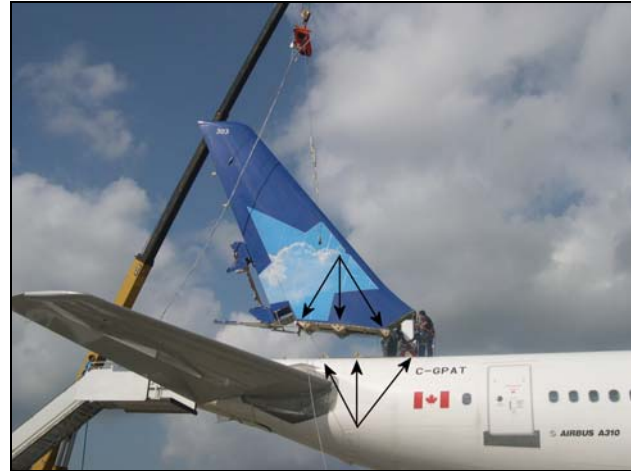
Photo 2 shows the VTP and its rudder residuals being removed from the aircraft. The damage to the VTP trailing edge panels was generally limited to minor paint chipping. There was no damage suggesting that the rudder had been battered due to extreme travel from side to side.

The VTP main attachment fittings were examined. On the fuselage side, these fittings are constructed of metal. Following the occurrence, they were subjected to visual and NDI, and no damage was found. The six CFRP main attachment fittings on the VTP side were subjected to ultrasonic NDI. Delamination damage was found in the two aft main attachment fittings.

Photo 2. Removal of the VTP and a view of the position of the main attachment fittings

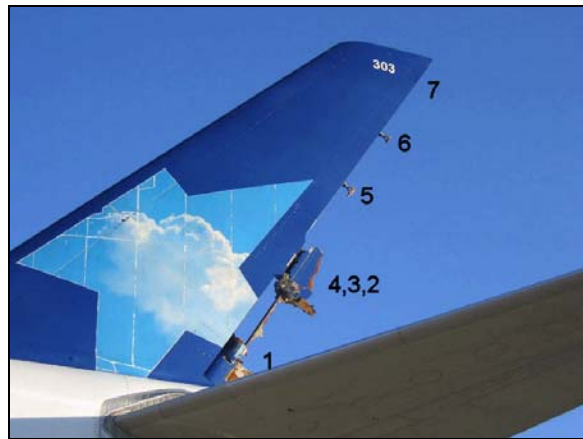
As will be discussed later in this report, subsequent analysis found that the rudder loss during flight was progressive, and by the time the aircraft landed, most of the rudder had separated from the aircraft. Photo 3 shows the empennage after landing in Varadero. The separated pieces fell into the ocean and none were recovered. Rib 0 remained attached, as did the length of rudder spar up to hinge point 4. A small piece of rudder side panel from each side remained attached to the spar in the region between hinge points 2 to 4, and also in the corner where the spar meets rib 0. The leading edge fairings between hinge points 2 and 4, and below hinge point 1, were still attached. The leading edge fairing between hinge points 1 and 2 had separated and some pieces were found jammed between the rudder and the VTP. At hinge points 5 and 6, small pieces of the rudder spar remained attached to the hinge arm. At hinge point 7, the VTP-side hinge bracket had fractured and separated, so none of the rudder remained.

Photo 3. Left-side view of VTP and rudder residuals

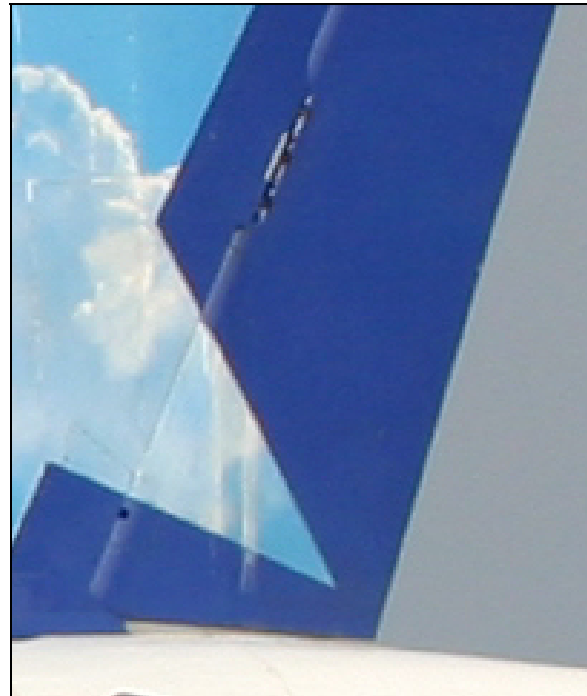
The vertical line features first appeared in photographs starting in early 2003, and the aircraft was subject to all its regular inspections in the intervening time. Examination of other aircraft found that staining of the rudder near the hydraulic actuators was not unusual. Subsequent testing found that hydraulic fluid could dissolve the Air Transat tail decal material and analysis of a vertical streak on sister aircraft MSN 600 found the streak to be composed of a mixture of hydraulic fluid and dissolved decal material.

Photo 4. Pre-occurrence photograph of aircraft

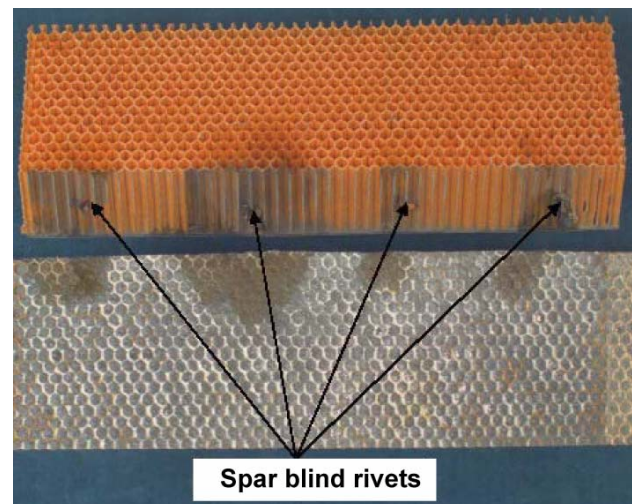
The rudder from aircraft MSN 361 was damaged at the trailing edge by unintentional contact with a maintenance dock during maintenance. Subsequent inspection found a disbond on the left inner-face sheet near the front bottom corner, approximately 830 mm long by 350 mm high. Stress analysis determined that the disbond was not caused by the impact with the maintenance dock. This internal disbond had not been detected by the AOT-1 (all operators telex – see Section 1.14.1) external tap test. Further examination revealed that hydraulic fluid had seeped into the left side panel around the blind fasteners at the front spar as shown in Photo 5, and that this fluid had weakened the bond between the honeycomb and the face sheet. In addition to the hydraulic fluid contamination, this rudder exhibited signs of water ingress around some trailing edge fasteners and at the leading edge immediately aft of the z-section.

Photo 5. MSN 361 honeycomb showing stain caused by hydraulic fluid ingress

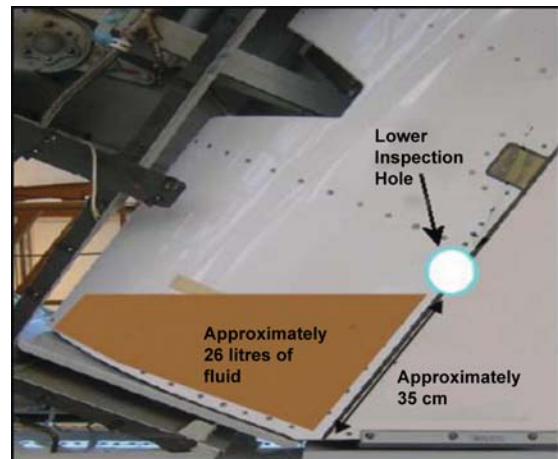
Trapped fluid was found in the lower nose area of the rudder of aircraft MSN 701 during the AOT-2 inspection (see Photo 6). The fluid was not formally identified, but was reported to be mostly water with some dirt, possibly containing hydraulic fluid and sealant chips. The fluid level was reported to be up to the lower inspection hole. The rudder box aft of the spar was dry. The two drain openings in the nose section were found to be clogged. The tap test did not show any sign of disbond. An X-ray and thermography inspection of side panels adjacent to the fluid did not reveal any fluidity entrapped inside the sandwich.

Photo 6. Fluid accumulation in the nose of the rudder of aircraft MSN 701

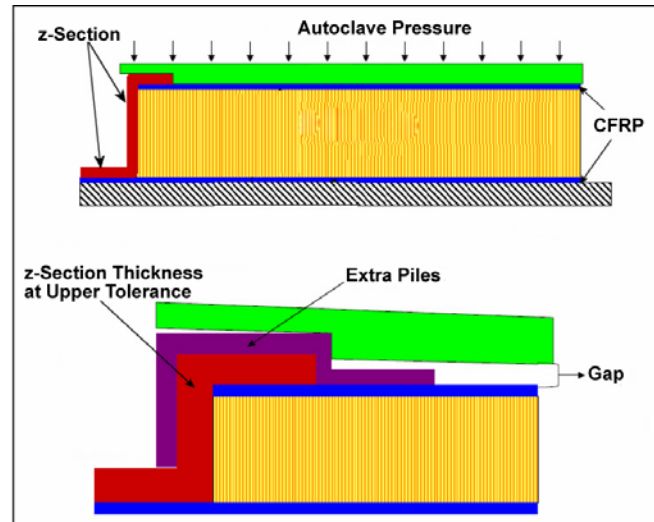
The front and bottom edge of each rudder side panel is trimmed with a z-section. Specimens of the inner skin bond taken near the z-section along the front edge of the left side panel of the occurrence rudder had a meniscus whose appearance was consistent with insufficient bonding pressure within a width of 20 mm. The investigation revealed that this condition could be caused by insufficient caul plate pressure during cure, either resulting from mispositioning of the z-section or accumulation of tolerances of the components. In Figure 6, the upper sketch shows correct orientation during cure. The lower sketch shows how dimensional tolerances can result in low bonding pressure next to the z-section.

Figure 6. Low bonding pressure next to the z-section

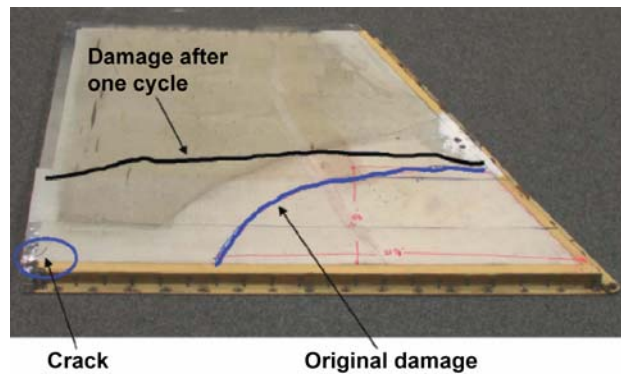
- A specimen from the damaged left side panel of the rudder of aircraft MSN 361, which included the disbonded area (approximately 2256 cm²), was subjected to vacuum cycling at room temperature. The area of the damage almost doubled instantly at a pressure of 0.44 bar (absolute). The rapid propagation event was reported to be explosively loud and violent, resulting in some damage to the interior of the test chamber. During the test, a surface crack developed in the CFRP face sheet at the panel edge (Photo 7). This fracture halted any further damage growth by removing the pressure differential.

Photo 7. Damage growth after one vacuum cycle
(rudder of aircraft MSN 361)

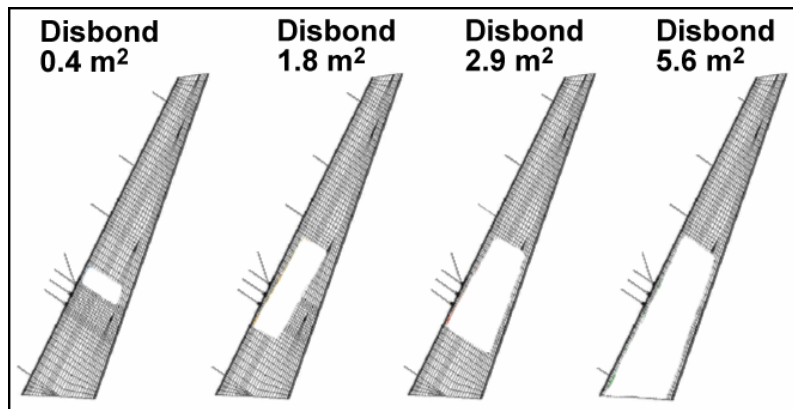
- Disbond** – The scenarios involved varying degrees of disbond between the honeycomb core and the inner face sheet, as shown in Figure 7. Single-sided disbonds were studied on the left panel, the right panel, and both panels. Simulating a

Figure 7. Disbond scenarios studied in flutter analysis

- disbond between the core and the face sheet was accomplished in the analysis by reducing the stiffness of the face sheet to 0 or 20 per cent of its original value in the affected area. The analysis found that there was an increase in flutter tendency with greater disbonds, and that double-sided disbonds were more critical than single-sided ones. There was no significant difference between left-side and right-side disbonds. No flutter was observed when stiffness was reduced to 20 per cent. When it was reduced to 0 per cent, the double-sided 2.9 m² disbond scenario and the single-sided 5.6 m² disbond scenario resulted in violent flutter below 150 KCAS. A more detailed examination of the single-sided 5.6 m² disbond scenario, within the range between 0 and 20 per cent stiffness, found that the flutter speed decreased as the stiffness was reduced, and that this decrease was steady and continuous down to about 5 per cent stiffness where flutter started. Below 5 per cent stiffness, the frequency and damping decreased rapidly leading to flutter conditions.

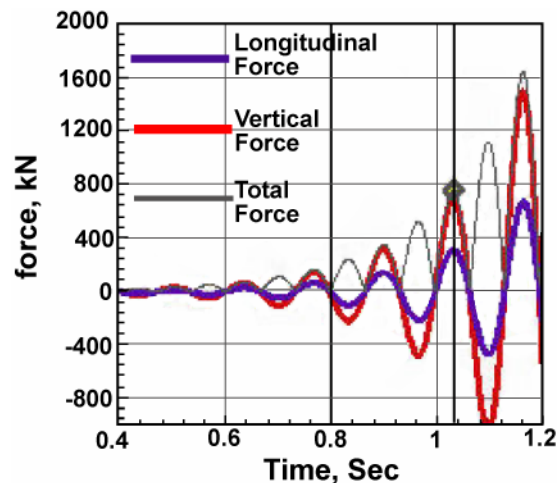
Upon excitation, the amplitudes of all the responses started to grow. Figure 8 shows a typical load response at the left rear VTP attachment. At design ultimate load, the maximum force acting at the aft VTP attachment is approximately 700 kN, and based on the attachment fittings damage, it is known that loads during the occurrence did exceed ultimate strength. Therefore, the time step where the load peaked above 700 kN was selected as a reference point for each scenario. All the remaining monitored variables were measured within an envelope around the reference time step, since all the maxima did not occur at the same time. Their peak value within this envelope was recorded. Both investigated scenarios showed no contradictions

Figure 8. Typical load response from time-domain flutter analysis

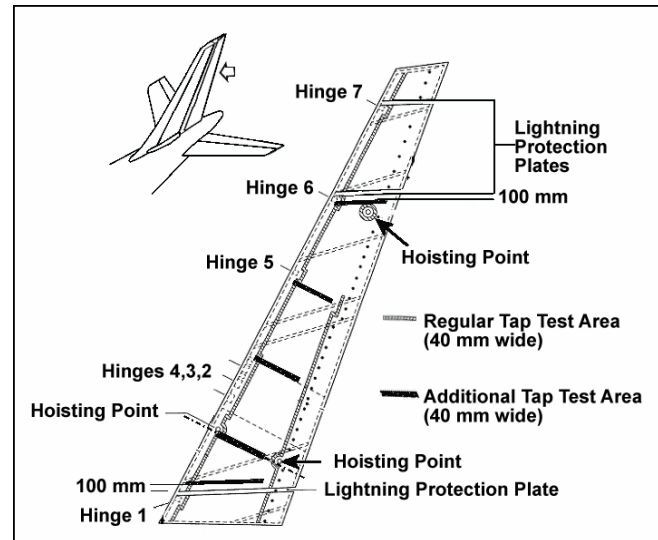
Figure 9. Schematic of AOT-1 areas of inspection

As a result of this investigation, the aircraft manufacturer issued AOTs A310-55A2035, A300-55A6035, A330-55A3035, and A340-55A4030 on 17 March 2005 for the inspection of all aircraft with part number A55471500 series rudders (Figure 9). These AOTs were subsequently made mandatory by an Airworthiness Directive issued by the Direction Générale de l'Aviation Civile (DGAC) of France, the State of manufacture. This inspection included 222 A310s, 146 A300-600s, 6 A330s, and 34 A340s. The aim was to verify the structural integrity of the rudder and its attachment by means of one-time visual and tap-test inspections. This included a

GVI of the VTP rear spar aft face, DVI of the hinge arms and actuator support fittings, DVI of the rudder hinge fittings, and a tap test of the rudder side panels. The tap test was conducted around the exterior perimeter of the rudder side panels as per the normal five-year inspection, as well as the inspection of additional bands through the centre as shown in Figure 9. It is noted that an exterior tap test is unable to detect disbonds on the interior face sheets. Airbus obtained results from operators for over 80 per cent of the affected aircraft, with the following results:

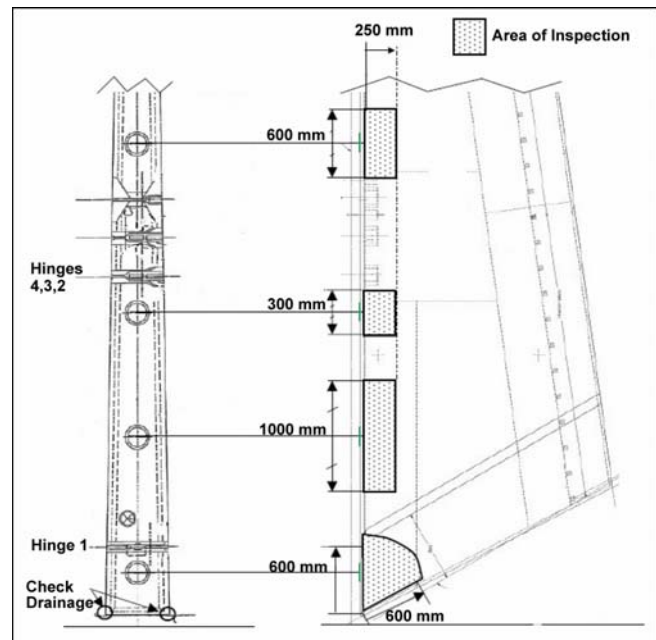
Figure 10. Schematic of AOT-2 areas of inspection

On 02 March 2006, the aircraft manufacturer issued a second series of AOTs (AOT A310-A552043, AOT A300-A556042, AOT A330-A553036, and AOT A340-A554031) for the inspection of all aircraft with rudder part number A55471500 series rudders. These AOTs were subsequently made mandatory by two Airworthiness Directives issued by the European Aviation Safety Agency (EASA), representing the State of manufacture. The aim was to verify the structural integrity of the rudder by means of a one-time tap-test inspection to the interior face sheets of the rudder side panels, as well as checking the drainage holes at the bottom of the rudder and cleaning hydraulic fluid from the external surfaces. Access to the interior of the rudder was through the inspection holes in the front spar of the rudder. It is noted that the access to inboard surfaces from the inspection holes is limited. Figure 10 shows the areas of inspection. Airbus obtained results from operators for over 90 per cent of the affected aircraft and no disbonds were found.
