AVIATION INVESTIGATION REPORT

A05Q0024

LANDING BESIDE THE RUNWAY

HAWKER SIDDELEY HS 125-600A N21SA

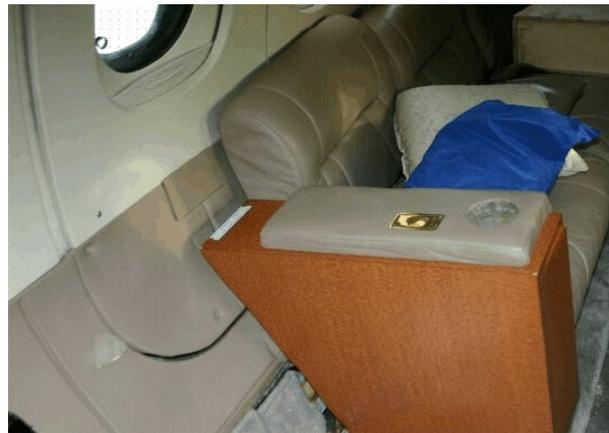
Photo 1. Armrest/cabinet

A cabinet that served as an armrest for the side seat was partially blocking the emergency exit (see Photo 1). The armrest/cabinet is connected to the seat by means of a rail along which it slides when it is necessary to remove it. According to Supplementary Type Certificate (STC) SA4147SW, a notice indicating that the armrest must be removed before each take-off and landing must be displayed when the armrest is in position. At the time of the accident, the armrest/cabinet was in position, and the notice stated that the cabinet should be pulled forward in order for the emergency exit to be used.

The emergency exit could not be opened due to structural damage, which delayed the evacuation and could have had serious consequences. As well, the armrest next to the side seat was blocking the access to the emergency exit. The notice on the armrest was not compliant with the STC, which required that the armrest be removed before each take-off and landing. STCs are not normally provided to pilots, so the flight crew had no way of knowing about this requirement.

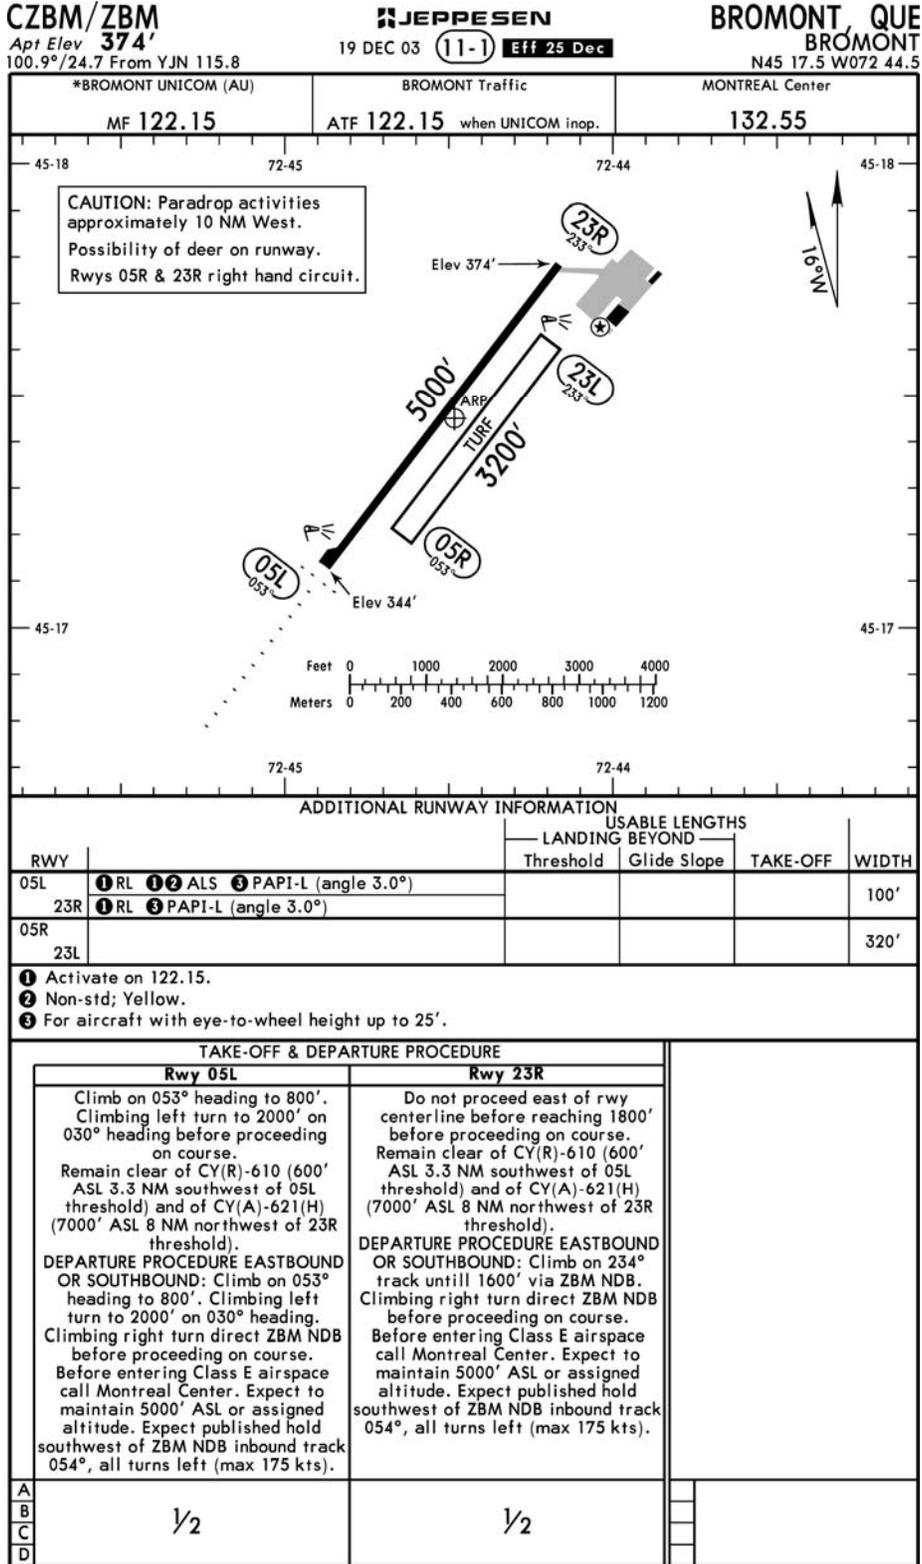
Appendix A – Aerodrome Map

At approximately 1000 feet asl and five miles from the threshold, the flight crew had the approach lights and the PAPI in sight. It was not evident whether the PAPI was positioned on the right or the left side of the runway. The airport chart published by Jeppesen indicated "PAPI-L" (see Appendix A), and interpretation meant that the PAPI was on the left. In response to a query from the crew, the Bromont dispatcher indicated that the PAPI was on the right side of the runway. From his location facing the aircraft, the PAPI was to the dispatcher's right. The approach chart, also published by Jeppesen, showed the position of the PAPI by means of a pictograph, showing a drawing of the runway threshold and the approach lights with the word "PAPI" on the left side of the drawing (see Appendix B). Although that chart was referred to during the approach, there is no indication that the crew noticed the pictograph.
