AVIATION INVESTIGATION REPORT
A07A0134

TOUCHDOWN SHORT OF RUNWAY

BOMBARDIER BD-700-1A11 (GLOBAL 5000) C-GXPR

FOX HARBOUR AERODROME, NOVA SCOTIA

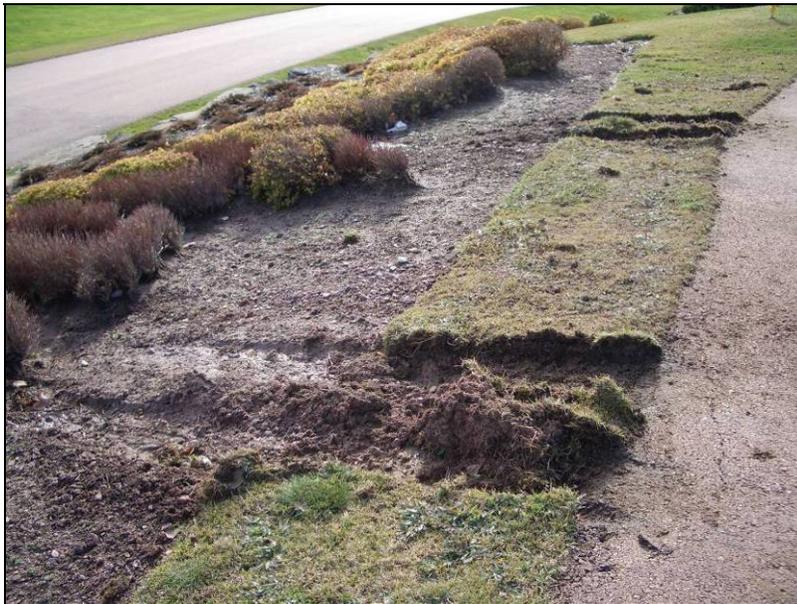
At 1434:25, the aircraft touched down 7 feet 6 inches short of Runway 33 and 18 inches below the surface of the runway (see Photo 1).

Photo 1. Initial impact point showing tire marks ending at the runway threshold

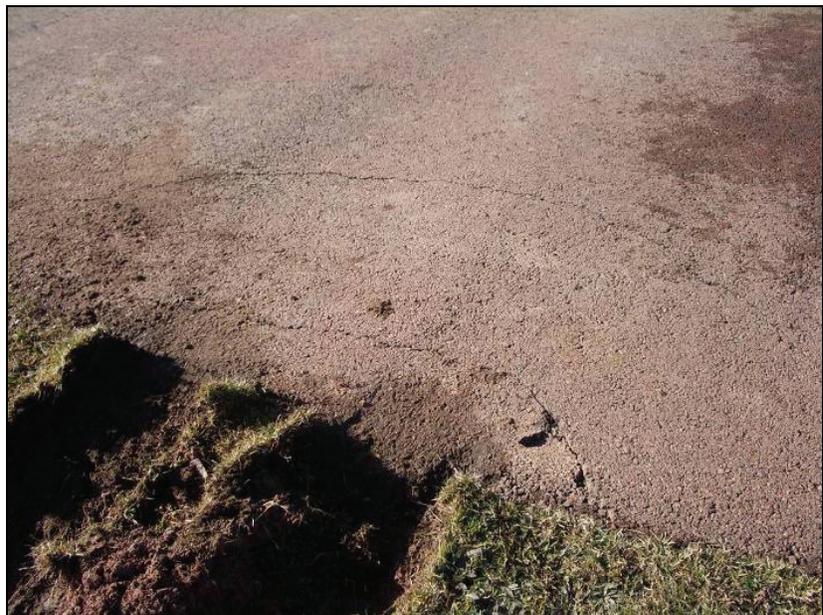
The tire tracks leading up to the paved asphalt runway surface were approximately five inches deep. Two semi-circular cracks were found in the asphalt, in line with the right main landing gear touchdown point (see Photo 2), resulting from the force of the gear striking the runway edge.

Photo 2. Runway edge damage from right main landing gear

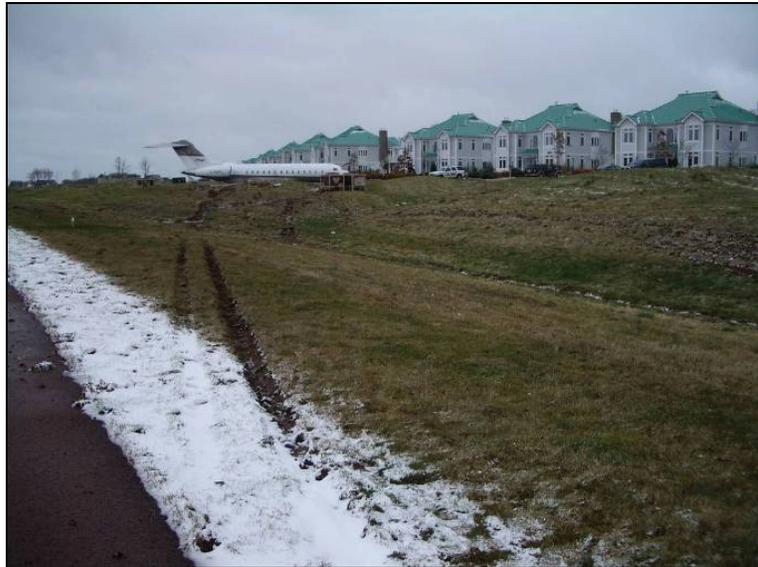
The left main landing gear tire tracks cross the centreline 457 feet from the threshold. A runway edge light located 600 feet from the threshold was broken. A ground scar indicates that the right main landing gear departed the runway surface 640 feet from the threshold (see Photo 3) while the left main landing gear departed the runway surface 694 feet from the threshold.

Photo 3. Point of departure from runway

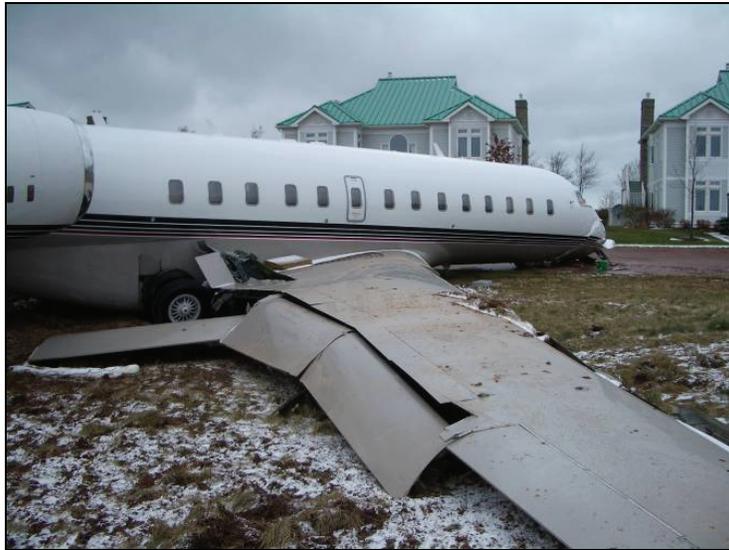
The aircraft sustained extensive damage all attributed to the impact and post-impact accident sequence (see Photo 4). There was extensive damage to the fuselage structure and systems in both main landing gear bay areas caused by the detachment and pivoting of the landing gear following the initial impact with the runway edge.

Photo 4. Aircraft damage

Most of the other damage was incurred as the aircraft departed the right side of the runway and travelled through the series of mounds. The nose section of the aircraft between fuselage stations 169 to 288 had structural buckling 6 to 8 inches deep. Both wings sustained extensive damage to the auxiliary spar and surrounding structure due to the detachment of the main landing gear. The flap system was also heavily damaged. Both engines were damaged after ingesting debris.

The main passenger door was skewed rearward and the occupants were unable to open it for the evacuation. The cockpit floor was buckled in several places and both the captain's and first officer's seats were deformed and jammed in the seat rails. Some of the passenger seats sustained damage, mostly due to the side load experienced during the post-impact accident sequence. Some glassware was dislodged from the galley storage and broken glass littered the galley floor. Damage to the left wing resulted in a small fuel spill that was contained by the first responders.

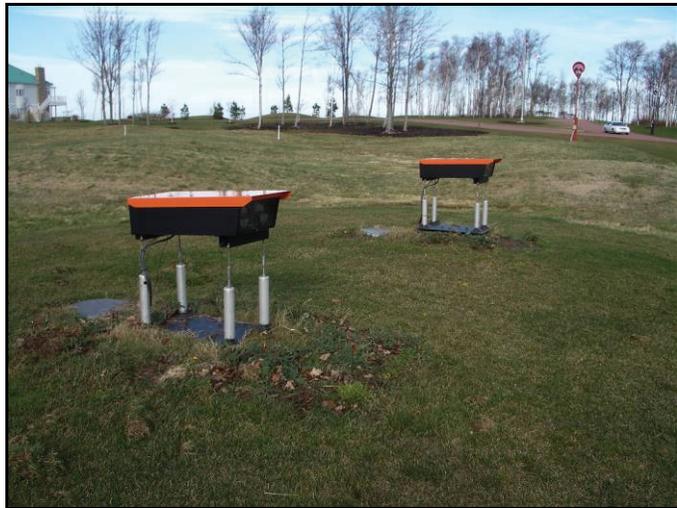
Photo 6. Fox Harbour APAPI

The APAPI was installed 480 feet from the threshold on the right side of the runway, because a ramp on the left side of the runway precluded installation on that side. It was calibrated using the manufacturer’s operating manual information, which describes the recommended Transport Canada aiming angles for a 3.0° glideslope. This operating manual also describes unit alignment procedures, recommended check intervals, and maintenance. For an APAPI installation, it recommends that the aiming check be carried out at least once per week.

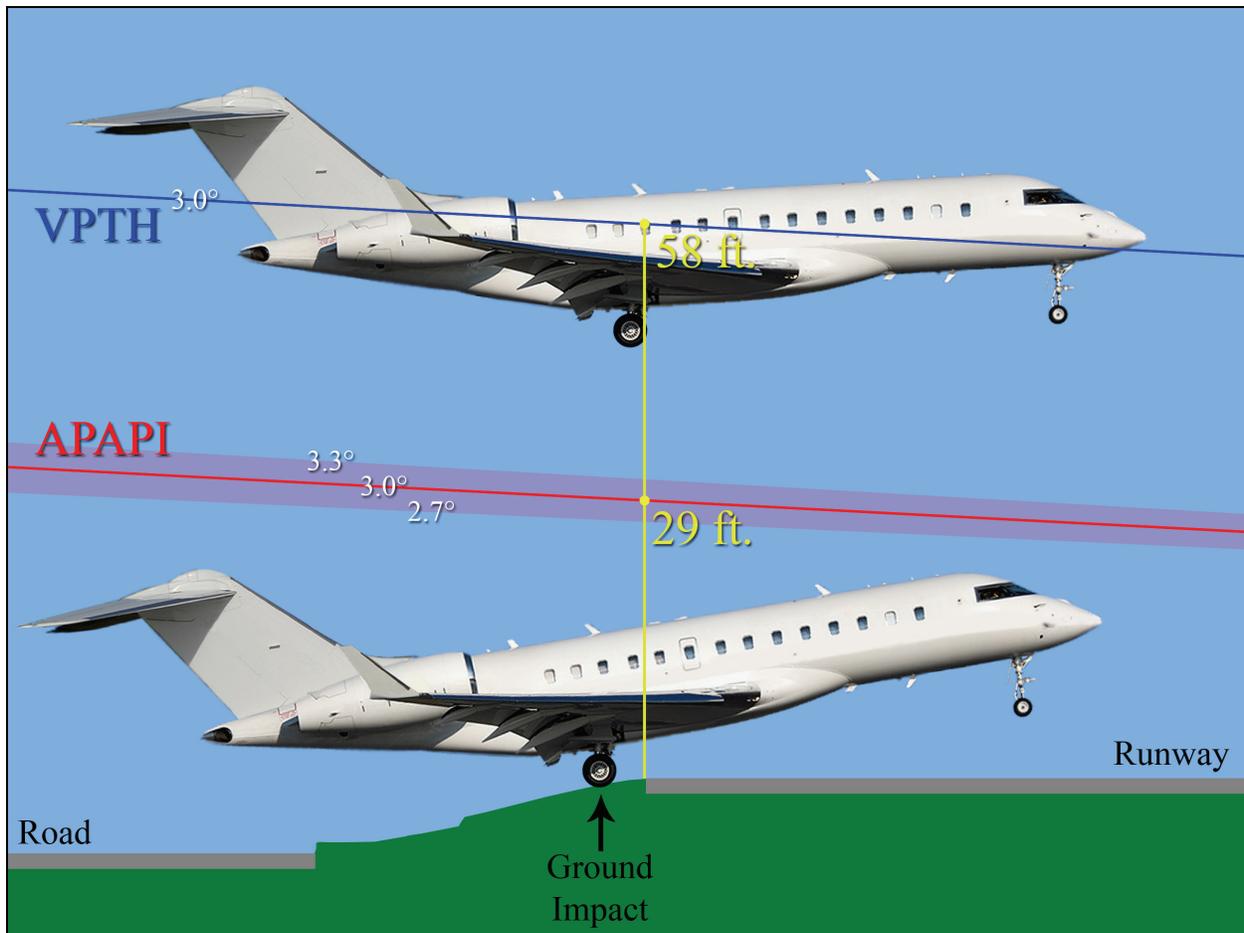
Figure 7. Aircraft in relation to vertical path (VPTH) and APAPI path

At a distance of 1.4 nm from the threshold of Runway 33, the PF disconnected the autopilot, which was following vertical path guidance. The PF continued the approach manually, initially correcting the flight path with reference to the abbreviated precision approach path indicator (APAPI) guidance. While the vertical path (VPTH) approach path of 3° meets the runway approximately 1000 feet from the threshold, the APAPI 3° path meets the runway approximately 500 feet from the threshold. Therefore, the aircraft was initially slightly above the APAPI on-slope indication (see Appendix B – Flight Data Recorder Approach Data) and the PF had to increase the descent rate to intercept the APAPI approach path.

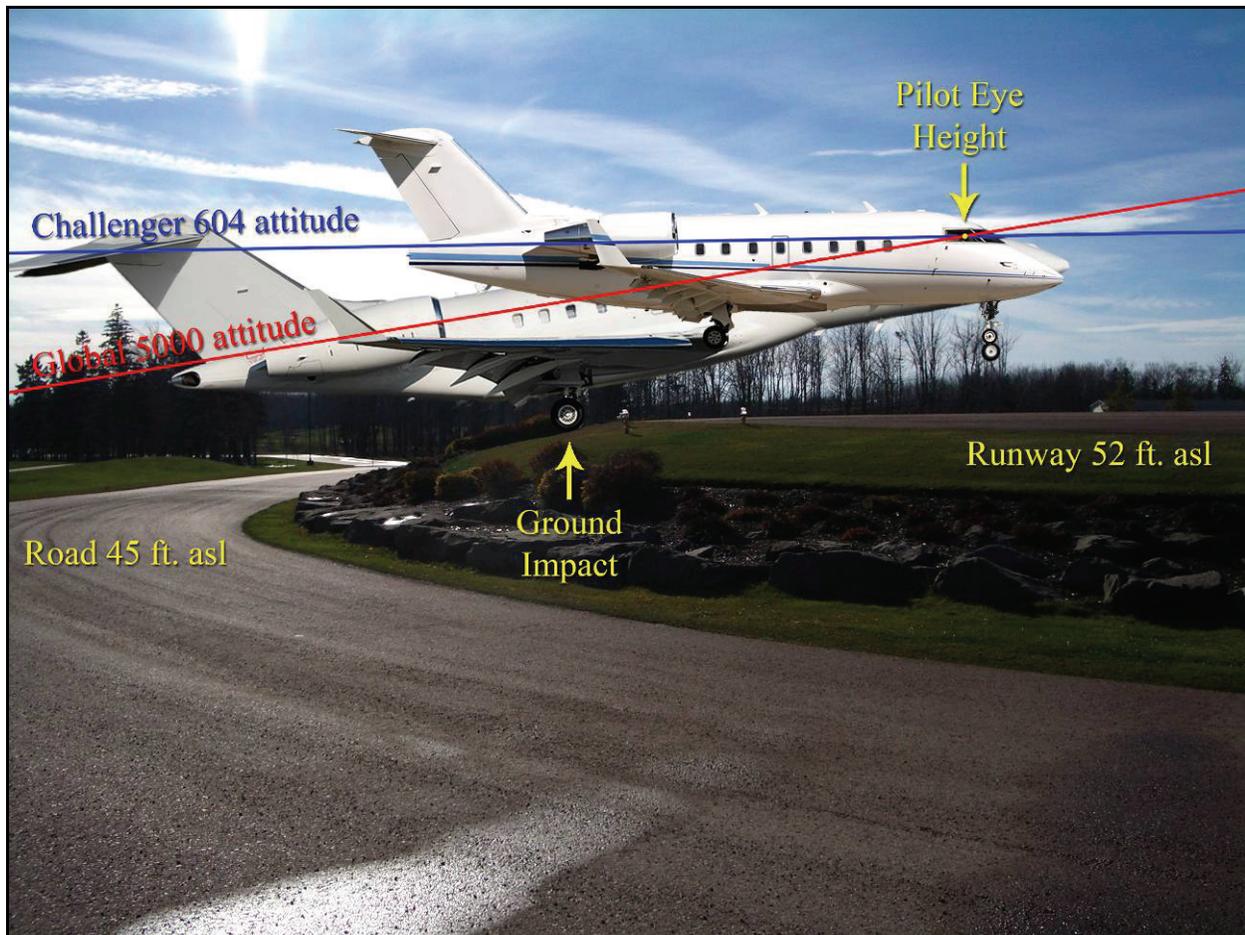
The pilot not flying (PNF) had less experience than the PF and it had been a considerable amount of time since he had completed his initial training on the Global 5000. It is therefore unlikely that the PNF could have helped the PF detect the unsafe profile. Like the PF, he was used to flying the same approach profile at CFH4 in the CL604 and Gulfstream G100. The profile flown on the occurrence day would have provided enough height for a CL604 to cross the threshold and land in the first 500 feet of runway (see Photo 7).

Photo 7. Aircraft attitude at threshold

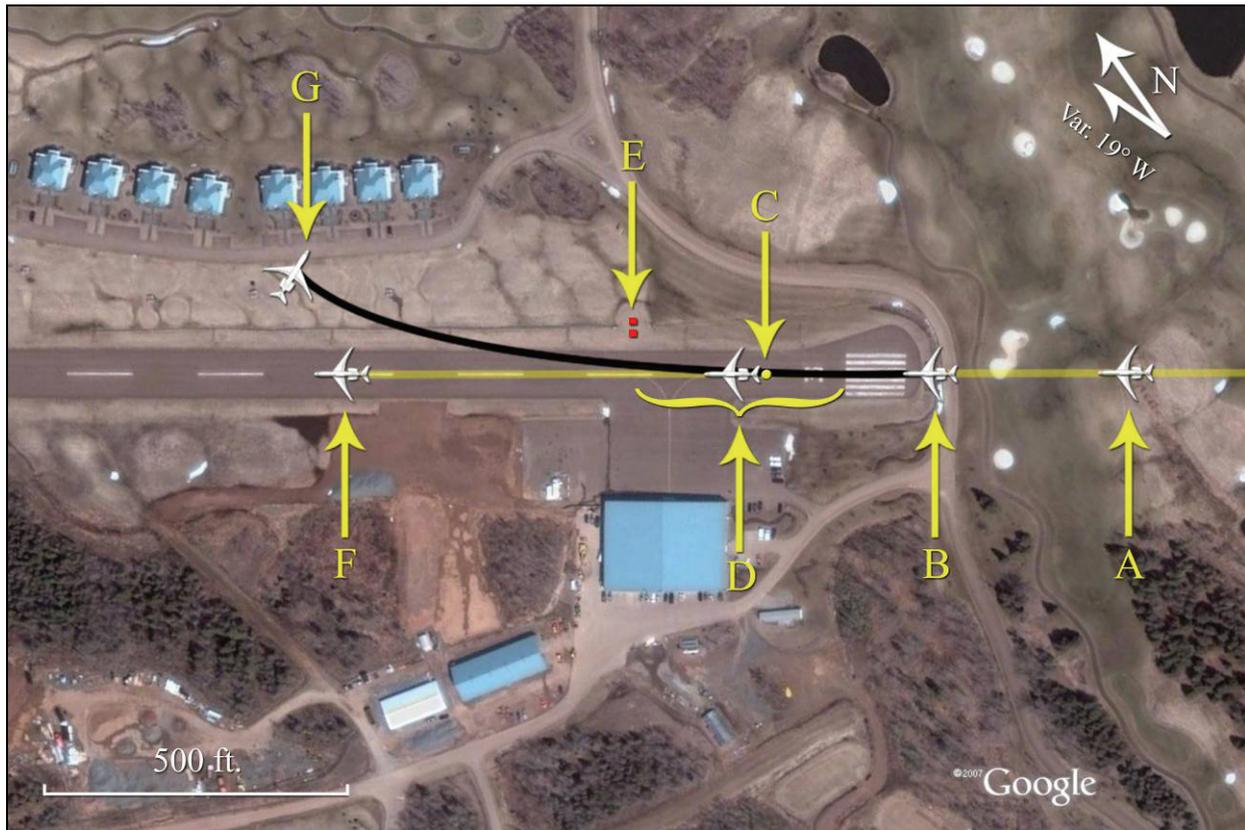
Appendix A – Touchdown Points

- A. Aircraft on final approach
- B. Impact point (-7.5 feet)
- C. Touchdown point if APAPI 3° slope was followed and aircraft not flared (213 feet)
- D. Planned touchdown area and main area of tire rubber deposits from other landings (129 to 500 feet)
- E. APAPI units (480 feet)
- F. Manufacturer recommended touchdown point (1000 feet)
- G. Final aircraft position (1017 feet)

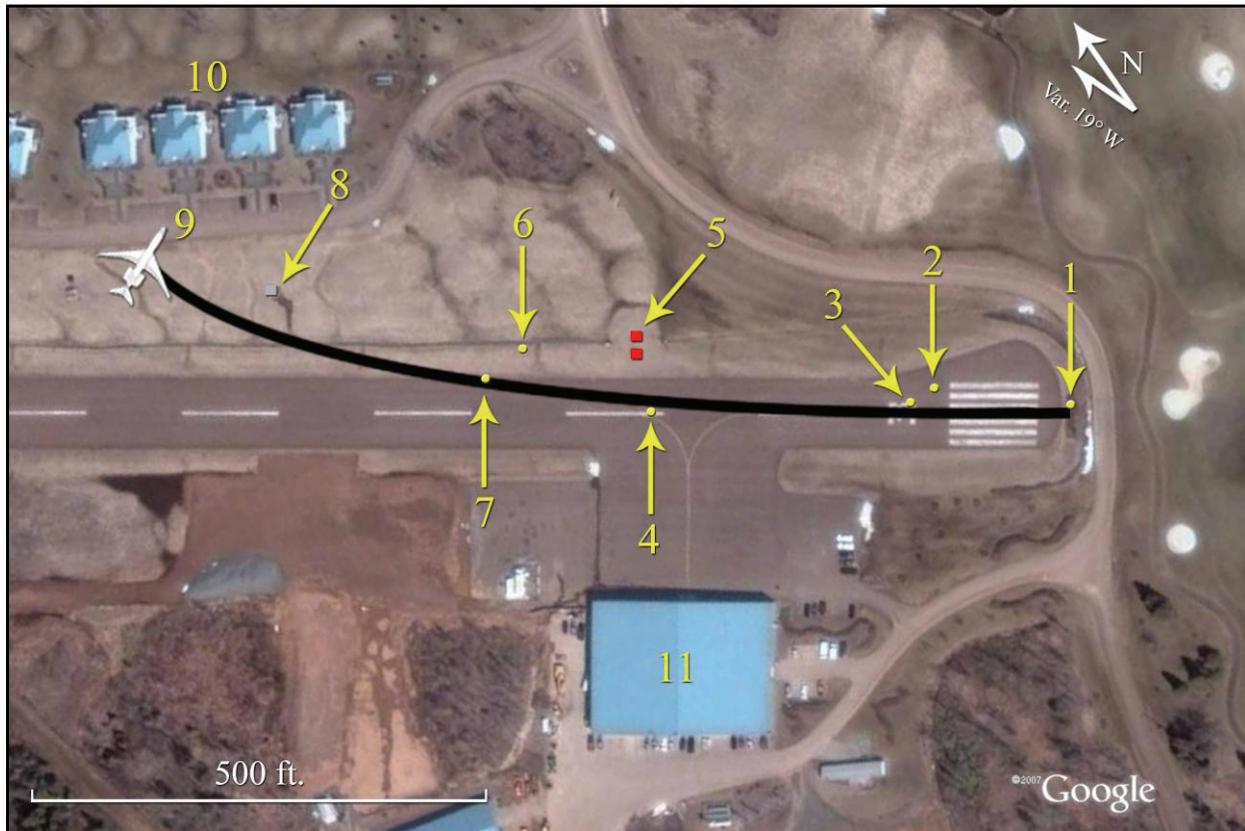
Appendix C – Wreckage Path

1. Impact point (-7.5 feet)
2. Start of scrape marks caused by outboard and centre canoe fairing (140 feet)
3. Start of scrape marks caused by inboard canoe fairing (170 feet)
4. Left main landing gear crosses centreline (457 feet)
5. APAPI units (480 feet)
6. Ground scar caused by right wing (600 feet)
7. Right main landing gear departs runway (640 feet)
8. Air conditioning units for condominiums (893 feet)
9. Final aircraft position (1017 feet)
10. Condominium units
11. Hangar
