**AVIATION INVESTIGATION REPORT**  
**A09A0016**

**MAIN GEARBOX MALFUNCTION / COLLISION WITH WATER**

**SIKORSKY S-92A, C-GZCH**

**12 MARCH 2009**

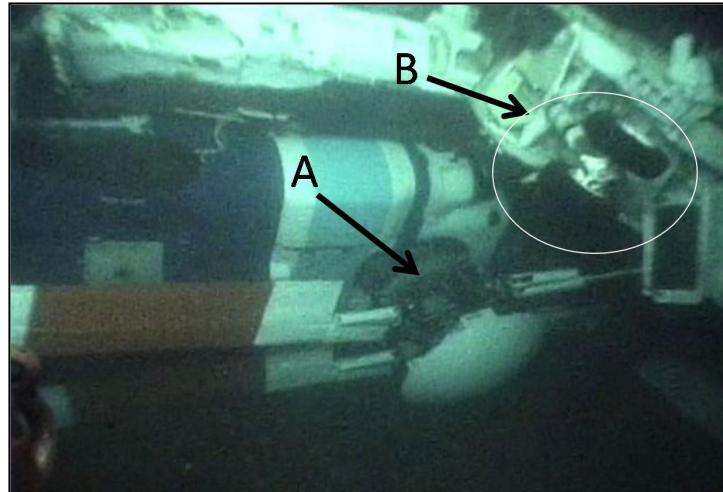
The cockpit was extensively damaged and had structurally separated from the main fuselage. Both crew emergency exit windows had been detached by the force of the impact as the cockpit fuselage structure had been severely crushed. The cockpit area, including the flight controls and instrument panel, from the nose rearward to where the cockpit joins the main fuselage, was found lying under much of the forward cabin wreckage. The left-hand pilot seat had remained attached to the cockpit structure but the right-hand pilot seat had separated from its attachment structure.

**Photo 1.** Photo taken by remotely operated vehicle prior to recovery: A - main rotor; B - main landing gear.

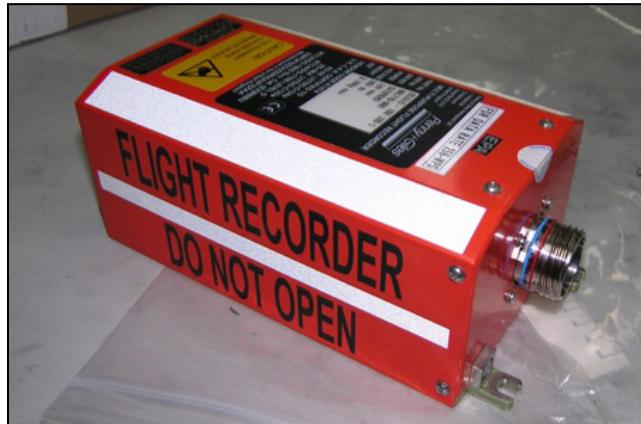
**Photo 4.** CHI91's MPFR

The MPFR stopped recording about 44 seconds before impact and then began recording again about 1.7 seconds before the impact. TSB's examination of the MPFR and the components which supply it with data, as well as the associated wiring, determined that there was no indication of a pre-existing condition that would have prevented normal operation.

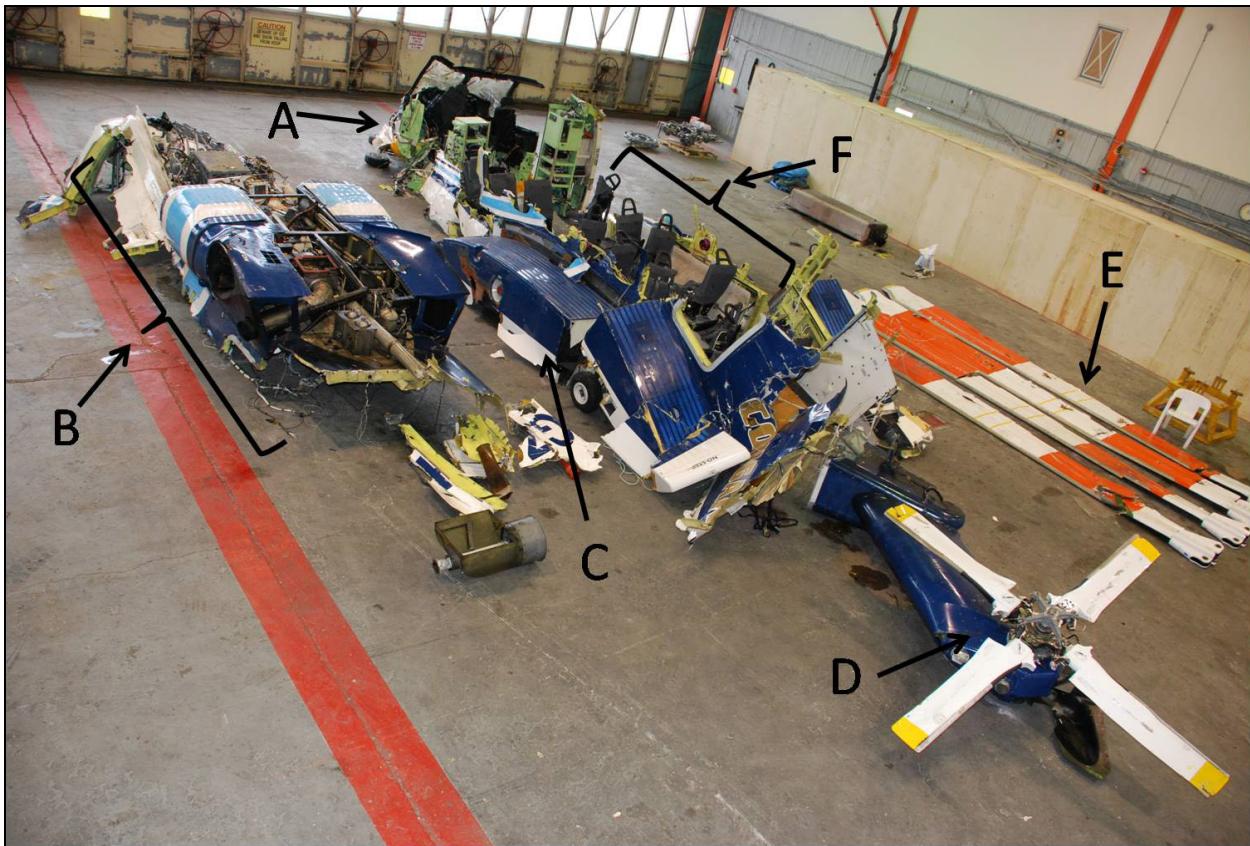
The relative integrity of the main rotor blades is consistent with a low blade energy state at the time of water impact. The tail rotor blades showed no sign of rotation at impact.

**Photo 5.** CHI91 wreckage layout: A – Cockpit; B – Upper deck/engines; C – Sponson; D – Tail rotor; E – Main rotor blades; F – Cabin area

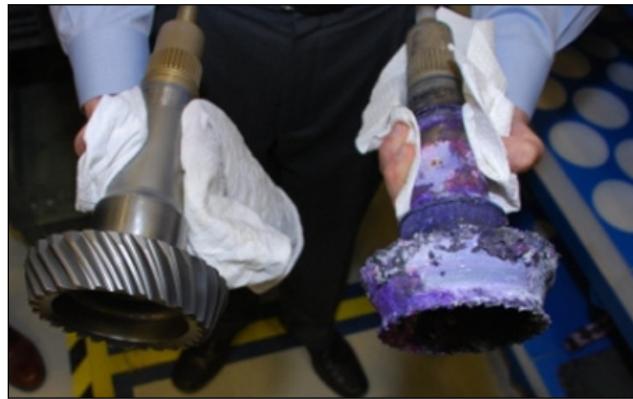
The TSB's examination of the MGB components and oil bypass system determined that there was no indication of a pre-existing condition which would have prevented their normal operation.

**Photo 6.** Damaged tail take-off pinion on right

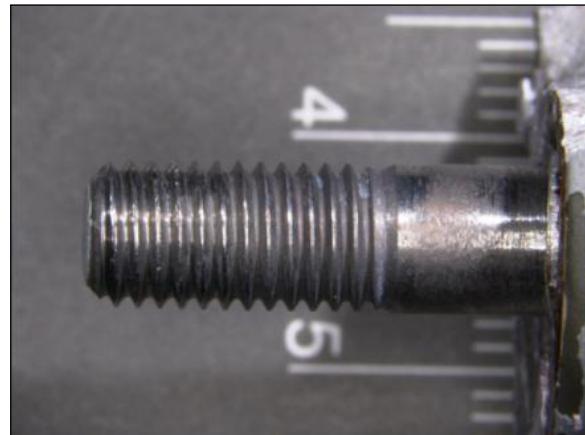
The TSB was able to examine the top stud which remained in CHI91's MGB housing (see Photo 8) and conduct testing on a sampling of new stud and nut assemblies, which were provided by Sikorsky, to quantify the nut and stud damage and the effect on preload associated with a certain number of assembly cycles. Examination of a new stud and nut showed that galling damage developed after the first installation and that the damage became progressively more severe with repeated installation/removal cycles (see Photo 9). Testing of the occurrence and exemplar studs and nuts showed that after 13 to 17 assembly cycles, the nut self-locking feature was significantly damaged and fragments were separating from the crests of the threads.

Photo 8. Top stud which remained in CHI91's MGB housing.

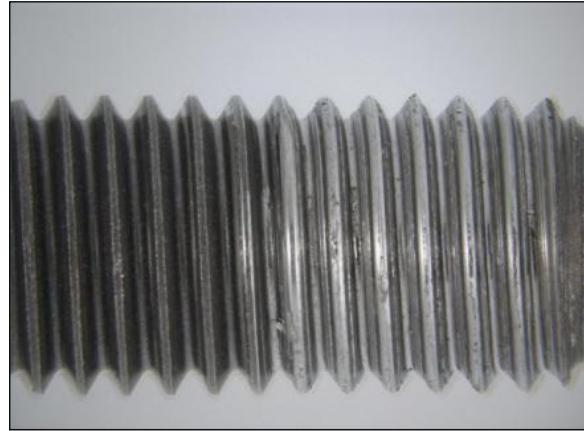
**Photo 9.** New exemplar stud – Left side original threads, right side after 10 installation/removal cycles using the same nut.

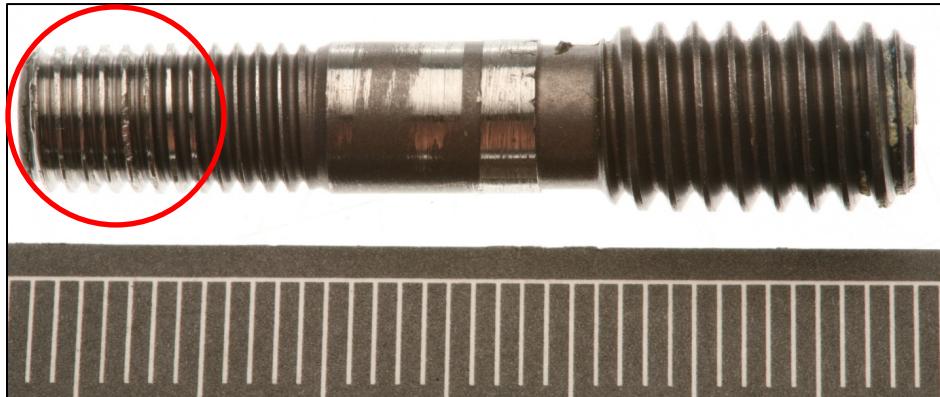
The occurrence helicopter, as well as at least three other Cougar helicopters, had MGB oil filter bowl attachment nuts with a grey paint residue that had been applied when the MGB was manufactured.

**Photo 15.** Stud removed from another Cougar Helicopters' MGB (scale in mm)

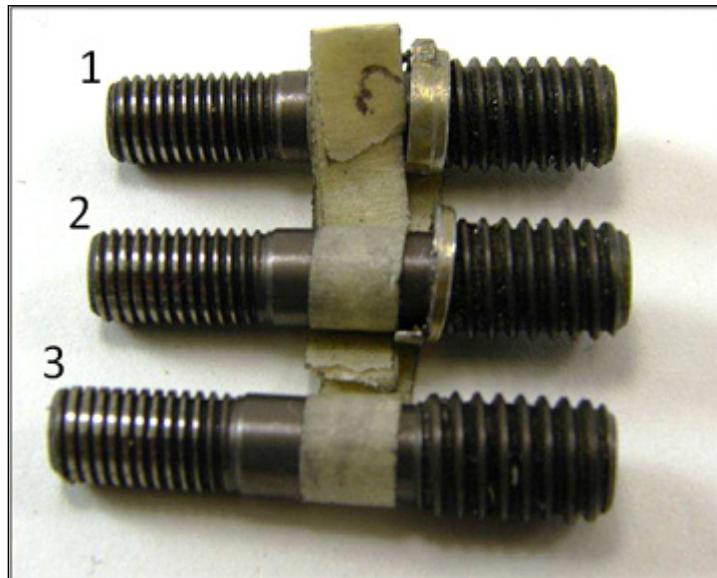
**Photo 16.** Studs returned to Sikorsky

Revision 13 in November 2008 and when AD 2009-07-53 was issued in March 2009. However, it did receive 59 studs from various operators after they had complied with the AD. Sikorsky examined these studs and found that they had varying degrees of galling of the threads, indicating multiple nut removals. Some of
