**AVIATION INVESTIGATION REPORT
A12C0084**

**CONTROLLED FLIGHT INTO TERRAIN
SUNRISE HELICOPTERS INCORPORATED
BELL 206B C-GUIK
ANGUSVILLE, MANITOBA, 6 NM SW
05 JULY 2012**

Report Number A12C0084

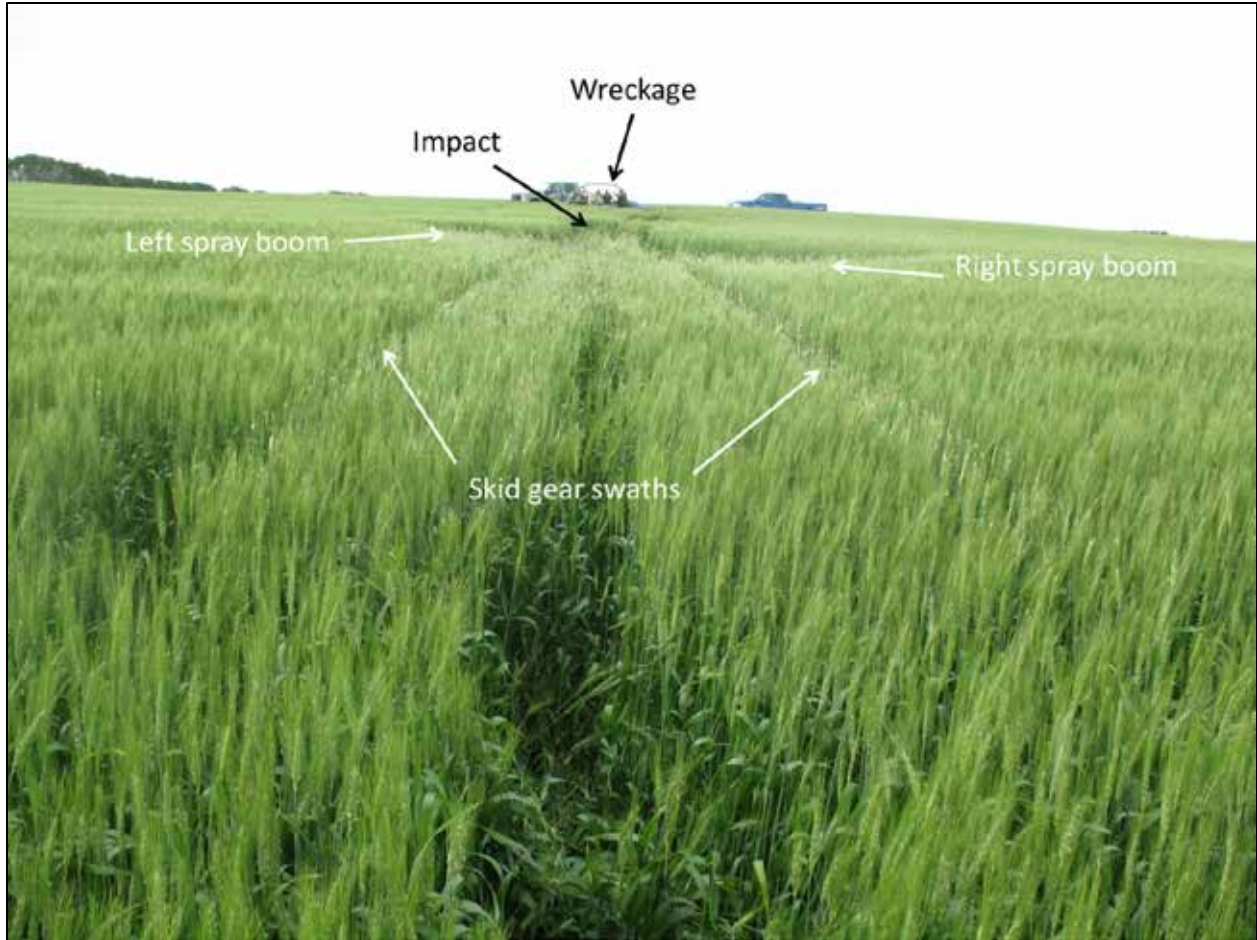
Photo 1. Wreckage site

The helicopter struck the ground in a slight right-skid-low attitude. The right spray boom contacted the wheat, followed closely by the left spray boom. The nose of the helicopter and the Simplex belly tank struck the ground along with the main rotor blades, leaving 8 distinct rotor-blade marks in the ground and crop to the right side of the wreckage trail. The helicopter flipped and became airborne, tearing the main transmission, rotor assembly and tail section free from the helicopter. The helicopter came to rest on its left side, approximately 225 feet from the initial crop contact.
