**AVIATION INVESTIGATION REPORT
A14O0165**

**LOSS OF CONTROL
EXPRESSJET AIRLINES
EMBRAER EMB-145LR, N16954
LONDON, ONTARIO, 53 NM W
05 SEPTEMBER 2014**

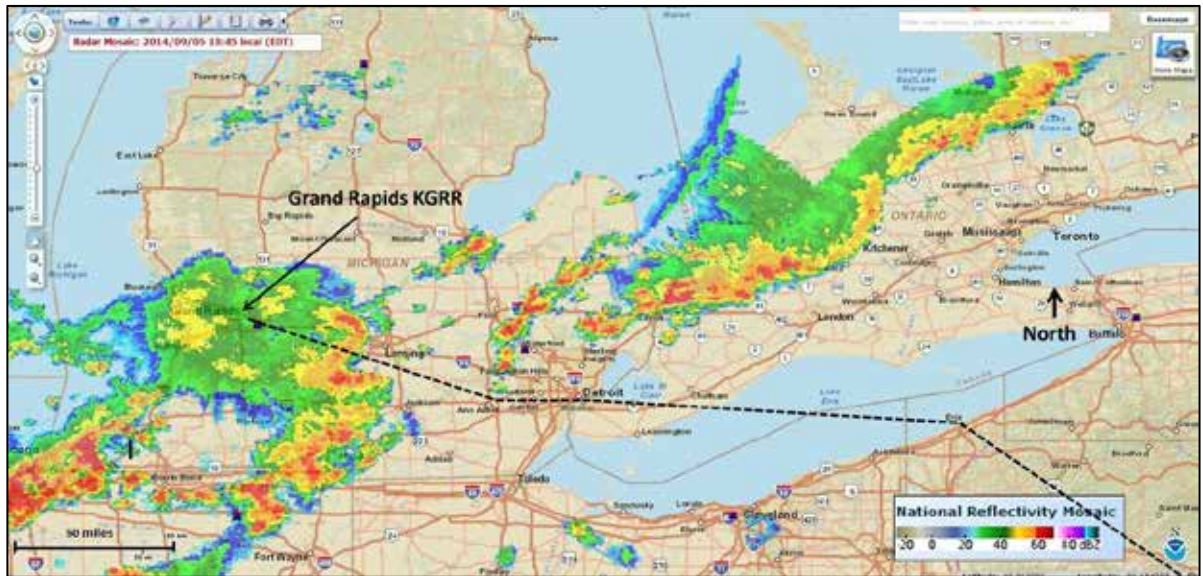
The flight crew decided that the line of thunderstorms appeared to be fragmented enough, with sufficient openings, to allow them to deviate from their planned route (Figure 1) around the weather system. At 1845, the aircraft departed and deviated 50 nautical miles (nm) north-northeast of KGRR. After its initial deviation, the aircraft turned east, paralleling a line of thunderstorms south of its position. The aircraft was in visual meteorological conditions (VMC).

Figure 1. Depiction of weather at time of departure (1845) and the aircraft's planned flight route (dashed line) (Source: National Oceanic and Atmospheric Administration [NOAA], National Weather Service, with TSB annotations)

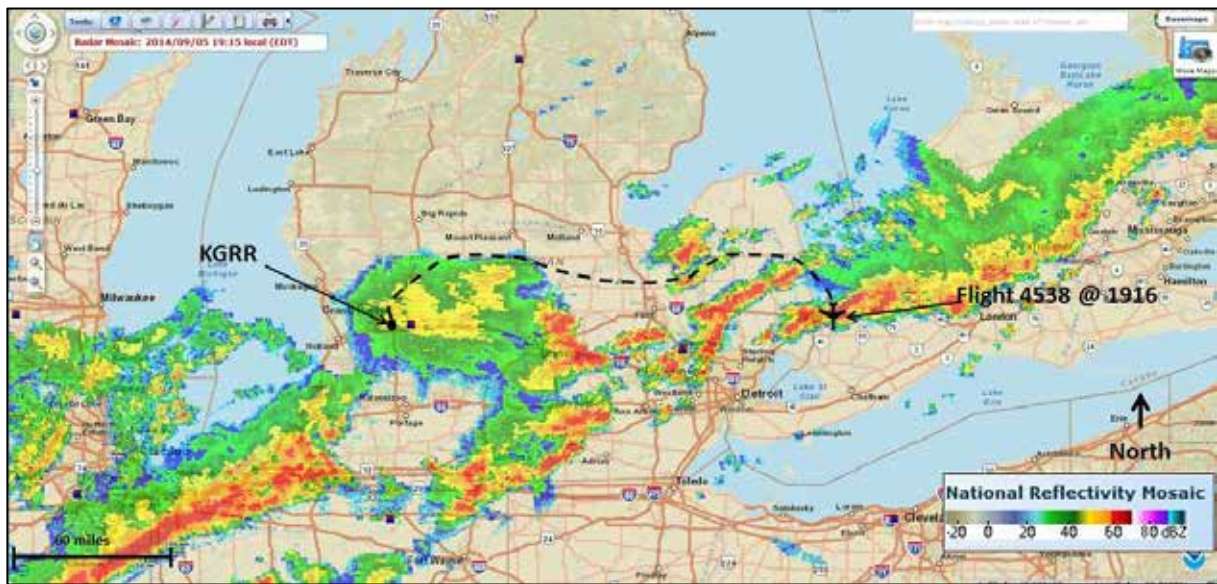
Radar data obtained after the occurrence indicated that, at 1916, the aircraft was flying in a southerly direction, through a line of thunderstorms (Figure 3).

Figure 3. Flight path (dashed line), weather, and aircraft location at 1916. The weather depiction was generated by a composite reflectivity radar source, using the maximum reflectivity from all of the multiple elevation angles. (Source: National Oceanic and Atmospheric Administration [NOAA], National Weather Service, with TSB annotations)

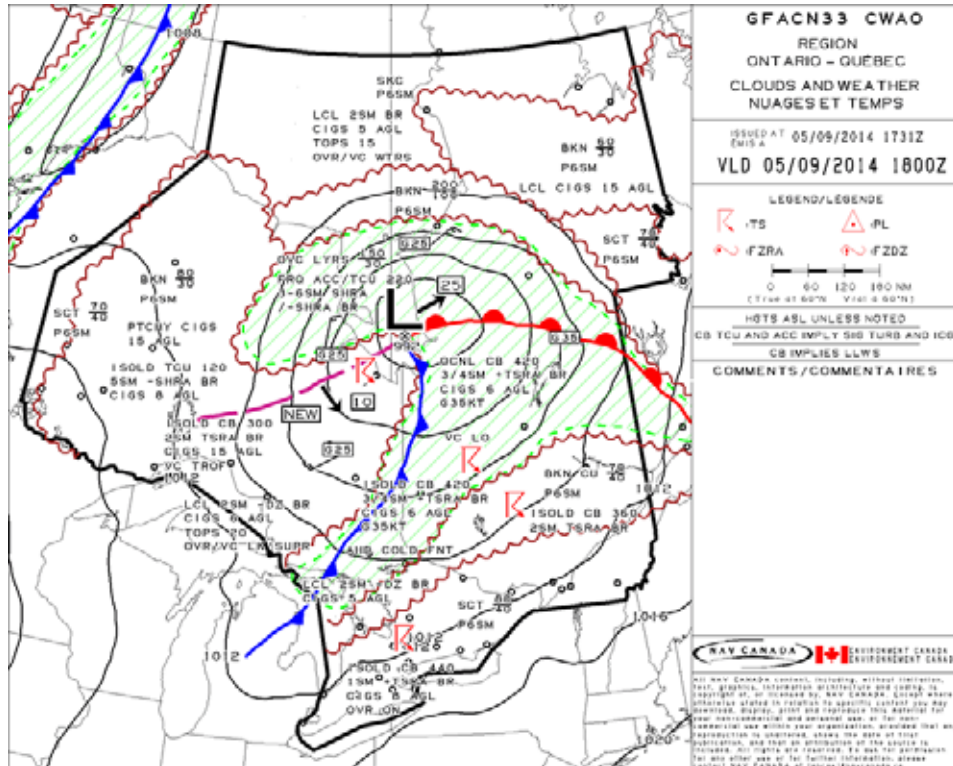
Appendix A – Graphical area forecasts

A line of thunderstorms, associated with a cold front, progressed from west to east through southern Ontario during the afternoon and evening on the day of the occurrence. The graphical area forecasts (GFA) covering southern Ontario (GFACN33) issued for the occurrence day (Appendix A) indicated potential for occasional widespread thunderstorms, with tops of 42 000 to 44 000 feet above sea level (asl) at 1400 (1800Z). The GFACN33 issued at 2000 (0000Z) forecasted the following weather along the cold front: frequent cumulonimbus clouds with tops of 52 000 feet asl, heavy thunderstorms, rain, and hail, with winds gusting to 40 knots.
