AVIATION INVESTIGATION REPORT A16P0045

Loss of control and collision with terrain

Airbus Helicopters AS 350 FX2, C-FBLW
TRK Helicopters Ltd.

16 March 2016

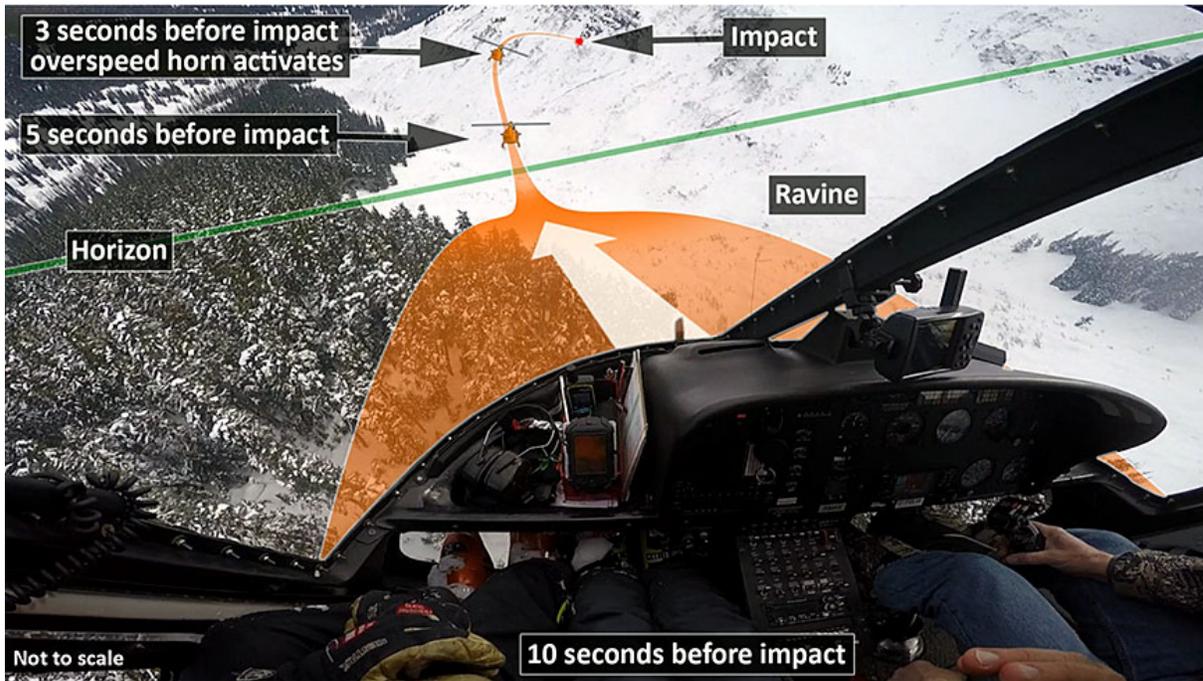
During this manoeuvre, approximately 10 seconds before impact, the helicopter's airspeed increased rapidly from 120 to 132 knots indicated airspeed (KIAS).⁴ At the same time, vertical flight loads decreased to approximately 0g,⁵ and the helicopter's vertical speed reached a descent rate greater than 5000 feet per minute.⁶

As the helicopter approached the rising terrain on the other side of the ravine, approximately 3 seconds before impact, the pilot applied aft cyclic control stick and attempted to turn left, away from the terrain ahead. However, the pilot was unable to move the cyclic control stick to the left. The helicopter then pitched up and, as it did so, its main rotor became aerodynamically overloaded and over-spun, activating the helicopter's main rotor high-rpm (revolutions per minute) warning horn. It experienced an uncommanded roll to the right and entered an uncontrolled descending right turn, which continued through approximately 180° of heading change (Figures 1 and 2).

Figure 1. Still from video recording taken during occurrence flight, with TSB annotations showing the helicopter's position at 10, 5, and 3 seconds before impact—cockpit perspective

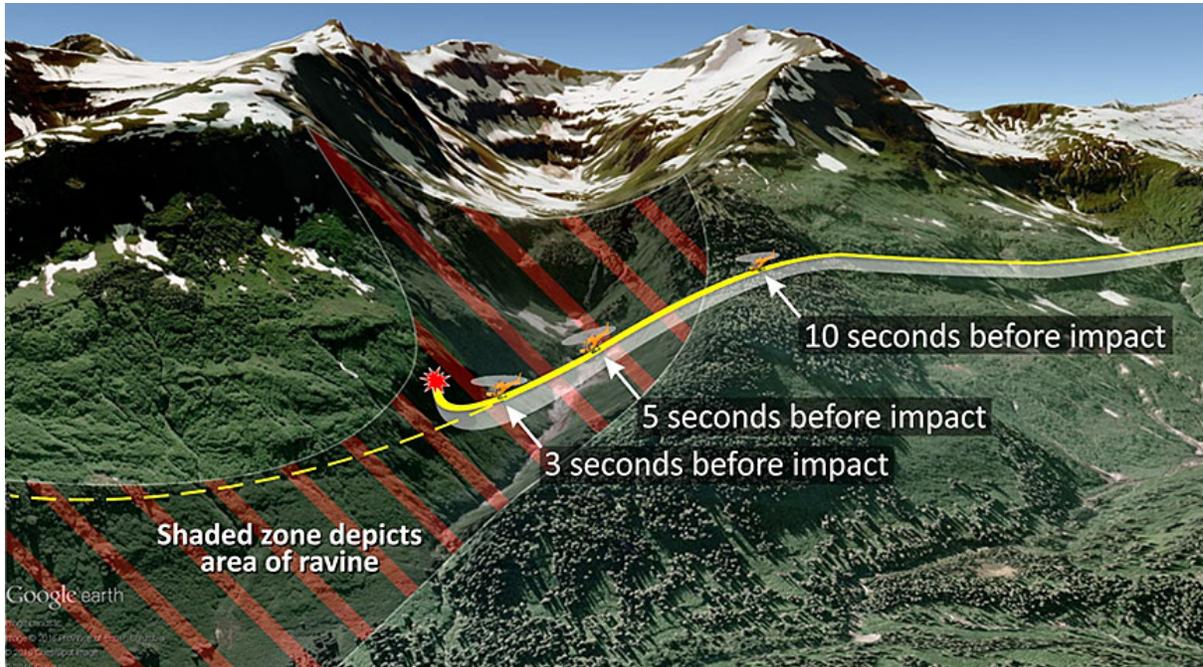
Figure 2. Helicopter position at 10, 5, and 3 seconds before impact—outside perspective (Source: Google Earth, with TSB annotations)

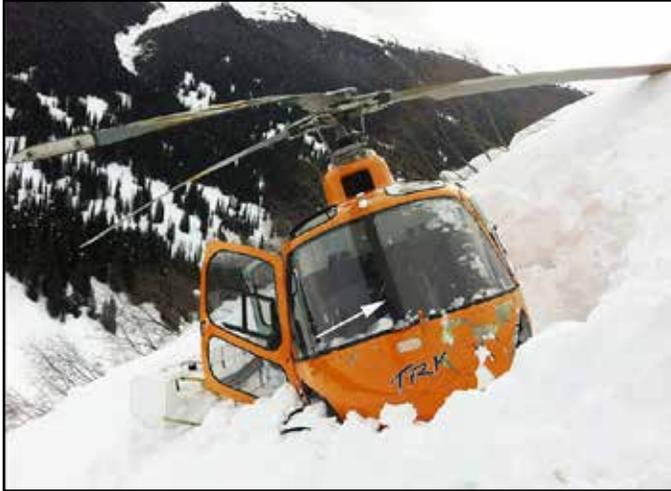
Just prior to impact, the pilot increased the helicopter's collective control in an attempt to reduce the helicopter's rate of descent. The helicopter struck the snow-covered slope of the ravine at an elevation of about 3100 feet above sea level, in a right-banked attitude, at approximately 25 KIAS.

The helicopter's main rotor blades cut a swathe through the snowpack on the aircraft's left side and continued to turn until the pilot shut down the engine and applied the rotor brake.

Figure 3. Occurrence site, showing front view of C-FBLW
(Source: TRK Helicopters Ltd.)

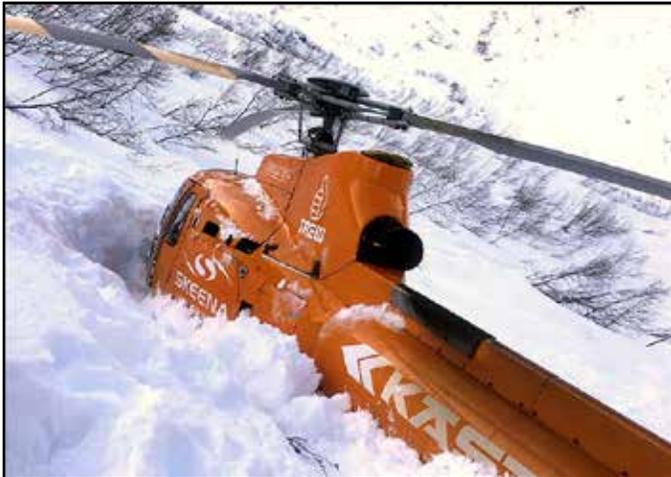
Figure 4. Occurrence site, showing side view of C-FBLW
(Source: TRK Helicopters Ltd.)
