## AVIATION INVESTIGATION REPORT A16P0186

### **Loss of control and collision with terrain**

Cessna Citation 500, C-GTNG

13 October 2016

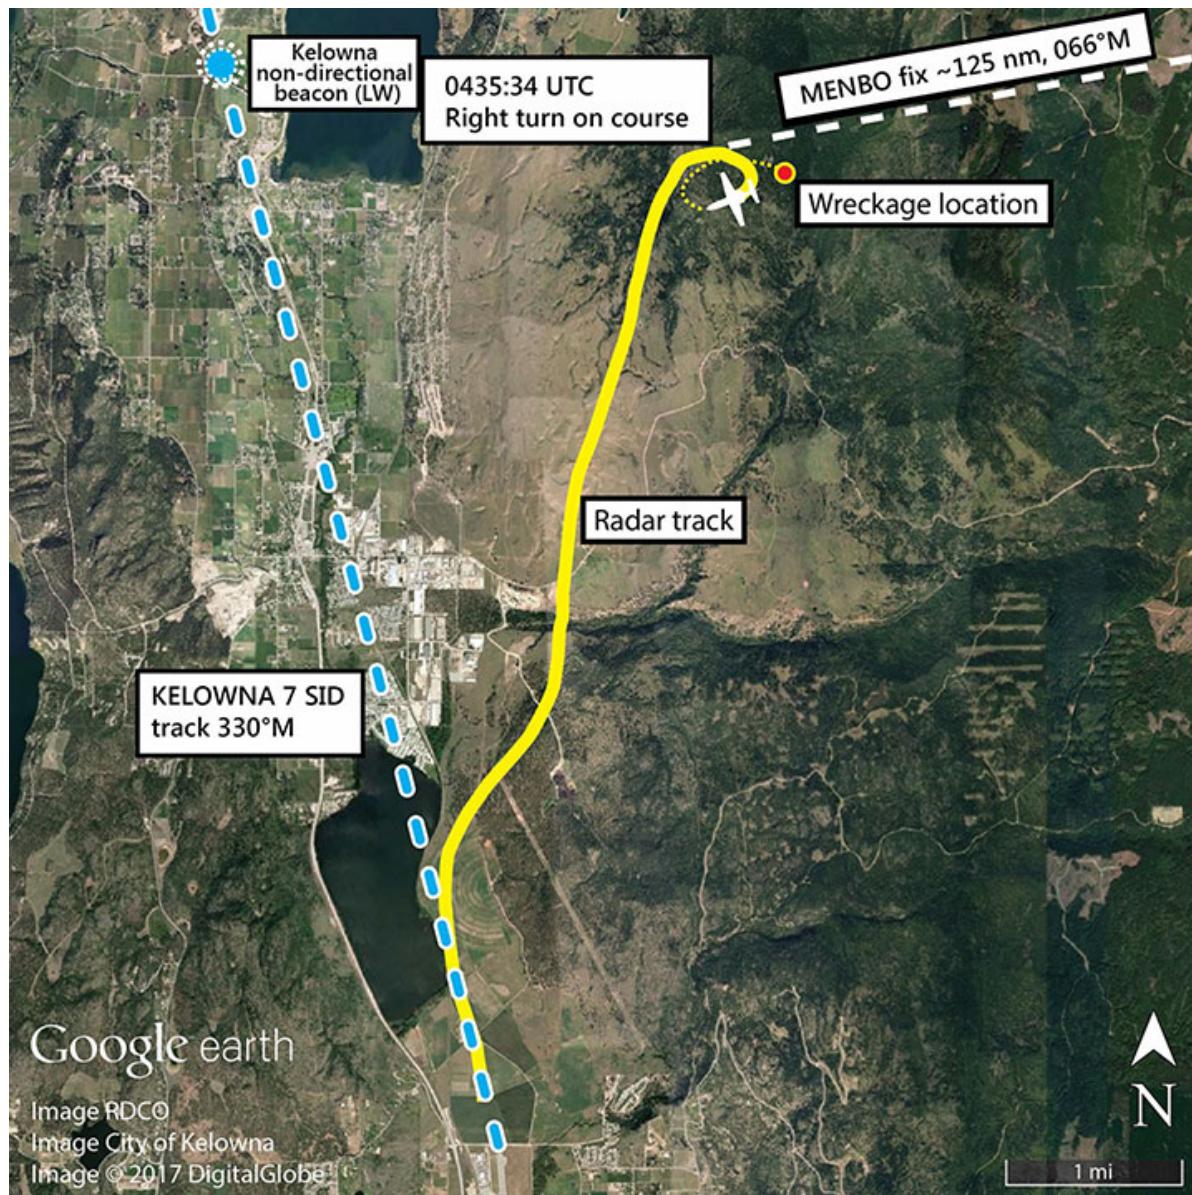
Figure 1. Overhead view of C-GTNG's flight path (Source: Google Earth, with TSB annotations)

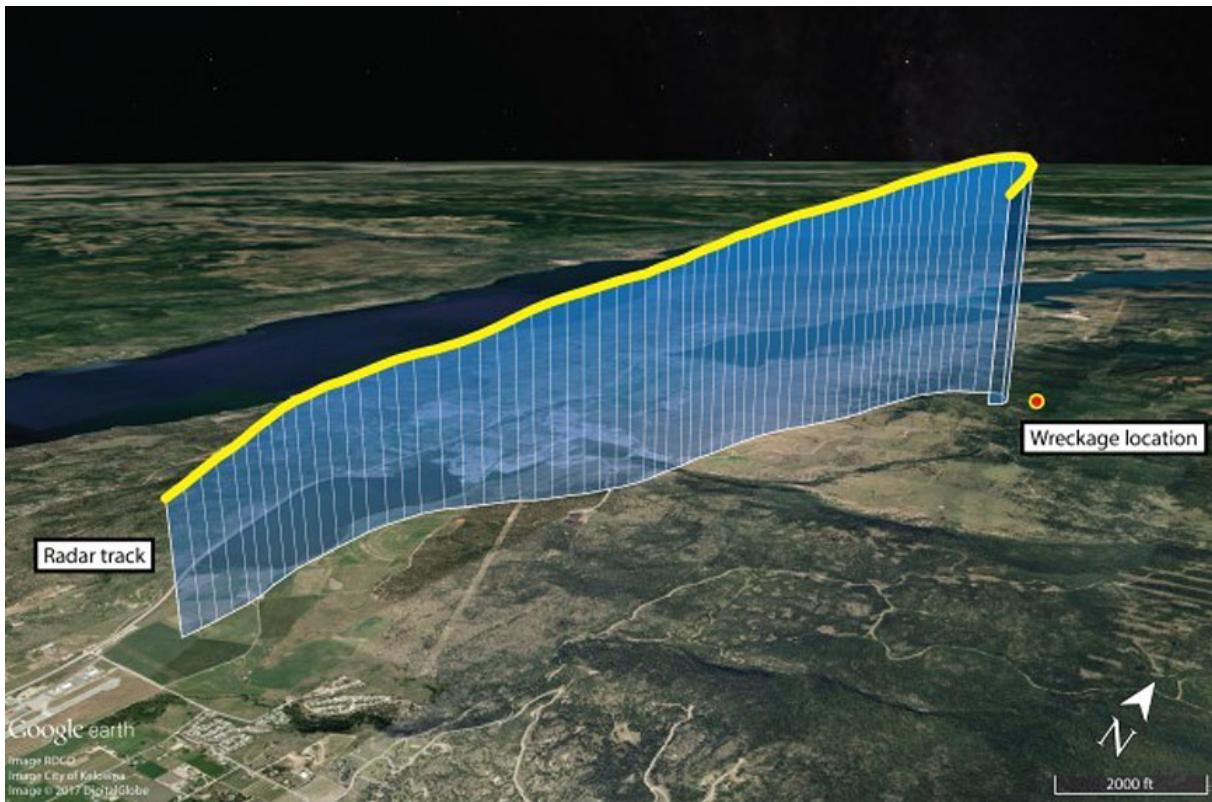
Figure 2. Side view of C-GTNG's climb profile (Source: Google Earth, with TSB annotations)

In this occurrence, weather conditions limited visibility shortly after takeoff, requiring the pilot to rely exclusively on flight instruments for information to help orient the aircraft. During the initial climb, and within seconds after takeoff, the aircraft experienced rapid changes in vertical rates of climb, decreasing from 4000 feet per minute (fpm) to 600 fpm within about 20 seconds, then increasing to about 6000 fpm after another 10 seconds. The

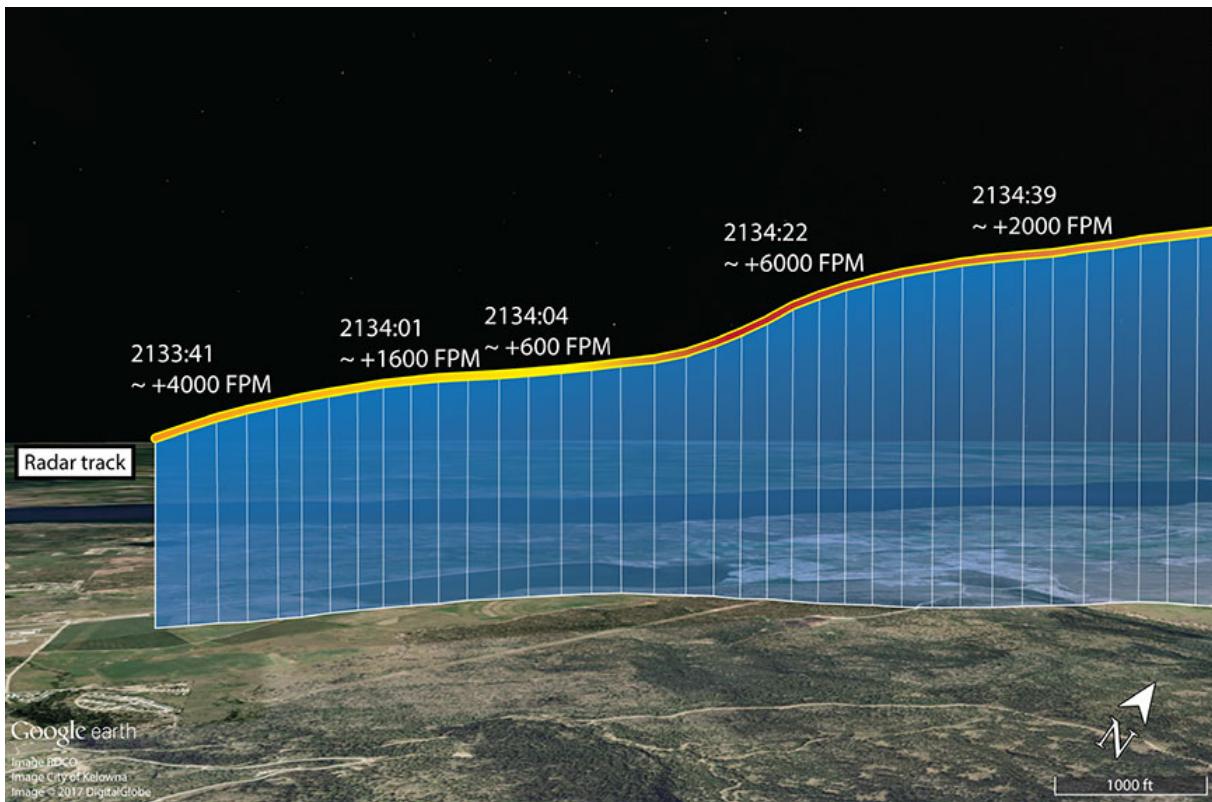
Figure 3. View of C-GTNG's rate of climb from 2133:41 to 2134:39 (Source: Google Earth, with TSB annotations)

Forward, intermittent acceleration during the take-off phase and climb into night IMC conditions, followed by a reduction in vertical airspeed as the aircraft stabilized while approaching 5800 feet ASL, may have increased the risk that the pilot experienced a somatogravic illusion, or erroneous sensation of pitch. If, at the same time, the pilot had made 1 or more head movements to look for or activate a flight control (for example, the autopilot control, which was positioned low on the centre console between the seats), the risk of stimulating the inner ear's semi-circular canals and of producing a Coriolis illusion, and the accompanying sensation of tumbling, would also have increased.

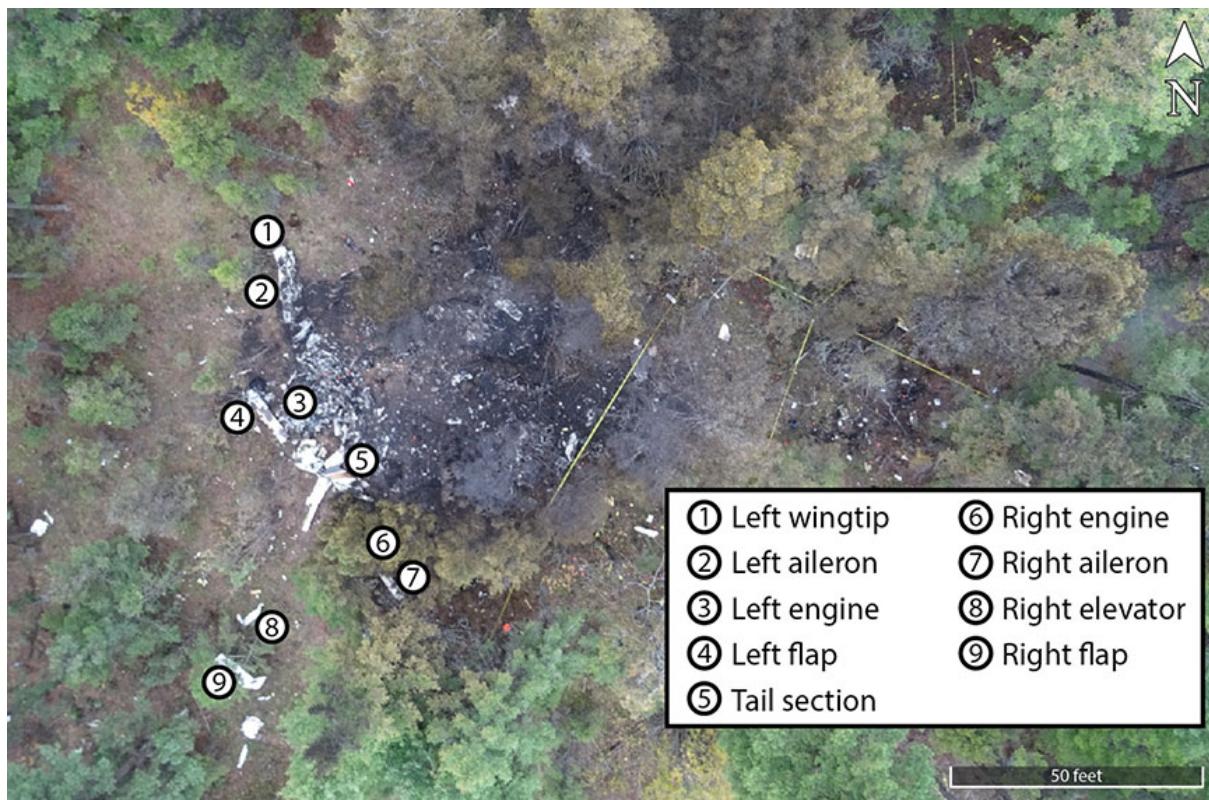
The high-energy impact resulted in a crater approximately 2 feet deep. Fragmented aircraft debris was projected into trees and scattered around an area of approximately 12 000 m<sup>2</sup>. The post-impact fire destroyed the majority of the aircraft structure and scorched approximately 710 m<sup>2</sup> of vegetation surrounding the wreckage (Figure 5).

Figure 5. The wreckage site (Source: Royal Canadian Mounted Police, with TSB annotations)

Both engines were severely damaged from the impact, and the internal components of both displayed features that were indicative of an engine producing significant power at the time of impact.

Inspection of the wreckage determined that all components were accounted for at the site. An inspection of all primary and secondary control cables found that the cables exhibited numerous overload failures and heat damage, likely the result of the impact and subsequent fire. An inspection of the remainder of the aircraft for any pre-impact anomalies was inconclusive owing to the extent of the damage caused by the impact forces and post-impact fire.
