Air Transportation Safety Investigation Report A18C0064

STALL AND COLLISION WITH TERRAIN

Clayton Air Service
Cessna A188B AGtruck (crop sprayer), C-GMXO
Carrot River, Saskatchewan, 3.5 nm E
12 July 2018

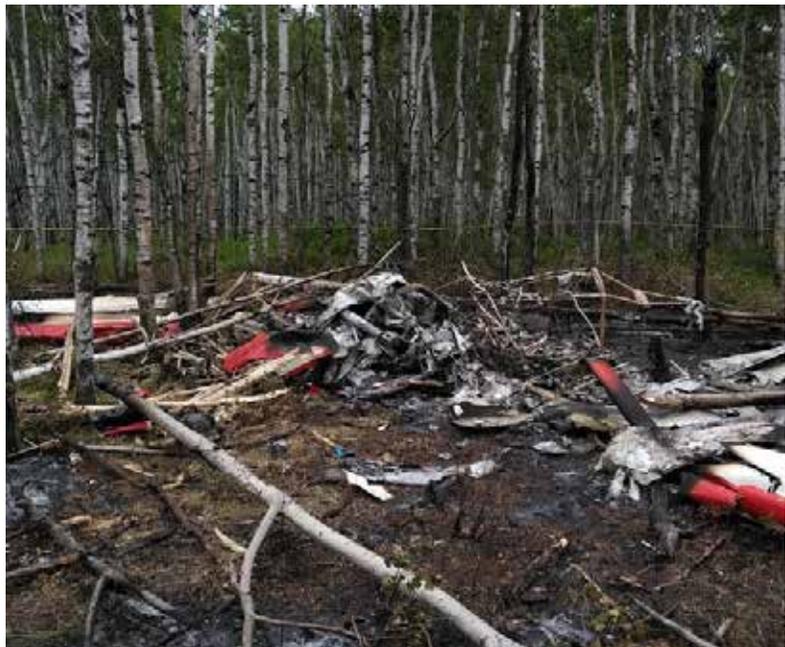
Figure 2. Wreckage site

The aircraft struck the ground in a wooded area at a very shallow pitch angle with a high rate of vertical descent, likely in a left turn, and came to a rest facing a northwesterly direction (Figure 2). The aircraft had little forward speed and did not leave a wreckage trail. This type of surrounding damage is indicative of an aerodynamic stall² from a low altitude.

post-impact fire. An inspection of the flight control cables revealed continuity of the elevator, rudder, flaps, and the left aileron. The right aileron cables were found severed and frayed. Analysis of the fractured cable ends revealed cup and cone fracture surfaces, which are indicative of an overload failure during the impact sequence. Damage to the surrounding trees by the propeller indicated that the propeller was rotating and a substantial amount of power was being produced by the engine at the time of impact.
