Air Transportation Safety Investigation Report A18W0025

COLLISION WITH TERRAIN

Sahtu Helicopters Ltd.
Airbus Helicopters AS 350 B2, C-FWCR
Tulita, Northwest Territories, 3 nm WNW
15 February 2018

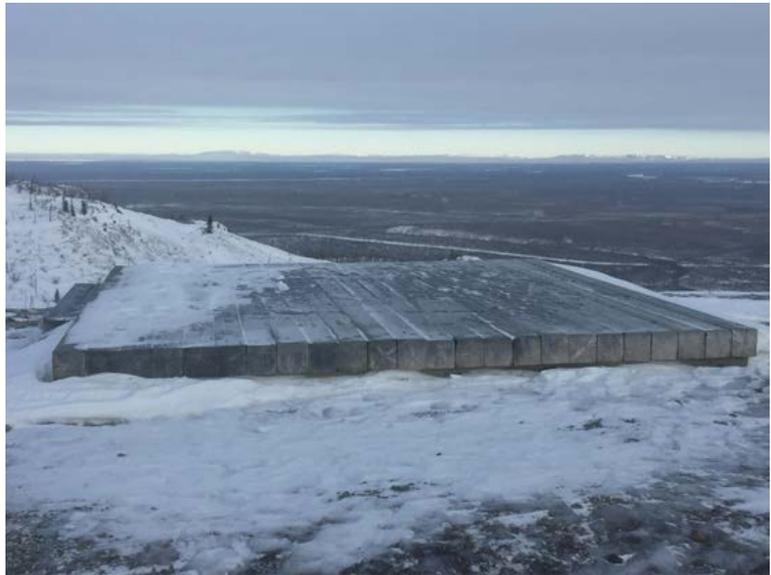
At 0958, the helicopter landed on a helipad near the telecommunications tower and was shut down. The helipad, measuring 16 feet by 16 feet, is made of treated timber and is located 165 feet from the telecommunications tower service building. At the time of the occurrence, the helipad was mostly bare wood; however, there were several patches of ice (Figure 1).

Figure 1. Helipad on Bear Rock (Source: Great Slave Helicopters Ltd.)

The occurrence aircraft was equipped with both of these systems. It is unknown if the flexible steel strips on the aft end of the helicopter skids landed on the bare wood or on the ice patches on the helipad.

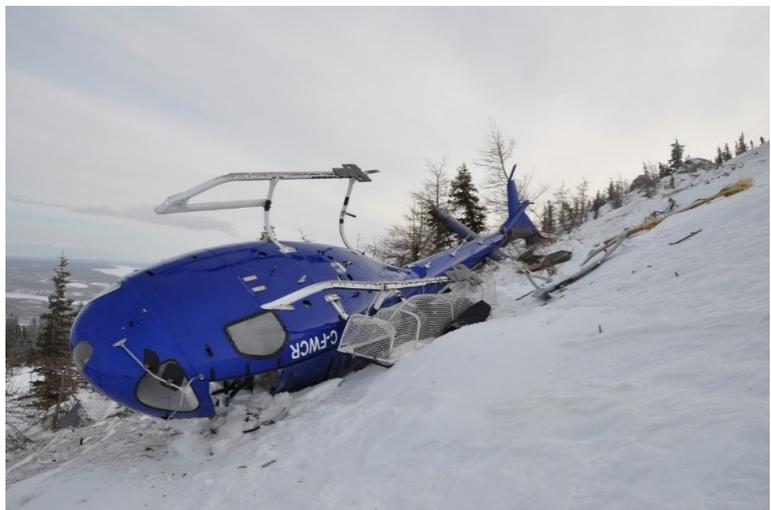
At approximately 1110, the helicopter descended, collided with terrain and came to rest 50 m downslope of the helipad (Figure 2). The emergency

Figure 2. Front side of the occurrence helicopter, looking to the east (Source: Great Slave Helicopters Ltd.)

During the impact sequence in this occurrence, the main rotor head was significantly damaged. Two of the 3 frequency adapters were recovered from the accident site. Examination of the rotor head components did not identify any indications of pre-impact failure.
