AIR TRANSPORTATION SAFETY INVESTIGATION REPORT A19A0055

INADVERTENT DESCENT DURING APPROACH

Canadian Helicopters Offshore
Sikorsky S-92A (helicopter), C-GICB
Halifax, Nova Scotia, 155 NM ESE
24 July 2019

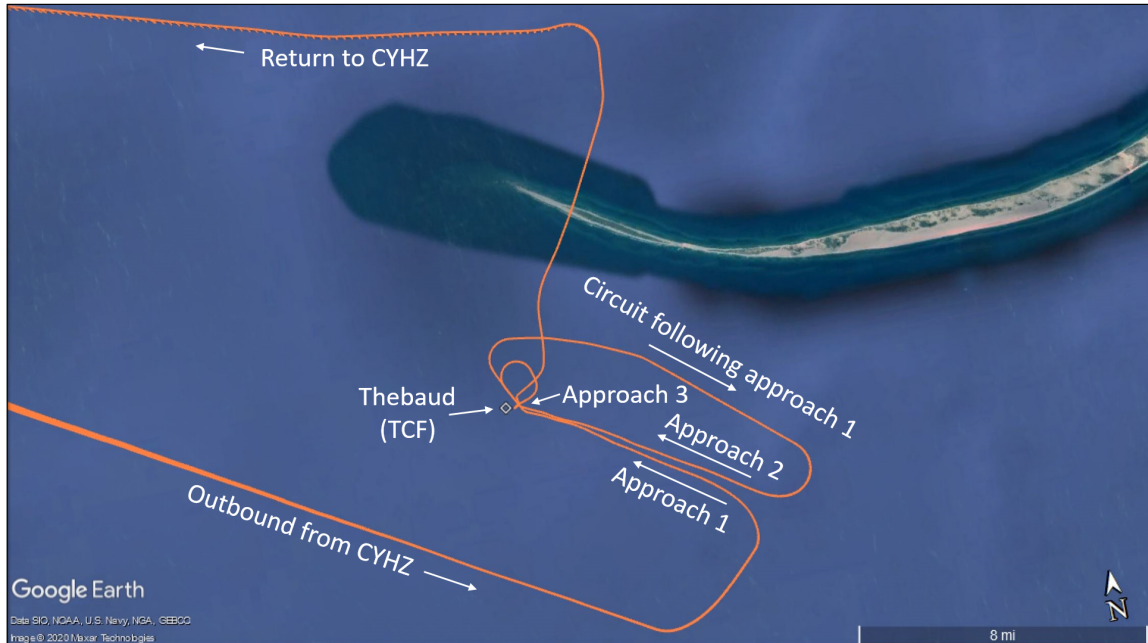
Figure 2. Plot showing occurrence aircraft's approach paths (Source: Google Earth, with TSB annotations)

During both approaches, the pilots initiated a missed approach in accordance with CHO's standard operating procedures (SOPs), because there were insufficient visual cues for landing, at approximately 0.5 NM from the TCF, at 225 feet RADALT and 55 KIAS. To avoid the platform's superstructure, the missed approaches consisted of a climbing right-hand turn, approximately 30°, away from the TCF. The downwind leg of the circuit between the first and second offshore/ARA procedures was flown at 800 feet above the water, on top of the cloud layer, coupled with heading (southeasterly), airspeed, and RADALT hold,¹⁰ roughly 2.0 NM northeast of the inbound approach track. The pilots had decided that they would proceed back to CYHZ if the second instrument approach was unsuccessful.

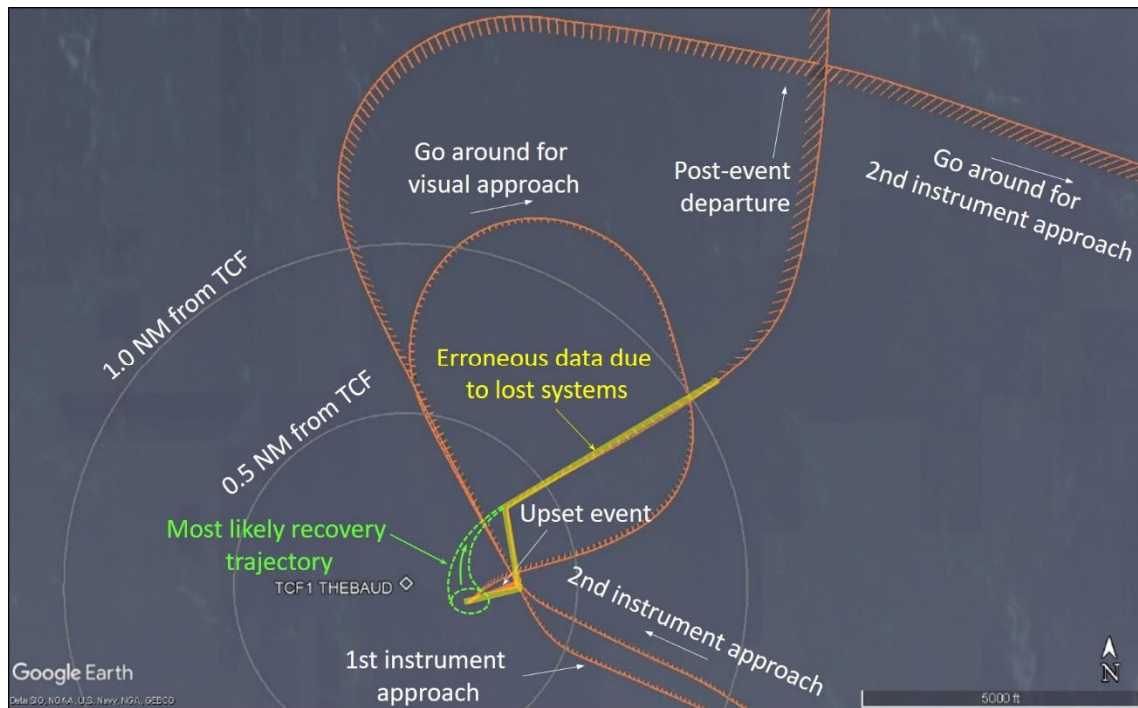
Figure 4. Flight path nearest Thebaud Complex (Source: Google Earth, with TSB annotations)

At 1334:55, the helicopter's altitude peaked at 1350 feet RADALT, then it began descending and the airspeed increased to 125 KIAS. While this was happening, the pilots attempted to engage barometric altitude hold twice; however, in both instances it failed with a master caution light. They also pressed the AFCS mode reset button on the AFCS control panel 8 times, without success.

Unbeknownst to the pilots, airspeed had increased to 148 KIAS, while descending through 650 feet RADALT at 1700 fpm. The PF recognized and arrested the descent at approximately 480 feet ASL (463 feet RADALT) as the helicopter was passing over the northwestern tip of Sable Island.²⁷ The captain then increased collective to regain the lost altitude. The pilots were unaware that the helicopter had overflown Sable Island. The helicopter was levelled off at 1500 feet ASL and the pilots assessed their options. Knowing that there were low clouds and visibility in the vicinity of the TCF and Sable Island, the pilots decided to return to CYHZ, where weather conditions would permit a visual flight rules (VFR) approach to landing.

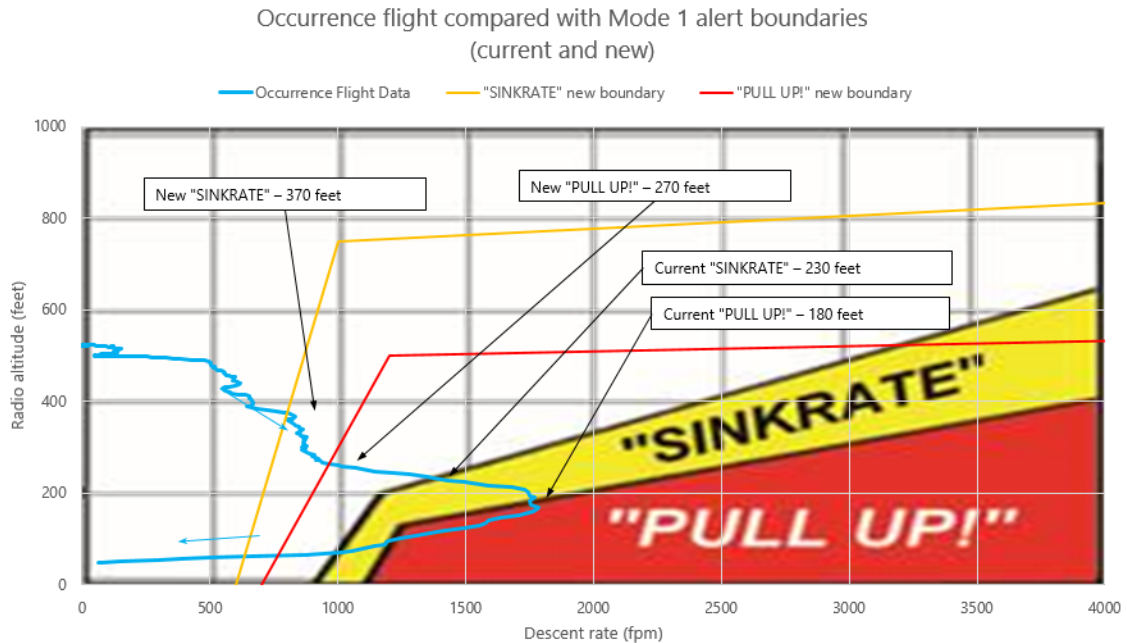
Figure 8. Occurrence flight compared with current and new Mode 1 alert boundaries (Source: Honeywell, with TSB annotations)

Figure 8 shows a comparison of the occurrence flight profile compared to the current and new (EGPWS-036) Mode 1 alert envelopes.

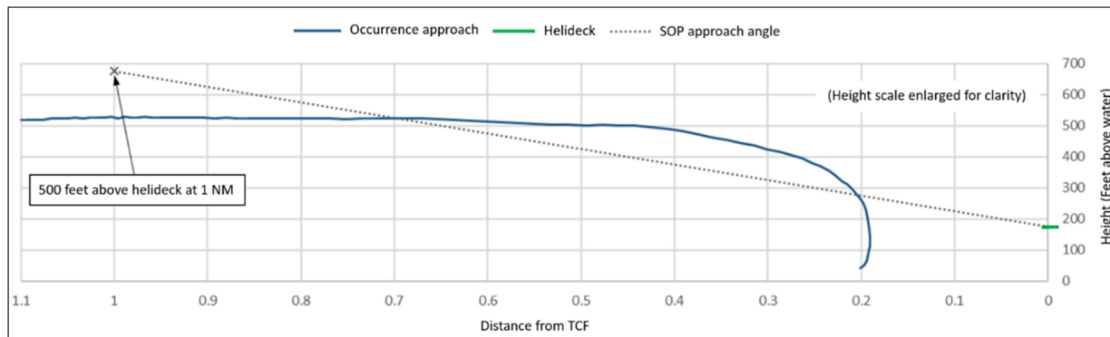
Figure 16. Vertical profile of occurrence flight versus company standard (Source: TSB)

CHO's visual approach procedure did not include any intermediate progress targets (e.g., specific altitude or groundspeed at a certain distance from facility), typically referred to as gates. Gates will be discussed in more detail later in the report.

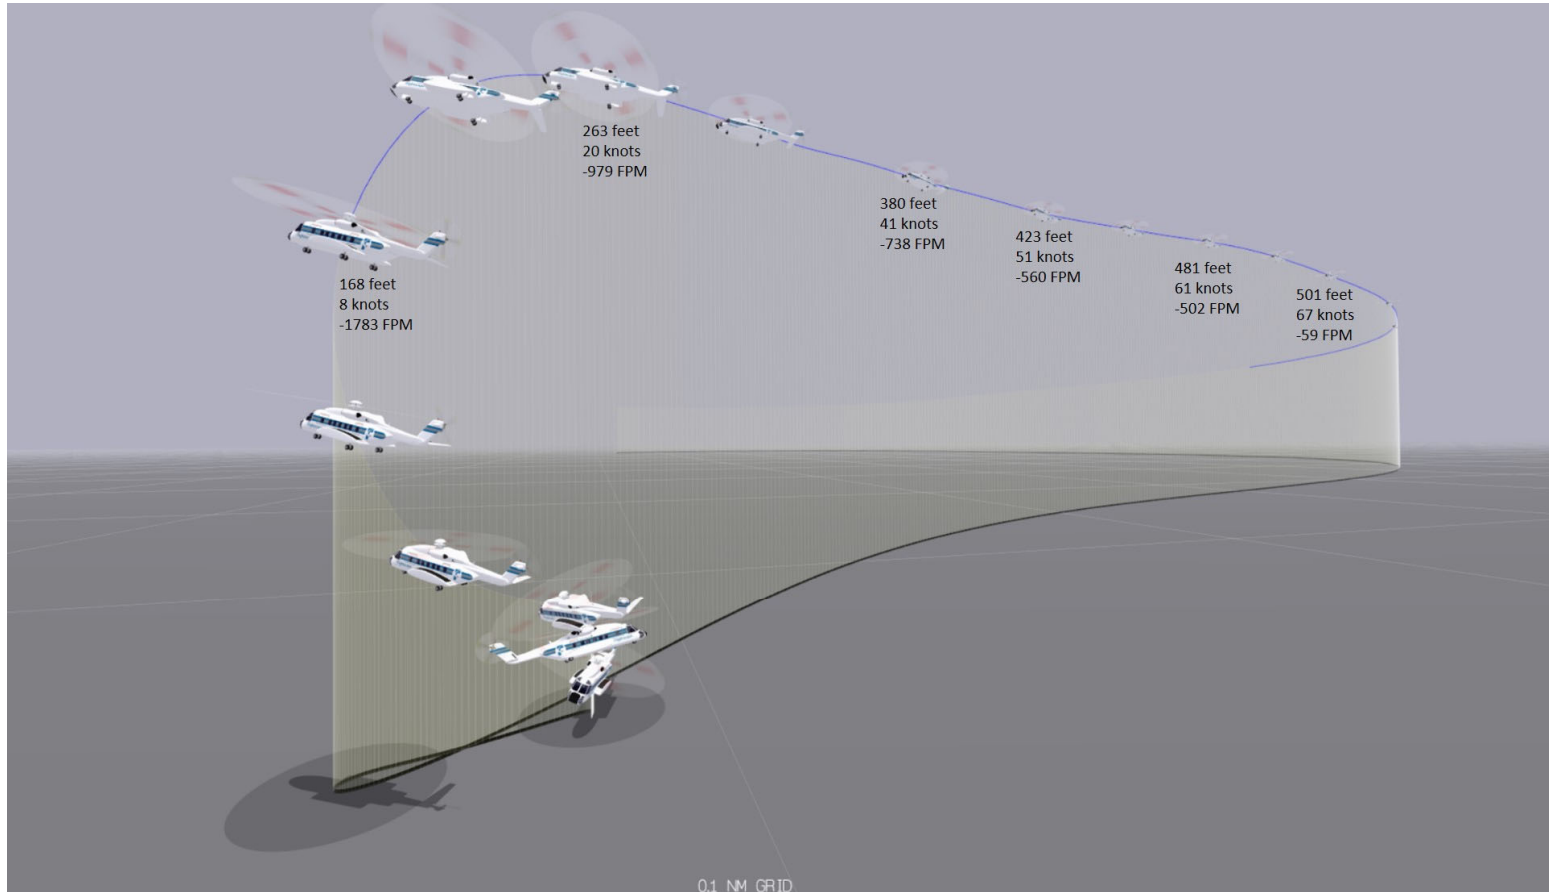
Figure A1. Select points along flight path. Values depicted: radar altitude, total horizontal airspeed in any direction, and vertical speed. View to the west, close up, from low angle.

the right bank (caused by sideslip), peaking at 22° right bank. As engine torque increased from 45% to 103%, at low airspeed, the rate of descent increased from 1200 to 1800 fpm as the helicopter descended below the helideck height; about 3 seconds after the engine torque reached 100%, the descent rate began decreasing (below 1500 fpm) (see Appendix A).

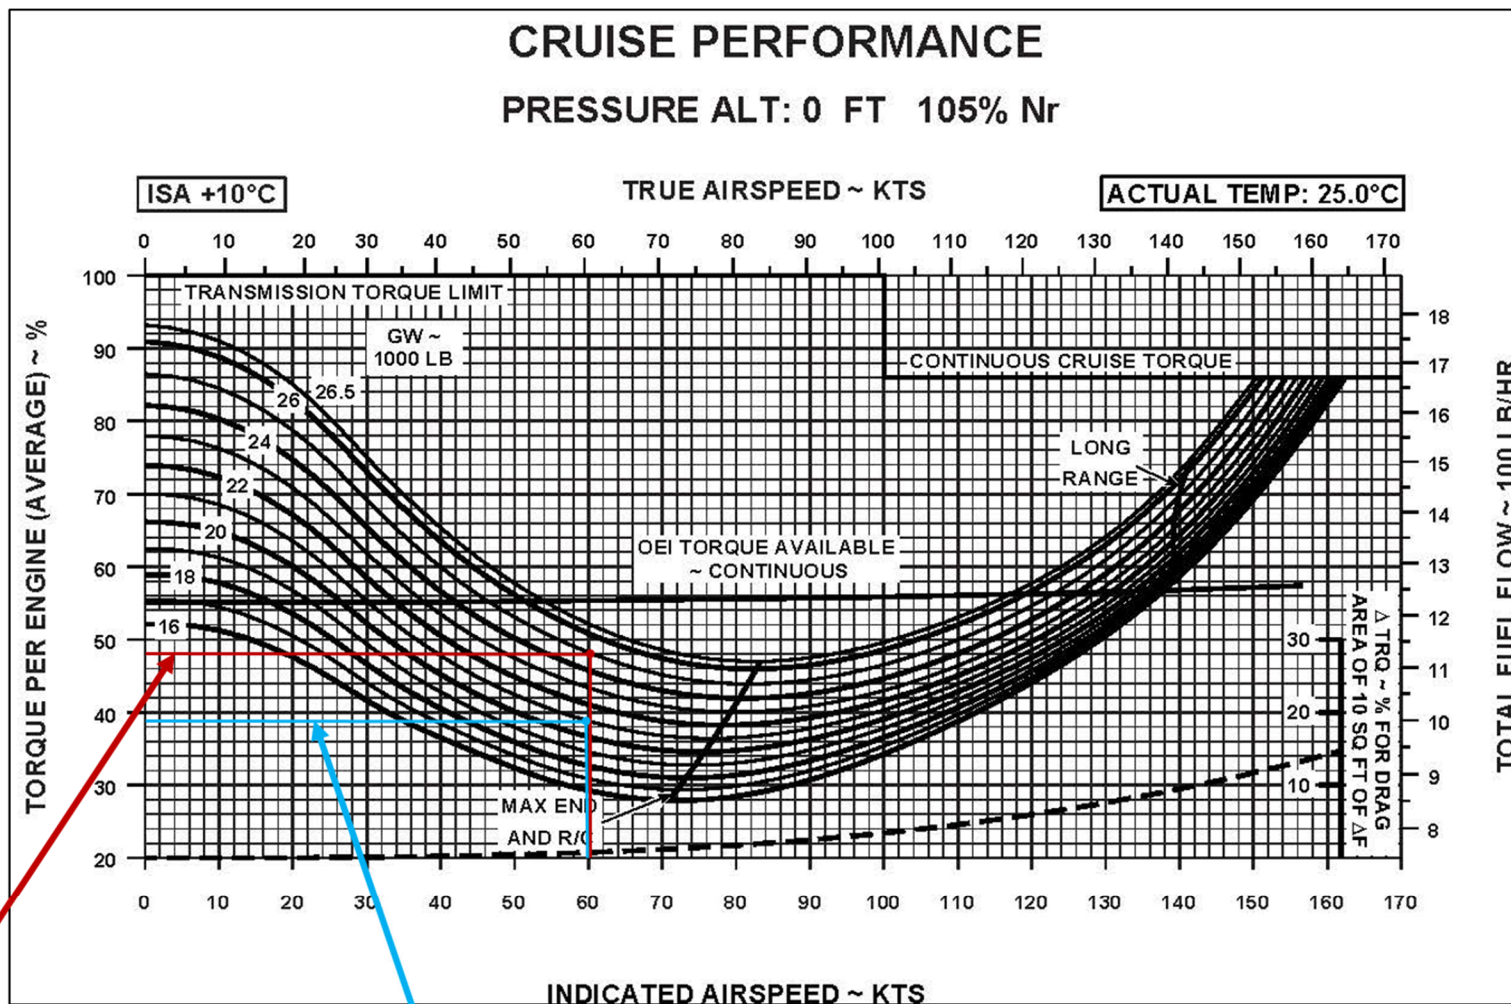
Appendix E – S-92A cruise performance chart (occurrence conditions)

Level at 60 KIAS with a 25 000 pound helicopter would require approximately 48% torque.

500 fpm descent at 60 KIAS would require a 9% torque reduction (based on manufacturer's calculations); therefore, it would be approximately 39%.
